## ASSIGNMENT

#05-01 NTUC TRADE UNION HOUSESINGAPORE 189556			
		Date: 08-11-2018	
		Code: INC4	
<b>1. Policy Particulars :- THIRD PARTY CLAIM</b>			
Insured Veh.	SDY 1368D	Veh. Inspected	SHC 1323B
Policy No.	5082152702-02	Coverage (\$)	0.00
Claim No.	MT/1017764-002	Excess (\$)	0.00
Assign From		Assign Date	29/10/2018
<b>2. Vehicle Particulars &amp; Condition</b>			
Make & Model	TOYOTA PRIUS	c.c	1798
Engine No.	HIDDEN	Year of Reg.	2017
Chassis No.	JTDKB3FU103560560	Colour	BLUE
Odometer	164899	Steering	IN ORDER
Brakes	IN ORDER	Modification	STANDARD ALLOY RIM
General	FAIR		
<b>3. Conditions of Tyres</b>			
	Size	Make	Balance
R/H Front Tyre	195/65 R15	WEST LAKE	7 mm
L/H Front Tyre	195/65 R15	WEST LAKE	7 mm
R/H Rear Tyre	195/65 R15	WEST LAKE	7 mm
L/H Rear Tyre	195/65 R15	WEST LAKE	7 mm
<b>4. Description of Damages</b>			
THE VEHICLE SUSTAINED DAMAGES AT THE REAR N/S PORTION. DAMAGES SEE DETAILS.

## ADJUSTMENT ON REPAIR COST FOR VEHICLE NO. SHC 1323B

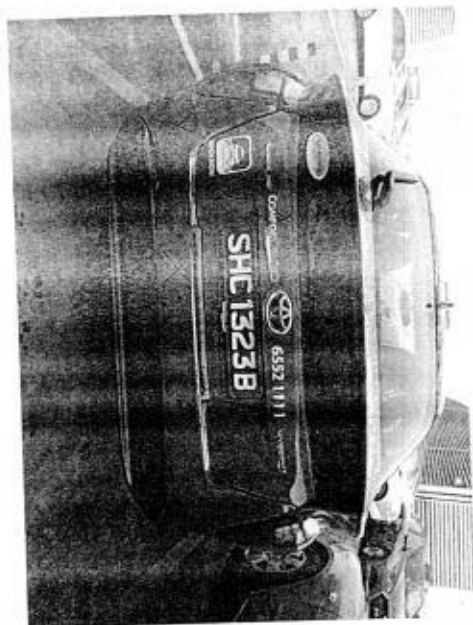
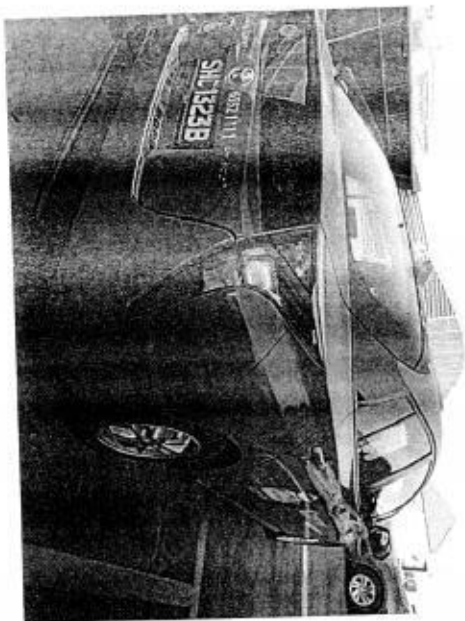
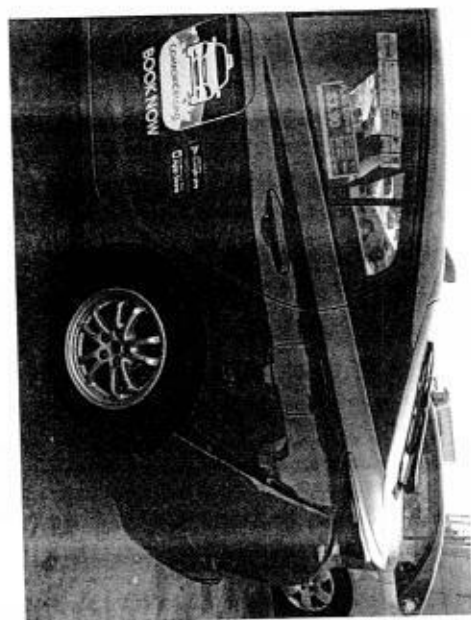
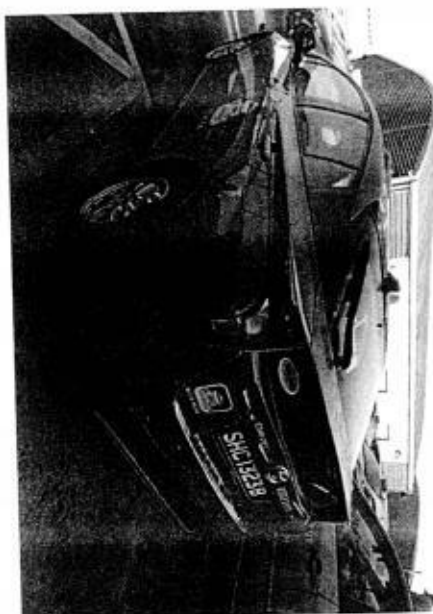
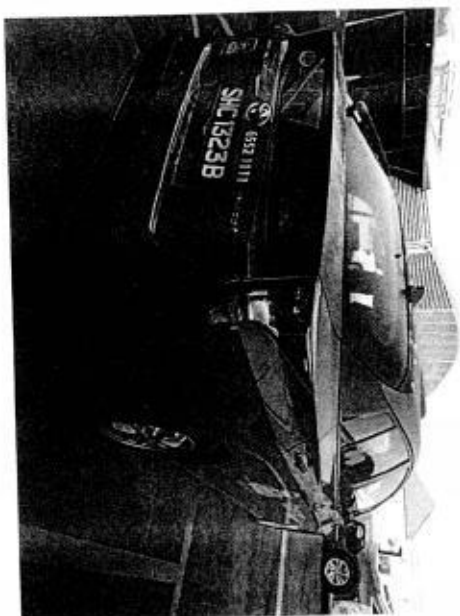
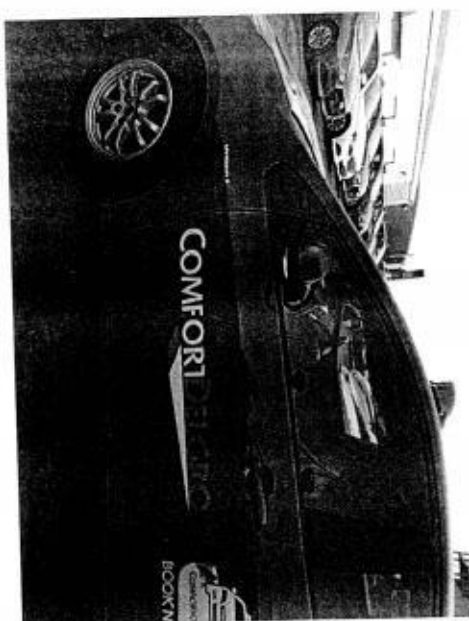
The UIC / Chassis frame / Body Structure affected due to collision.

Qty	Description of Parts	Condition	Estimate By Workshop (\$)	Our Adjusted (\$)
<b>REPLACEMENT OF PARTS</b>				
1	REAR TRUNK LID LOGO (PRIUS)	NECESSARY	52.90	52.90
1	REAR TRUNK LID LOGO (HYBRID)	NECESSARY	52.90	52.90
1	REAR TRUNK LID LOGO (TOYOTA STAR)	NECESSARY	47.00	47.00
1	REAR BUMPER	DEFORMED	458.60	458.60
1	REAR BUMPER RE-INFORCEMENT	SERVICEABLE	318.80	-
1	REAR BUMPER UNDER COVER	CUT	552.60	552.60
1	REAR BUMPER SIDE RETAINER	SERVICEABLE	112.70	-
1	REAR BUMPER UNDER SIDE CENTRE COVER	SERVICEABLE	552.60	-
10	REAR BUMPER CLIPS	NECESSARY	22.00	22.00
1	RETAINER,REAR BUMPER,SIDE,LH	CRACKED	94.80	94.80
1	SEAL,REAR BUMPER SIDE,LH	SERVICEABLE	148.40	-
1	TAIL LAMP ASSY (LOWER)(LH)	CRACKED	548.40	548.40
	LESS 20% DISCOUNT		-592.34	-
	LESS 25% DISCOUNT		-	-457.30
			2,369.36	1,371.90
<b>SPECIAL NETT ITEMS</b>				
1	REAR TRUNK LID APPS STICKER (SN)	NECESSARY	40.00	40.00
1	REAR TRUNK LID COMFORT & TEL NO STICKER (SN)	NECESSARY	60.00	60.00

1	REAR BUMPER METAL PLATE (SN)	SERVICEABLE	50.00	-
			150.00	100.00
<b>LABOUR</b>				
	PANEL BEATING.		400.00	300.00
	SPRAY PAINTING CHARGE.		600.00	400.00
	WIRING CHARGE.		30.00	20.00
	TUFF KOTE.		50.00	-
	REMOVE/REFIX REVERSE SENSOR.		80.00	30.00
		NOT NECESSARY	1,160.00	750.00
<b>GRAND TOTAL</b>			<b>3,679.36</b>	<b>2,221.90</b>

RECOMMENDED COST OF REPAIRS (CONFIRMED)			2,221.90
---	--	--	----------
