To Inspect Vehicle No: SLR 381m Insured: SLP 358S

## ESTIMATE

## FINAL REPORT

## VEHICLE DAMAGE INSPECTION REPORT

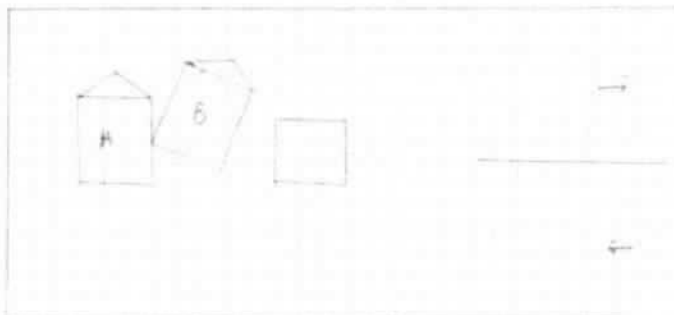
### SKETCH PLAN

A = 2018 KIA  
B = 2018 KIA

On 23/01/2018 at 21:00hrs my vehicle was parked along  
the drop-off point of Sky Habitat Condo when 2018 KIA  
reversed into me. No injuries were sustained in the accident.
