1. Policy Particulars :- THIRD PARTY CLAIM			
Insured Veh.	SJP 8645J	Veh. Inspected	SHD 3350D
Policy No.	5096320067-01	Coverage (\$)	0.00
Claim No.	MT/1017911-002	Excess (\$)	0.00
Assign From		Assign Date	01/11/2018

4. Description of Damages			
THE VEHICLE SUSTAINED DAMAGES AT THE FRONT N/S PORTION. DAMAGES SEE DETAILS.			
5. General Information			
Accident Date	30/10/2018	Inspection Date	01/11/2018
Survey held at	COMFORTDELGRO ENGINEERING PTE LTD 59 LOYANG DRIVE SINGAPORE 508969		
5a. Remarks			
A)THE INSPECTION WAS CONDUCTED ON A"WITHOUT PREJUDICE" BASIS. B)IN ACCORDANCE TO YOUR INSTRUCTIONS, WE HAVE NOT AUTHORISED REPAIRS.			
5b. Estimate Days of Repair			
ESTIMATED NORMAL PERIOD FOR REPAIR:		2 Working Days

ADJUSTMENT ON REPAIR COST FOR VEHICLE NO. SHD 3350D

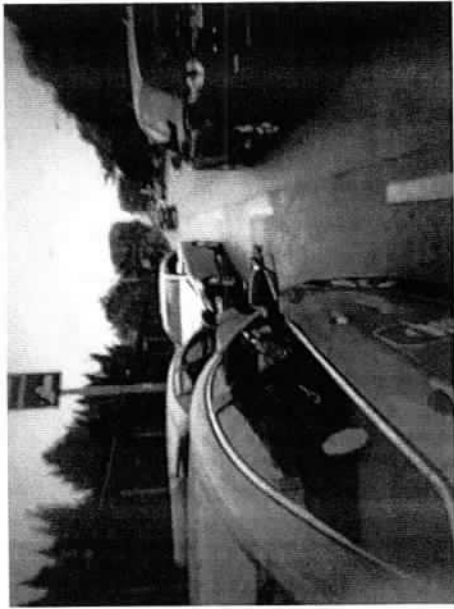
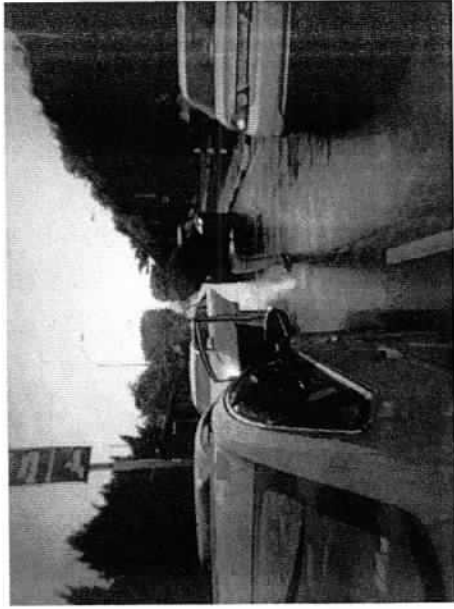
Front n/s

The U/C / Chassis frame / Body Structure affected due to collision.

Qty	Description of Parts	Condition	Estimate By Workshop (\$)	Our Adjusted (\$)
<u>REPLACEMENT OF PARTS</u>				
1	RADIATOR GRILLE	CRACKED	1,110.10	1,110.10
1	RADIATOR GRILLE H EMBLEM	NECESSARY	39.50	39.50
1	FRONT BUMPER COVER	DEFORMED	1,052.20	1,052.20
1	FRONT BUMPER SPONGE	SERVICEABLE	99.20	-
1	FRONT BUMPER REINFORCEMENT	SERVICEABLE	402.10	-
2	FRONT BUMPER BRACKET TOP (LH/RH) @\$22.40	SERVICEABLE	44.80	-
2	FRONT BUMPER BRACKET (LH/RH) @\$24.60	SERVICEABLE	49.20	-
	LESS 20% DISCOUNT		-559.42	-440.36
			2,237.68	1,761.44
<u>NETT ITEMS</u>				
1	FRONT NUMBER PLATE (N)	CRACKED	25.00	25.00
1	FRONT NO PLATE TRIM COVER (N)	CRACKED	30.00	30.00
	LESS 10% DISCOUNT		-	-5.50

55.00	49.50
<u>LABOUR</u>				
	PANEL BEATING.		400.00	200.00
	SPRAY PAINTING CHARGE.		300.00	200.00
	TOWING FEES.	NOT NECESSARY	60.00	-
			760.00	400.00
GRAND TOTAL			3,052.68	2,210.94
RECOMMENDED COST OF LUMP SUM REPAIRS (TO ITS PRE-ACCIDENT CONDITION) (CONFIRMED)				1,750.00
