Vehicle : Toyota Dyna (with Canopy) (M) - YL 8332 E

VEHICLE INSPECTION REPORT

Report No. TP/0110/01/18	Date of Report	: 3 October 18
To : New Castle Builders Pte Ltd	Date of Request	: 21 September 18
	Report requested by	: New Castle Builders Pte Ltd
63, Hillview Avenue, #07-05	Date of Accident	: 15 September 18
Lam Soon Industrial Building	Date of Inspection	: 21 September 18
Singapore 669569	Claim No.	: Third Party Claim

VEHICLE DAMAGE INSPECTION REPORT

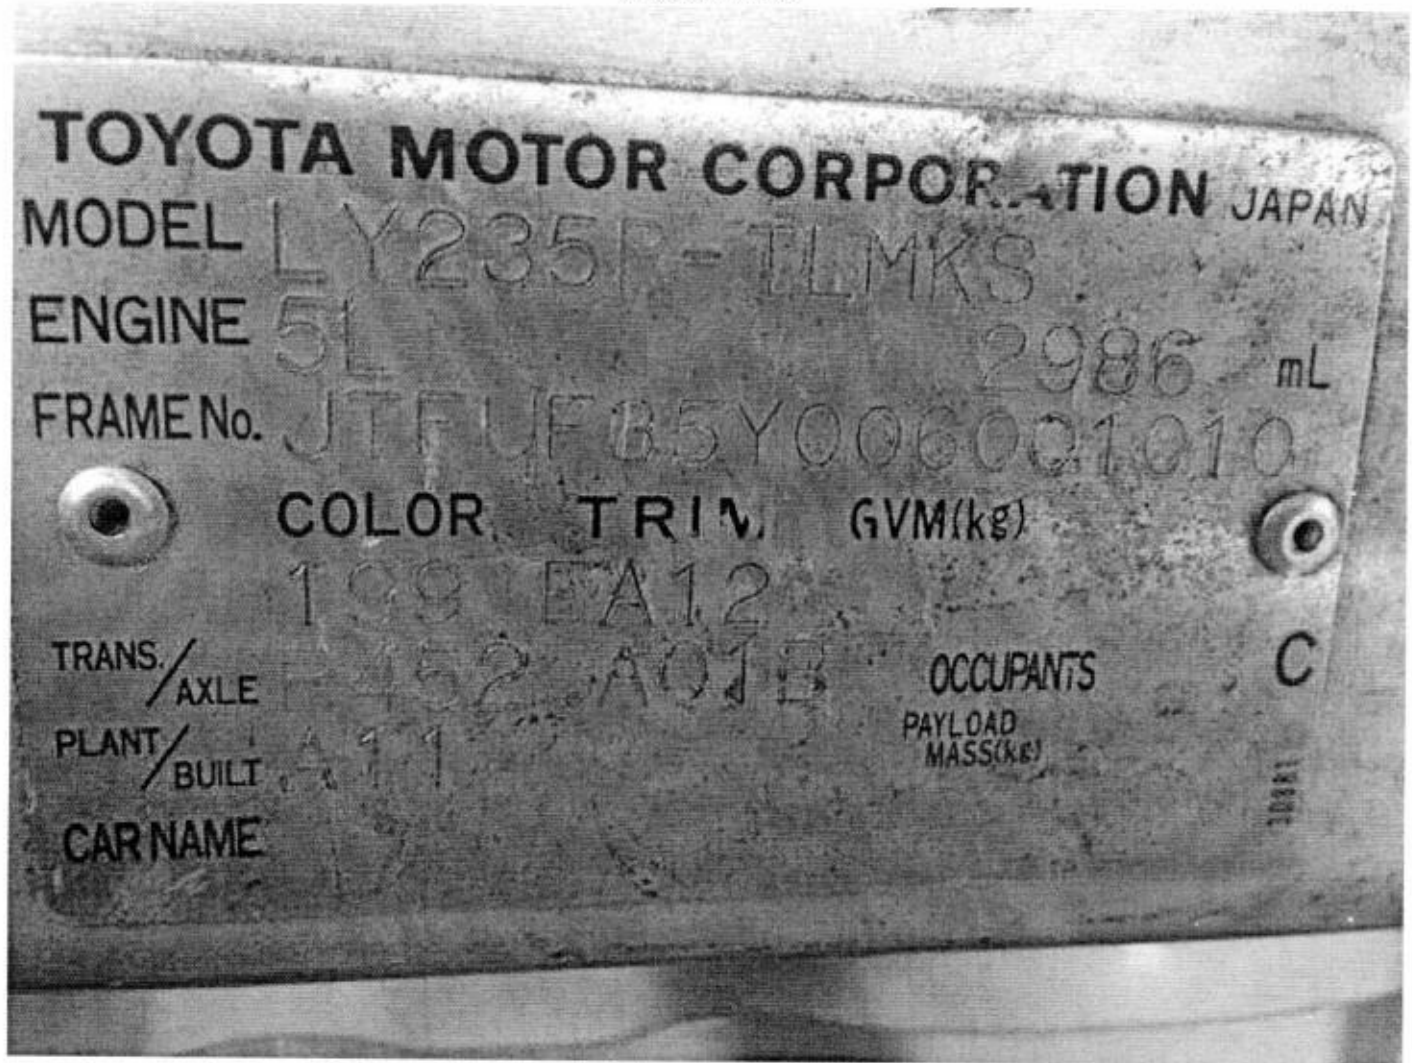
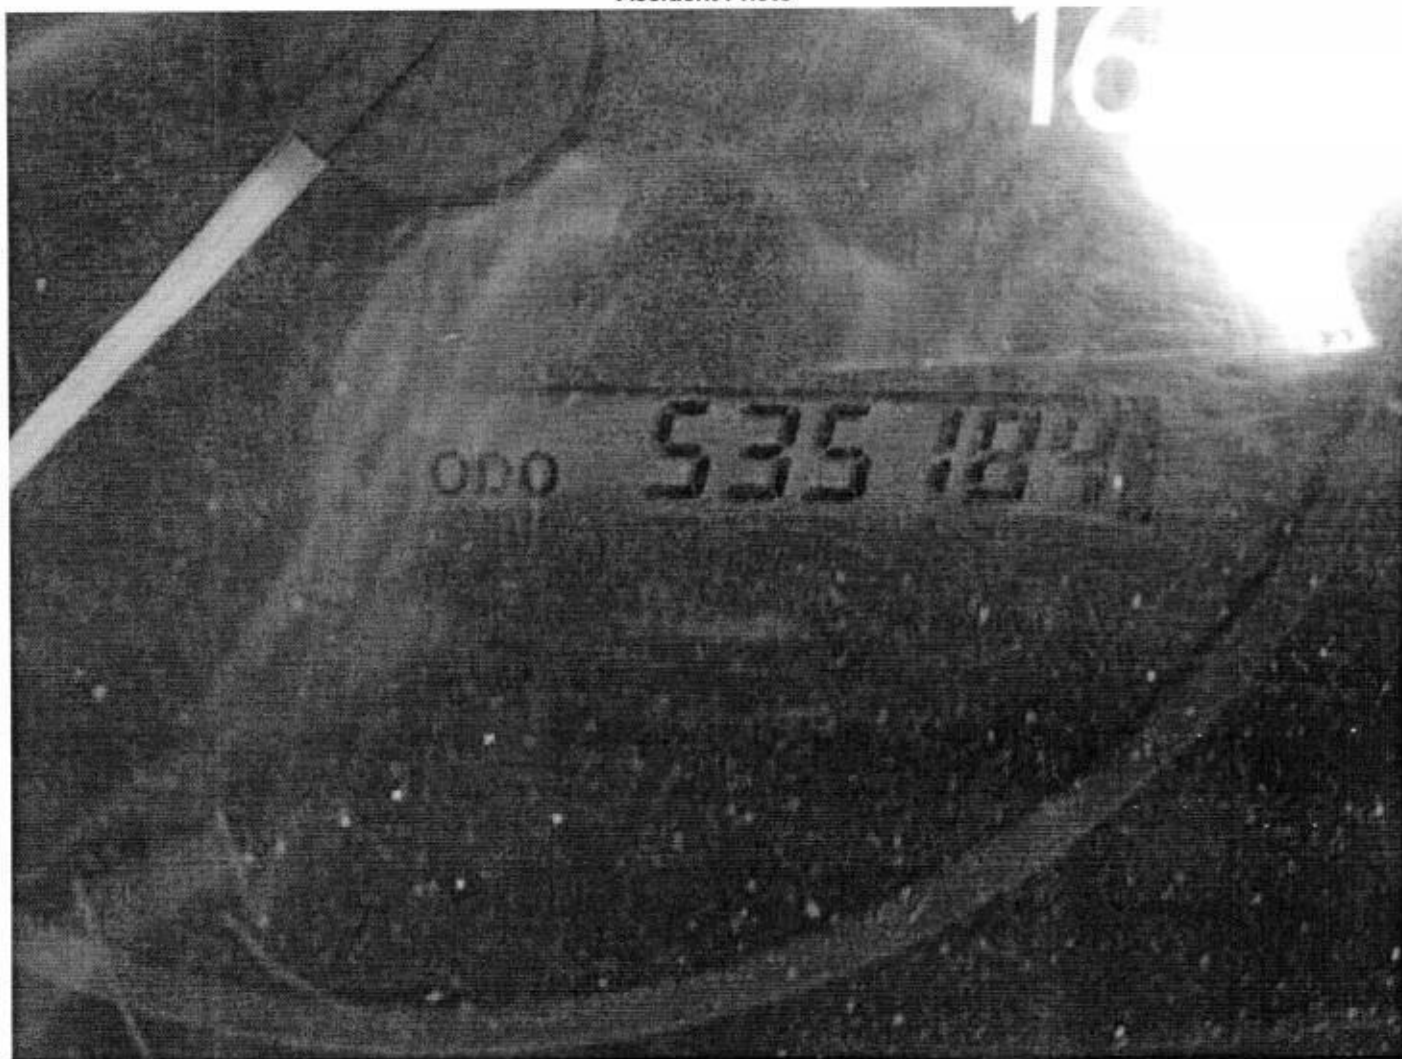
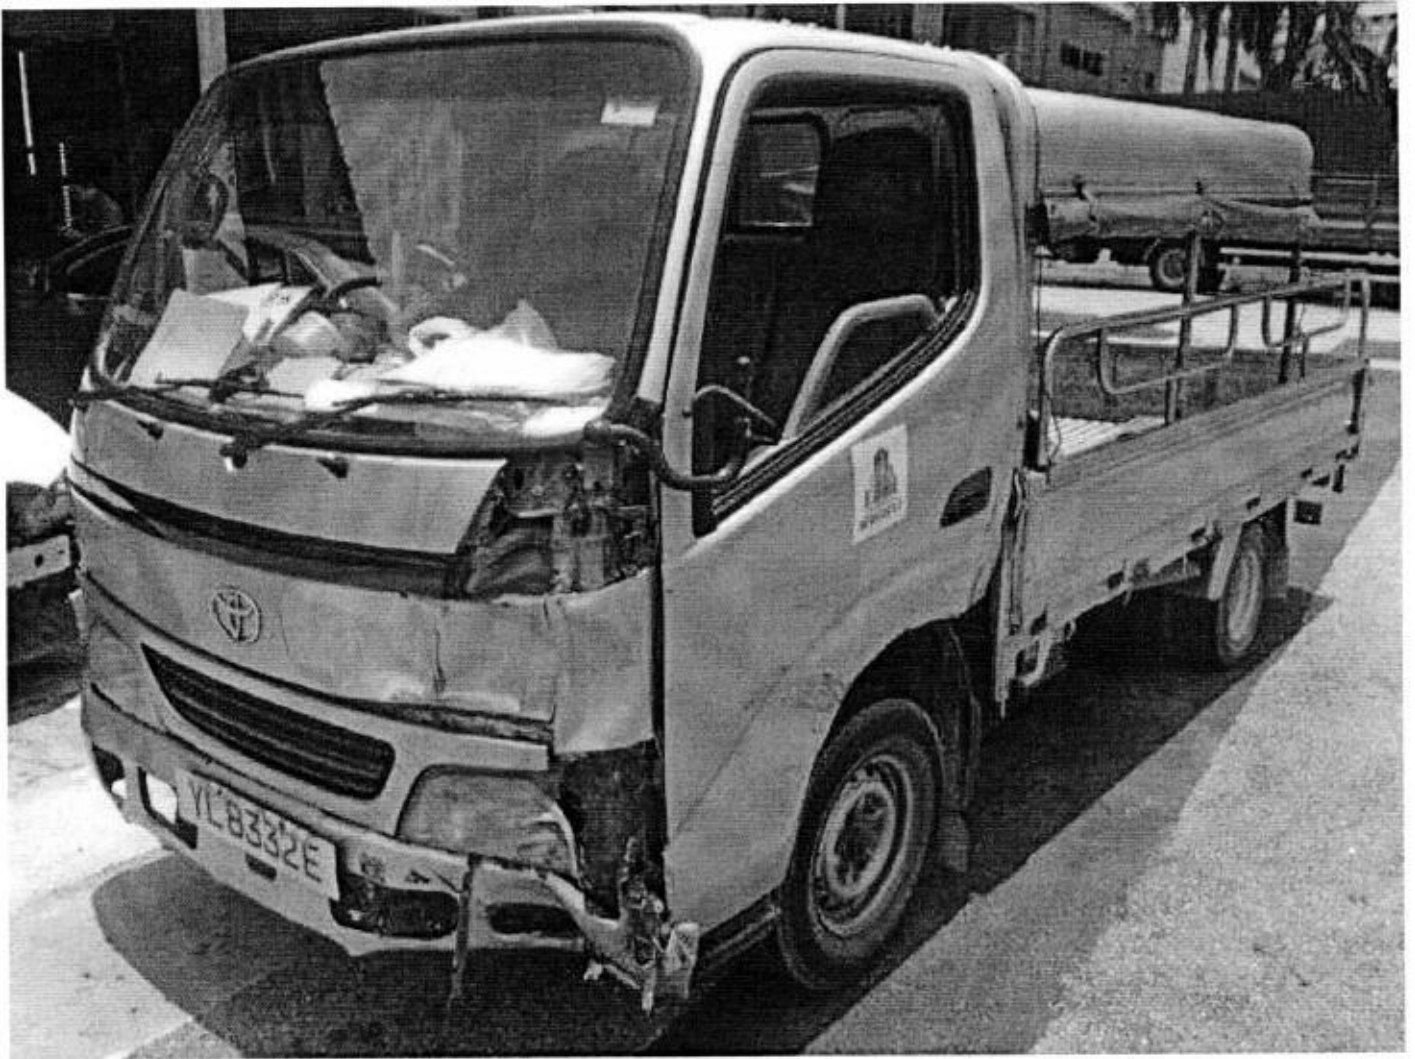
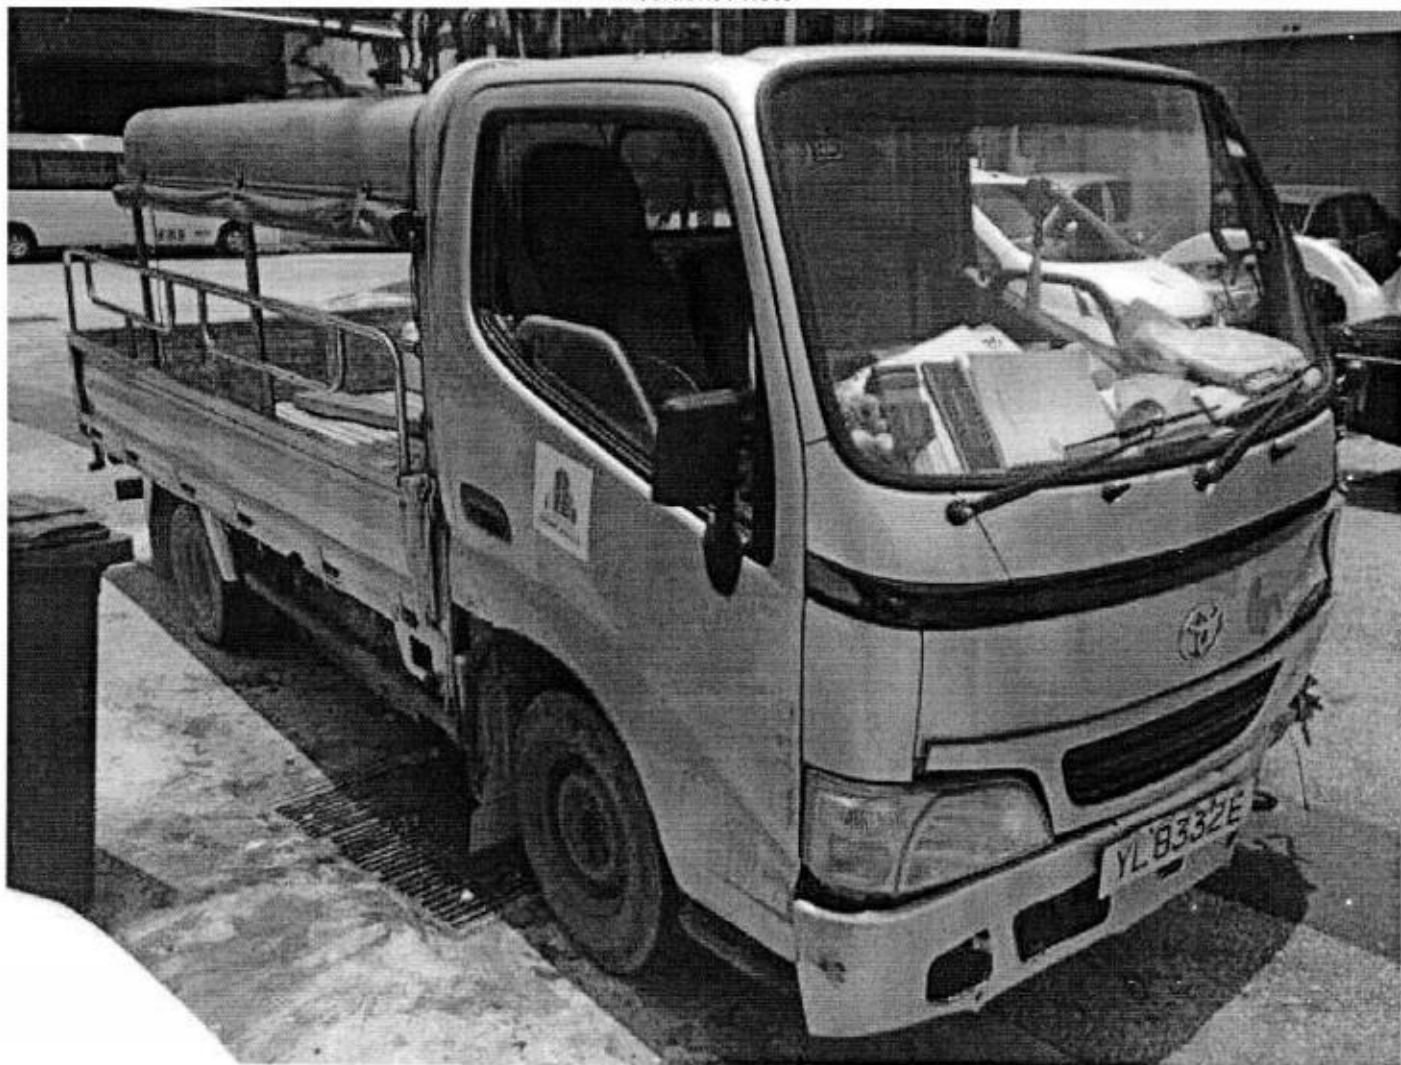
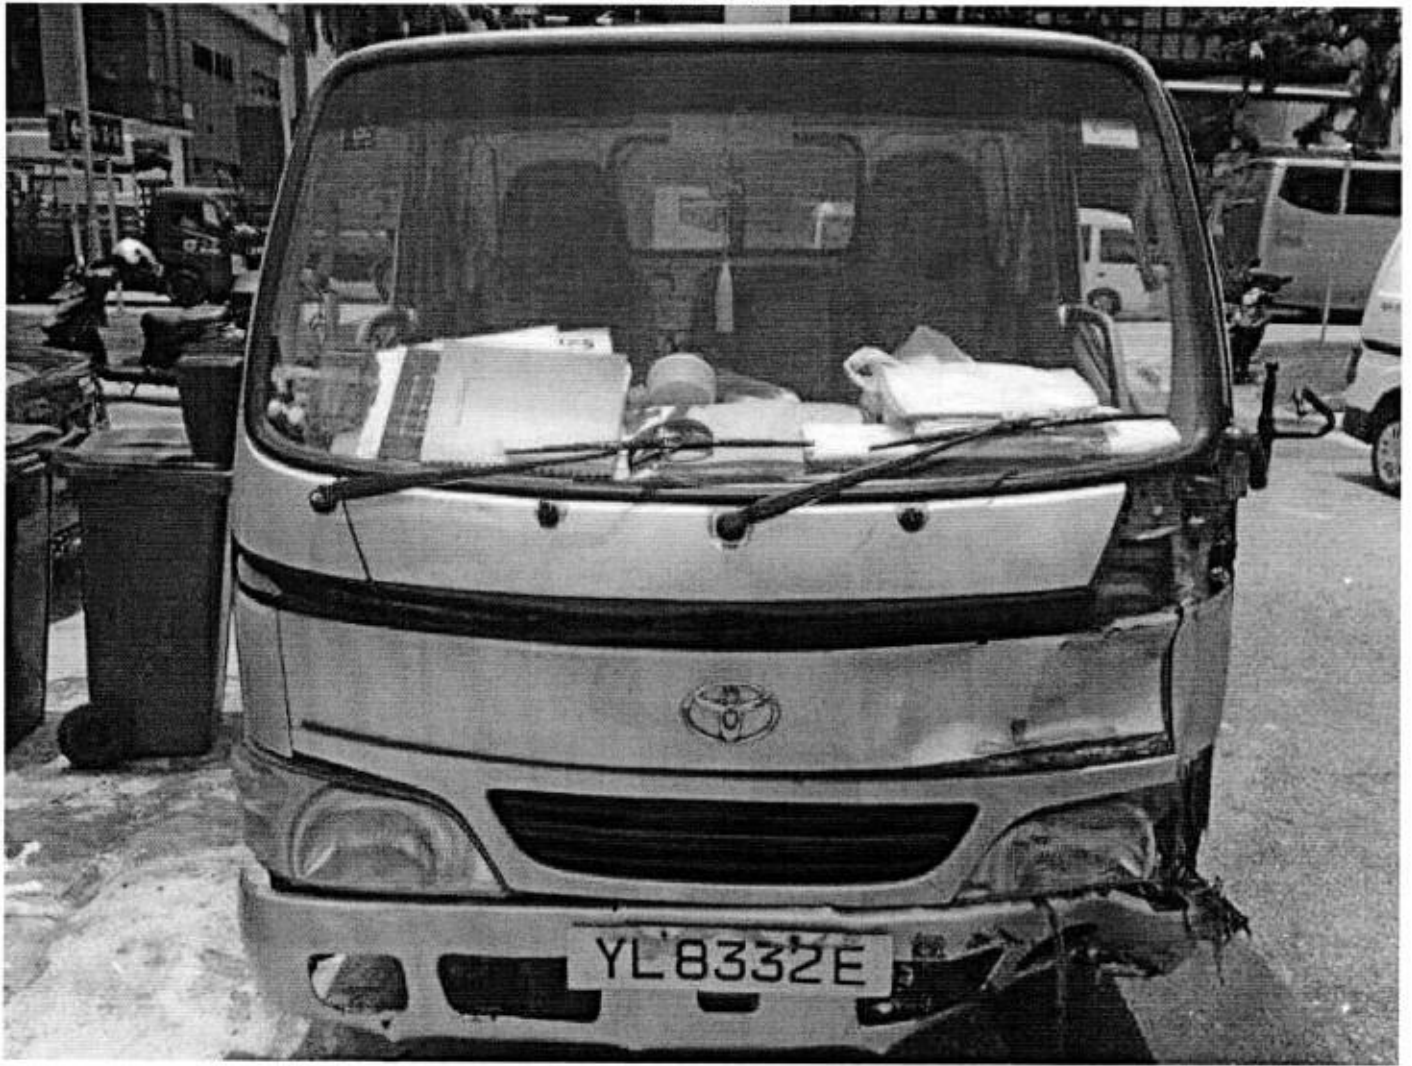
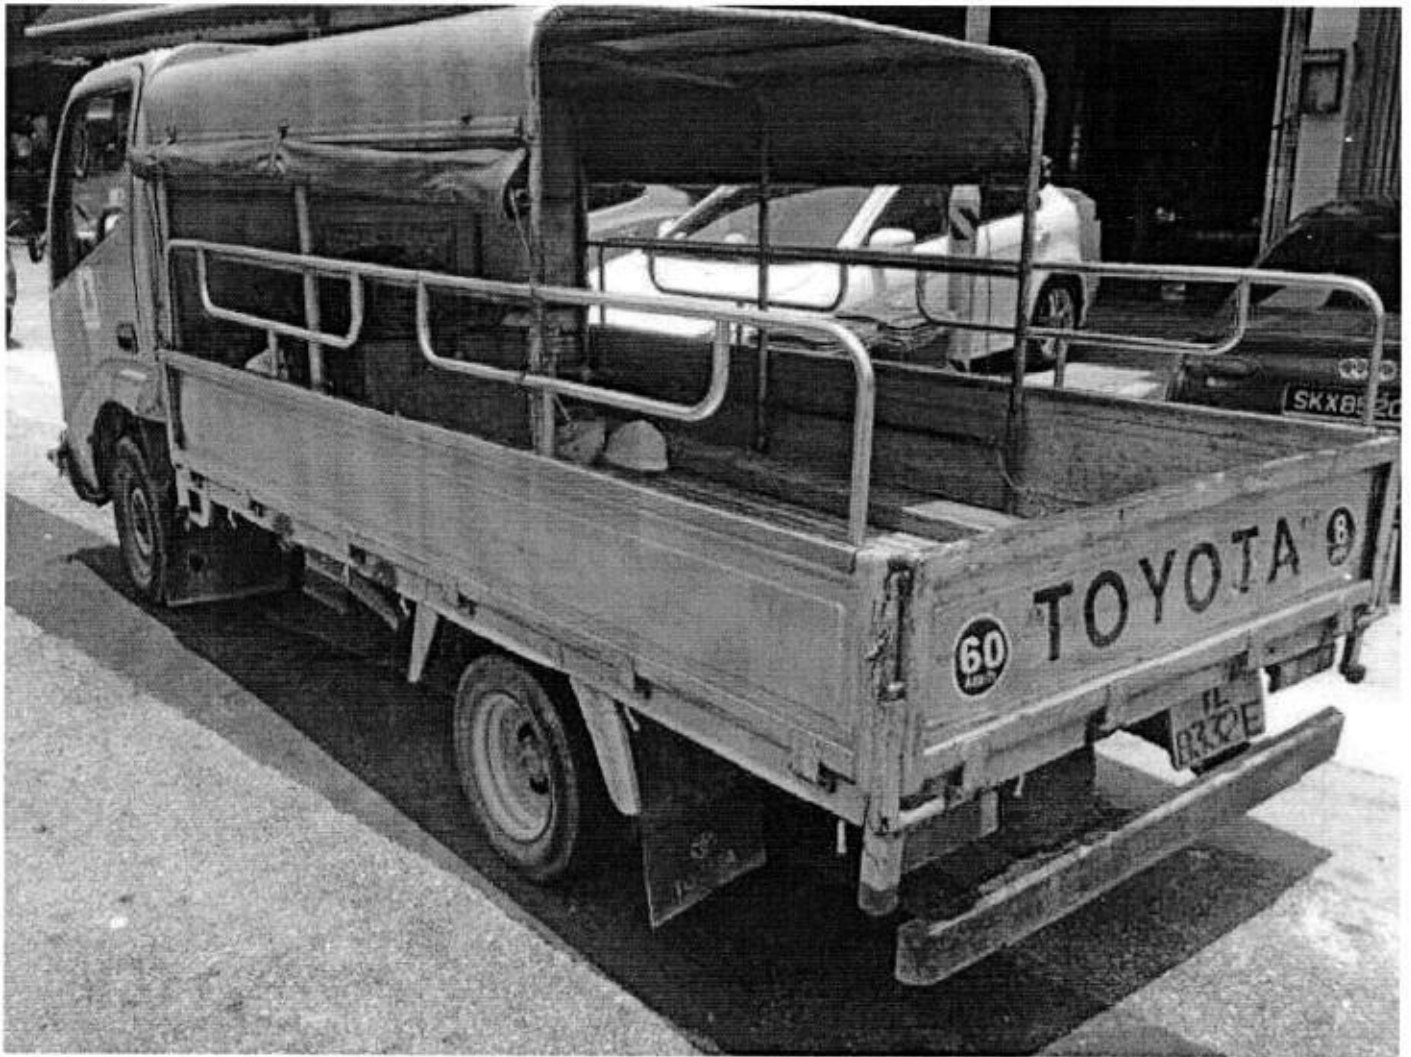
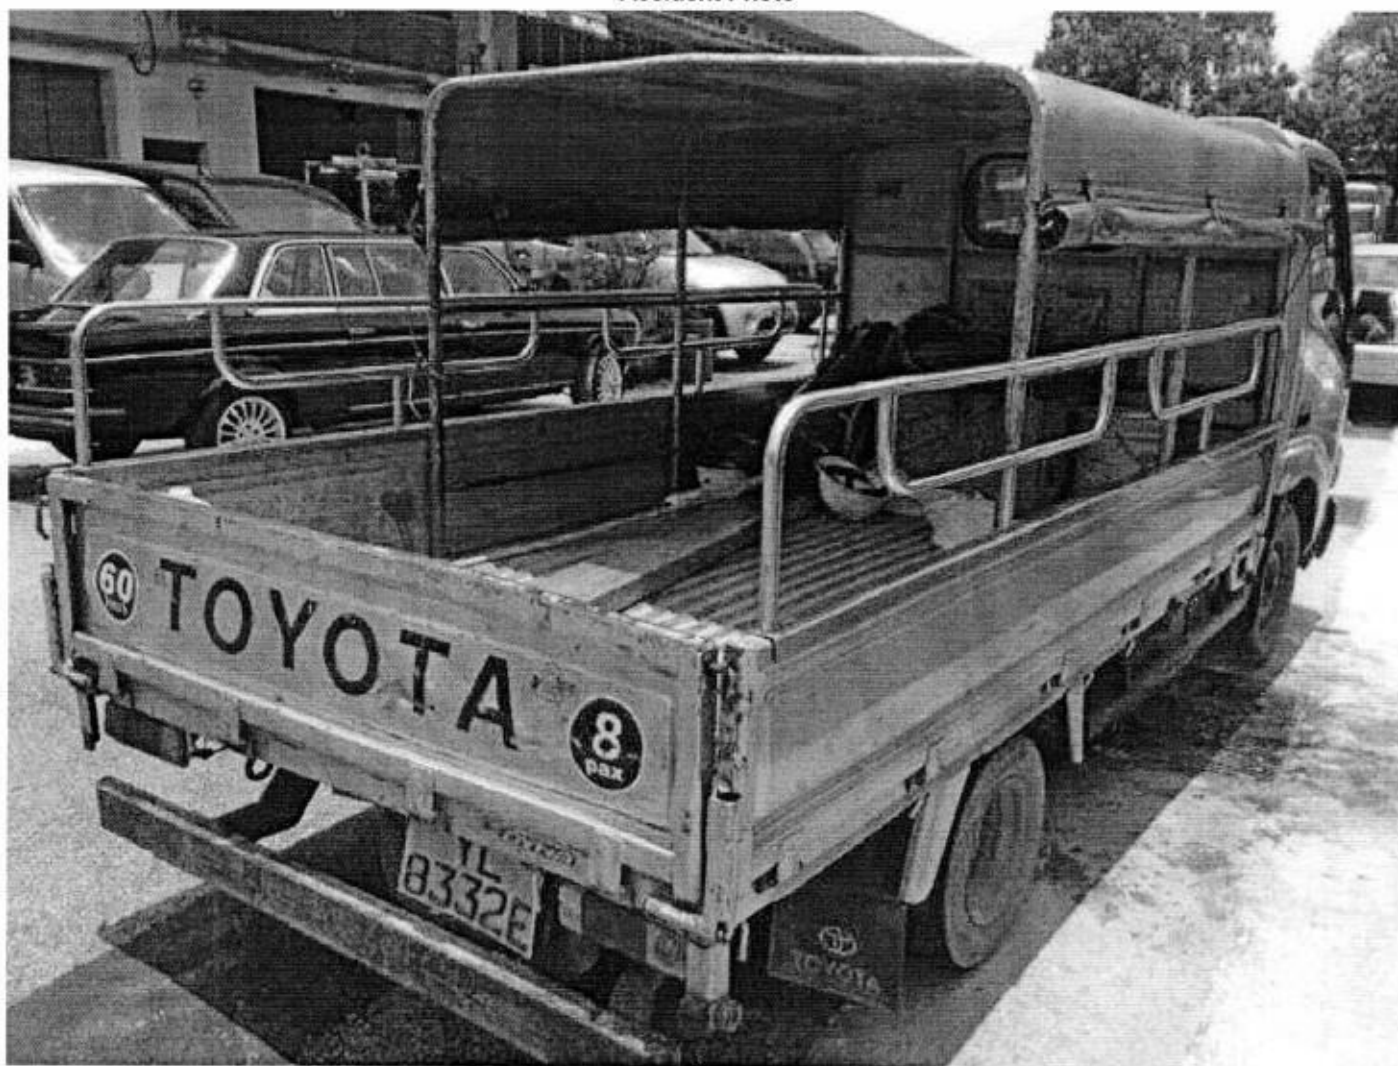
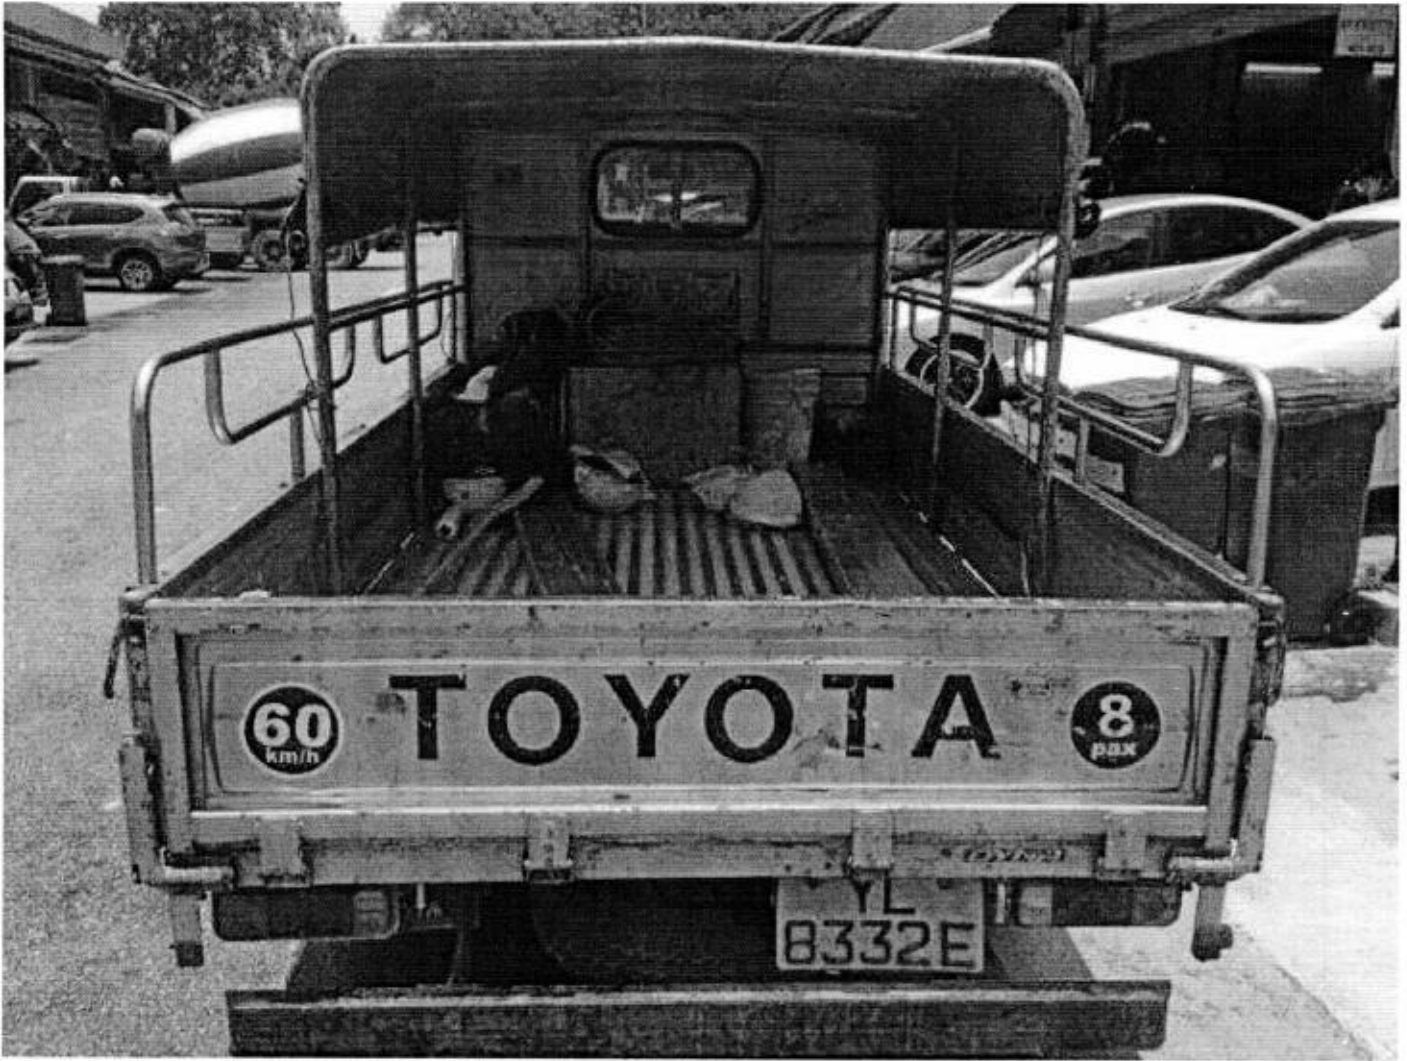
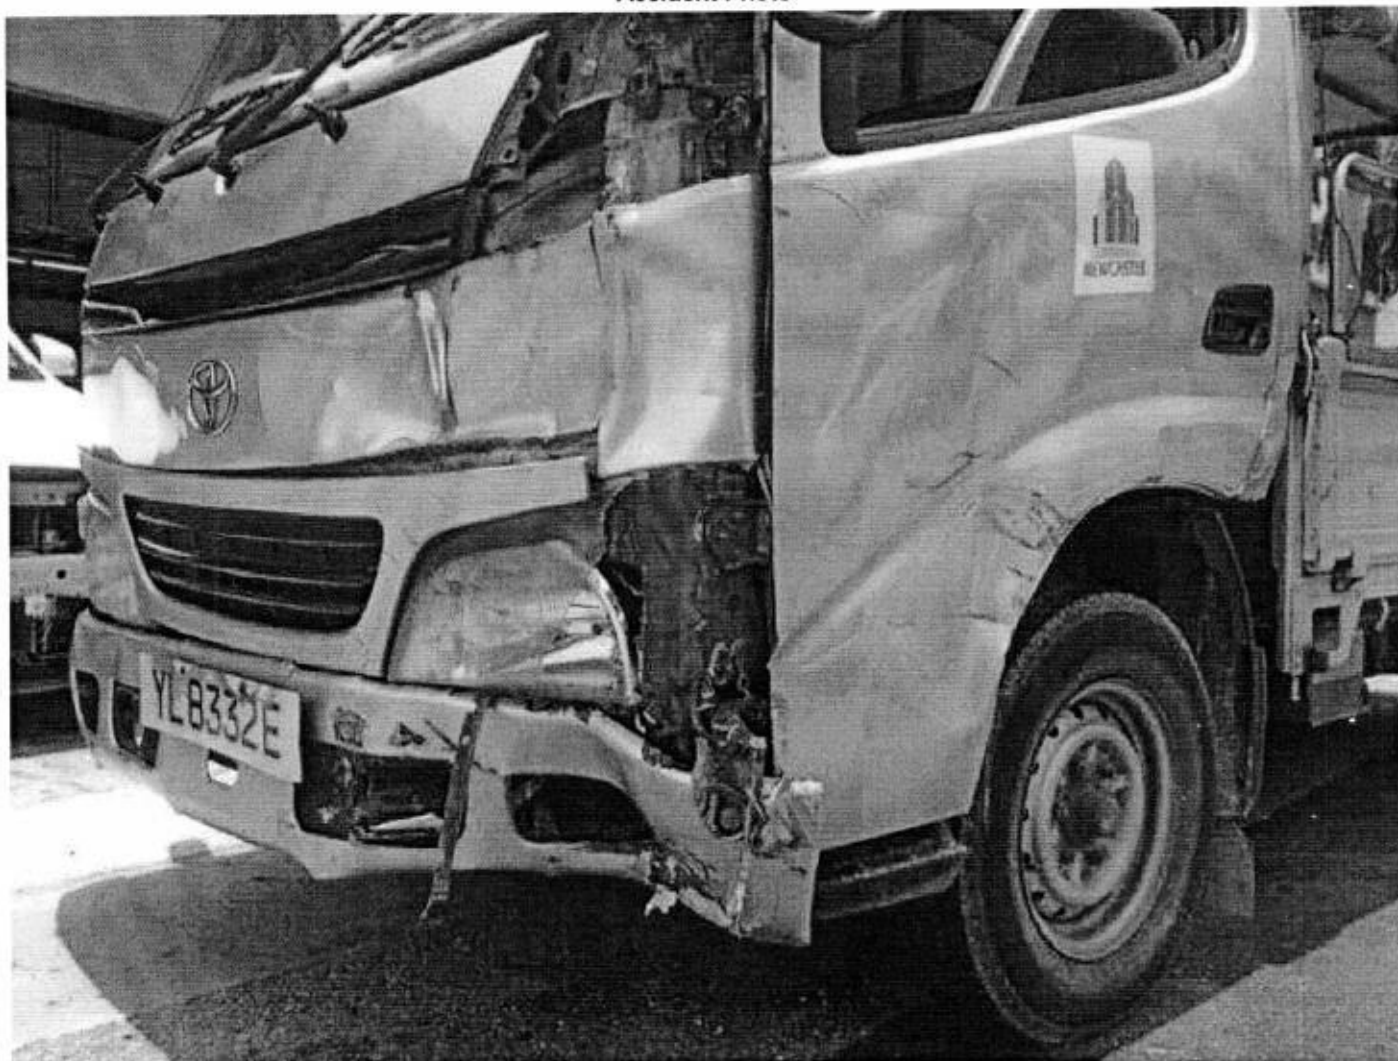
Accident Photo

At the front LH portion.

The front bumper, front bumper brackets, front panel, front inner panel, front grille, LH tail-lamp, wiper panel, LH front door, LH front door pillar, LH front door rear panel, LH side wheel arch panel, A/C blower, A/C heater, dashboard, LH side gate, LH side gate lock, etc.

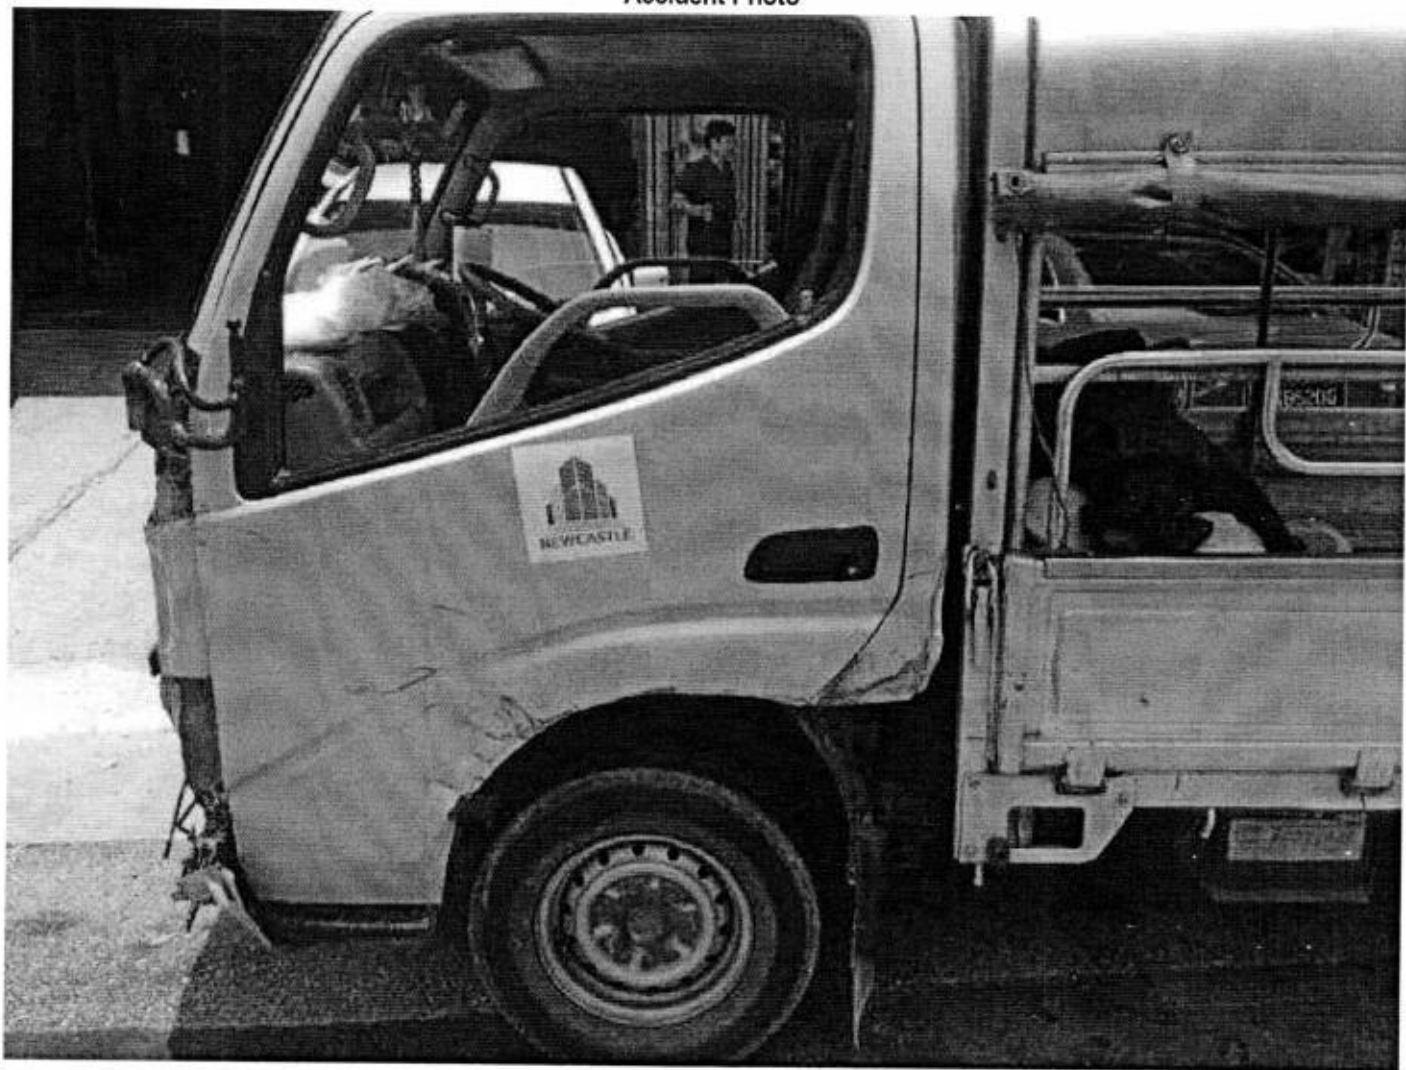
Accident Photo

Damages

Other parts were also found damaged. (see schedule for details)

We have inspected thoroughly each and every item on the repairer's estimate against the actual damages found on the vehicle and we list the breakdown of our findings and our recommendation as per schedule attached.

Our adjusted amount for the cost of repairs is \$12,452.20

The repairer has agreed to undertake repairs at a lump sum of \$9,950.00
