nationale Des Experts En Autor	
TRA	NS-CAB AUTO SE	ERVICES PTE LTD	Ref : CS/TP1802067	72/Kvbe2
NO.	2 ANG MO KIO ST	REET 63SINGAPORE 569	9111 Date: 28-11-2018	
			Code: TP378	***************************************

4.	a Trial trial and the	Descr	ription of Damages	
	THE VEHICLE SU	STAINED DAMAGES AT THE	E REAR PORTION.	
	DAMAGES SEE D	ETAILS.		
5.		Ger	neral Information	
	Accident Date	06/05/2014	Inspection Date	07/05/2014
	Survey held at	TRANS-CAB AUTO SERVIO	CES PTE LTD	
		NO. 42 SUNGEI KADUT ST SINGAPORE 729346	1	
5a.			Remarks

ADJUSTMENT ON REPAIR COST FOR VEHICLE NO. SHC 5939Z

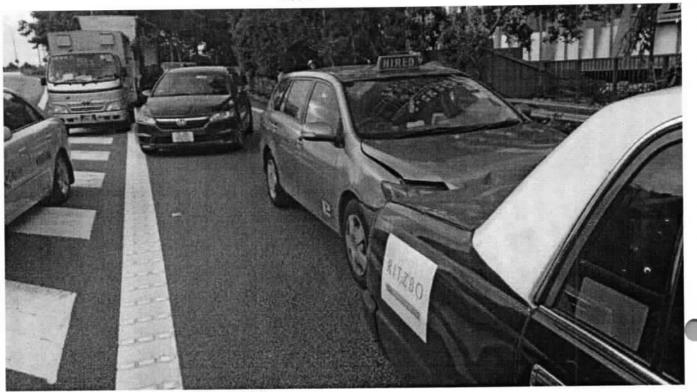
Accident Scene Photo

On 06.05.2014 at about 1645hrs, I was traveling straight from the slip road of PIE slip road towards CTE (City) when vehicle in front of me suddenly jammed his brake. I immediately applied brake to avoid the collision and manage to stop in time. Subsequently, I felt an impact from the rear. Vehicle B (SHD20686B) collided onto my taxi's rear portion. Vehicle A: 3 passengers Vehicle B: 2 passengers /rc

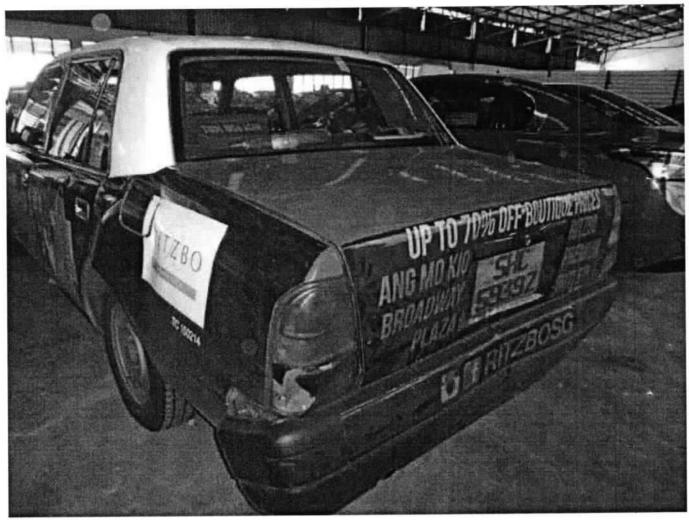
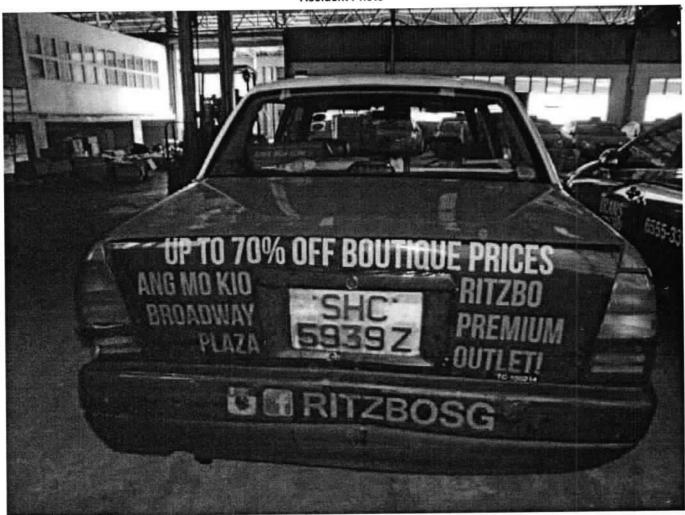
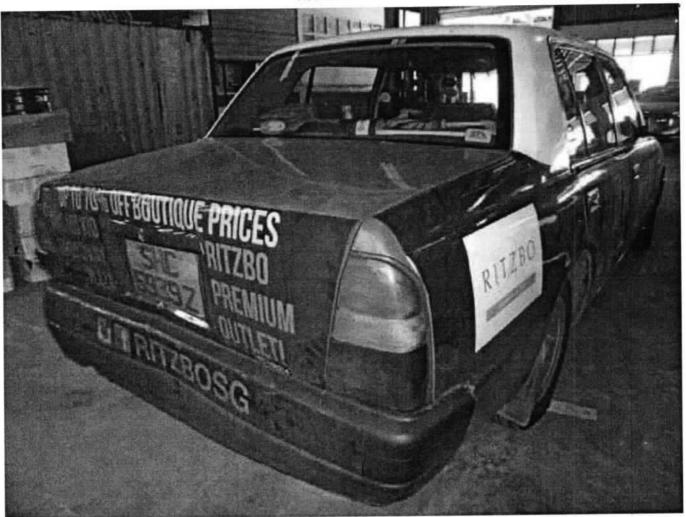
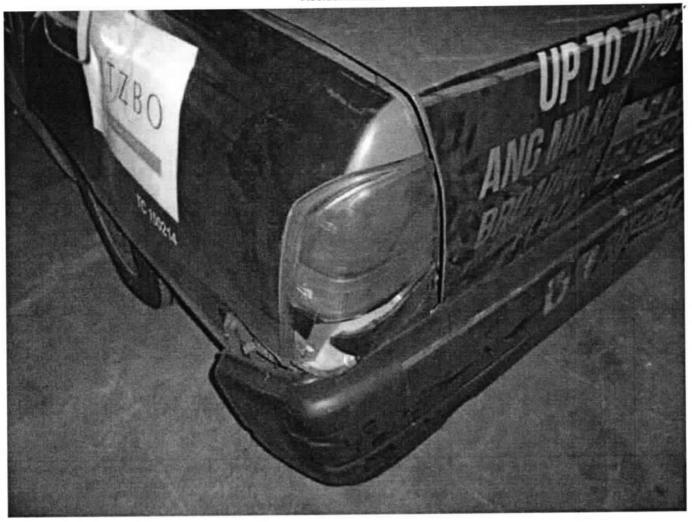
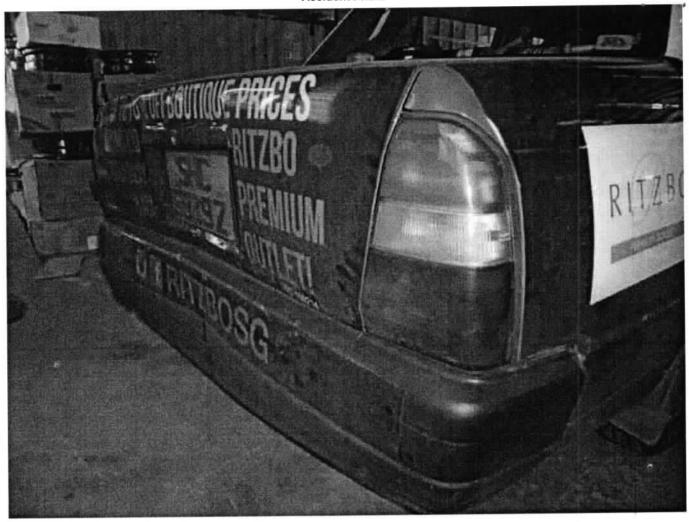
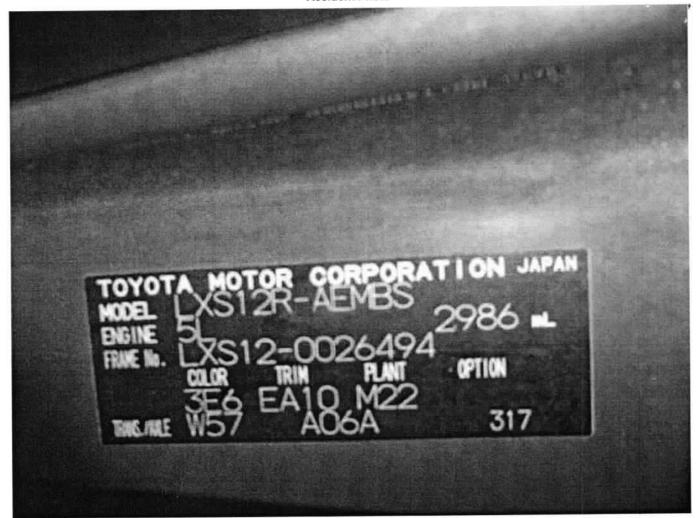
Qty	Description of Parts	Condition	Estimate By Workshop (\$)	Our Adjusted (\$)
	REPLACEMENT OF PARTS			
1	REAR BUMPER ASSEMBLY	BUCKLED	460.12	460.12
1	REAR BUMPER BEAM	BENT	119.97	119.97
1	REAR BUMPER CENTRE ABSORBER FOAM	SERVICEABLE	125.00	-
1	REAR END PANEL	BENT	427.75	427.75
1	REAR END PANEL INNER TRIM COVER	CRACKED	193.80	193.80
1	REAR LUGGAGE FLOOR PANEL	TO REPAIR SEE LABOUR	917.80	-
1	REAR LUGGAGE FLOOR PANEL TRIM BOARD	SERVICEABLE	245.95	
1	REAR LUGGAGE FLOOR PANEL INSULATOR	NOT NECESSARY	250.00	
1	REAR LAMP (TAIL LAMP) LH	CRACKED	298.49	298.49
1	REAR LAMP PANEL LH	BENT	90.64	90.64
1	REAR LAMP (TAIL LAMP) RH	CRACKED	298.49	298.49
1	BOOTLID	BENT	791.04	791.04
1	BOOTLID 'TOYOTA' BADGE	NECESSARY	35.53	35.53
1	BOOTLID 'CROWN' BADGE	NECESSARY	39.49	39.49
1	BOOTLID CENTRE LOGO BADGE	NECESSARY	32.23	32.23
1	BOOTLID LOCK - TOP	DENTED	59.26	59.26
1	BOOTLID LOCK - BOTTOM	TO REPAIR SEE LABOUR	21.42	-
1	BOOTLID OUTER CHROME GARNISH	SERVICEABLE	70.20	-

1	REAR FENDER LH	BUCKLED	854.13	854.13
1	REAR EXHAUST BOX	TO REPAIR SEE LABOUR	832.37	-
	LESS 25% DISCOUNT		-1,540.92	-925.24
			4,622.76	2,775.70
1	BOOTLID WEATHERSTRIP (SN) (50%)	DISTORTED	204.15	102.08
	LESS 25% DISCOUNT		-51.04	-

TO RUST-PROOFING OF THE AFFECTED AREAS.		220.00	90.00
	TO CHECK ELECTRICAL LIGHTING CONCERNED.		120.00	20.00
	TO REINSTALL REAR BUMPER PARKING SENSOR.		170.00	50.00
	PUTTY AND SPRAY PAINTING OF THE AFFECTED PORTION.		2,700.00	720.00
	TO REMOVE AND REFIT INTERIOR FITTINGS, TRIMINGS, GARNISH, FITTINGS AND OTHER, TO ENABLE REPAIR.		270.00	100.00
	TO TRANSFER OF BOOTLID FITTINGS, ATTACHMENTS AND PERFORM WATER SEEPAGE TEST.		170.00	50.00
	TO TRANSFER OF FENDER FITTINGS, ATTACHMENTS AND PERFORM WATER SEEPAGE TEST.	REPEATED	170.00	-
	TO REMOVE AND REPLACE CORPORATE STICKER.	NOT NECESSARY	330.00	-
	TO REMOVE AND REFIT REAR W/SCREEN GLASS TO FACILITATE BODYWORK REPAIR.		170.00	120.00
	TO DROP REAR EXHAUST BOX, RENEW THE SAME, TO REPAIR AND REALIGN CENTRE EXHAUST PIPE.		170.00	60.00
			7,290.00	2,410.00
	GRAND TOTAL		13,377.45	5,739.36

RECOMMENDED COST OF LUMP SUM REPAIRS	2,300.00
(TO ITS PRE-ACCIDENT CONDITION)
