To Inspect Vehicle No: SLT 1357S - Insured: SGG 7362P

Make/Model : HONDA SHUTTLE HYBRID 1.5 AUTO-2017

Report No: 0544-18-N51

ACCIDENT VEHICLE SURVEY REPORT

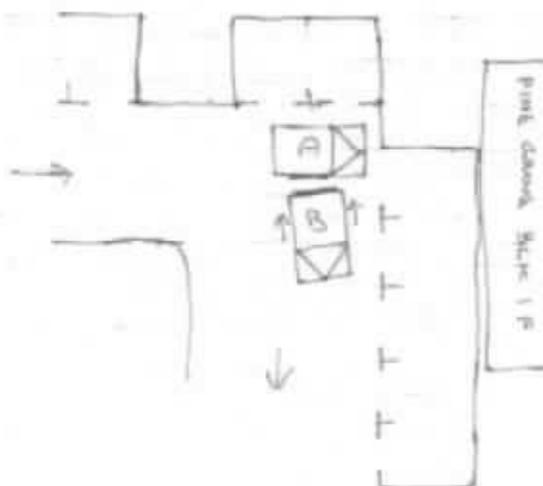
SKETCH PLAN

VEHICLE A - SLT 13975
 VEHICLE B - SGA 7362P

<p>MY VEHICLE CAME TO A STATIONARY POSITION TO ALIGHT PASSENGER</p>
<p>AFTER MY PASSENGER ALIGHTED, I ABOUT TO MOVE OFF SUDDENLY A VEHICLE REVERSE AND HIT ONTO THE RIGHT SIDE OF MY VEHICLE.</p>
<p>ALIGHTED FROM MY VEHICLE AND REALIZED A VEHICLE BEARING (SGA 7362P) HAD COLLIDED TO THE RIGHT SIDE OF MY VEHICLE WHILE I'M IN THE STATIONARY POSITION.</p>
<p>THE WHOLE ACCIDENT FOOTAGE WAS CAPTURED BY MY IN-CAR CAMERA.</p>
<p>VEHICLE A - SLT 13975 VEHICLE B - SGA 7362P</p>

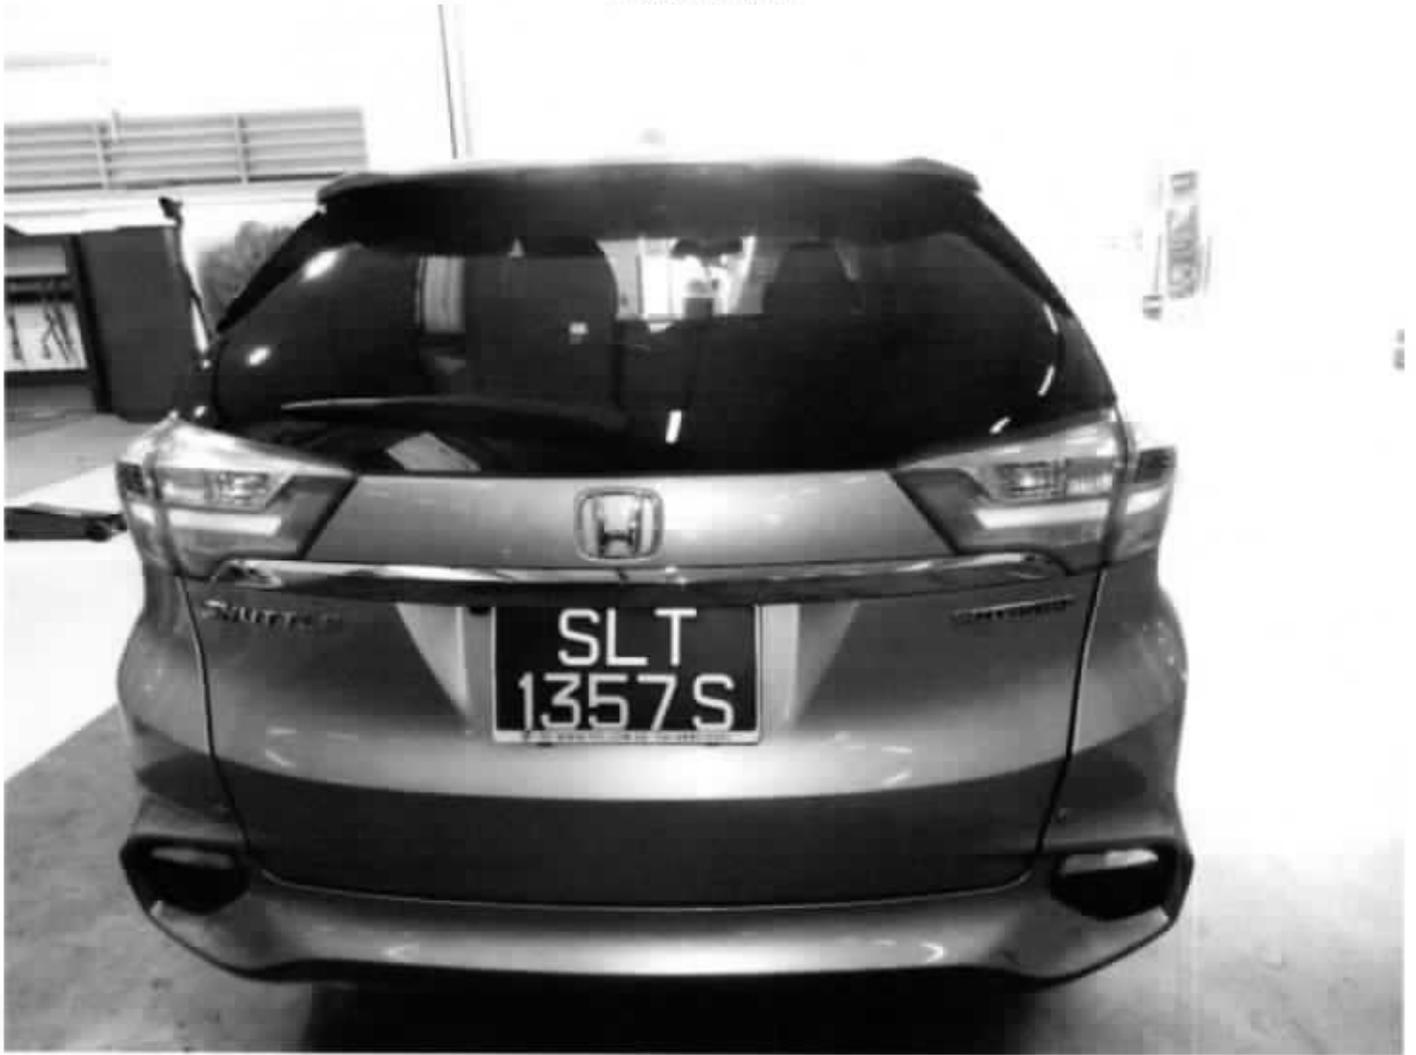
Accident Photo

Impact on the rear RH portion.
Please see details as described in the Annex for parts and labour.
