SLN 1625A

Make: Kia Cerato K3 CC: 1591
 Colour: Red A/C: Insured / Std / NI / NA
 Sp Reading: 84544 T/Radio: Insured / Std / NI / NA

- PRE-REPAIR INSPECTION - ACCIDENT INVOLVING OUR INSURE...

VEHICLE DAMAGE INSPECTION REPORTOur File No: CS3/AIG18020868/JCD3 E2
Date: 17/12/2018REFERENCE

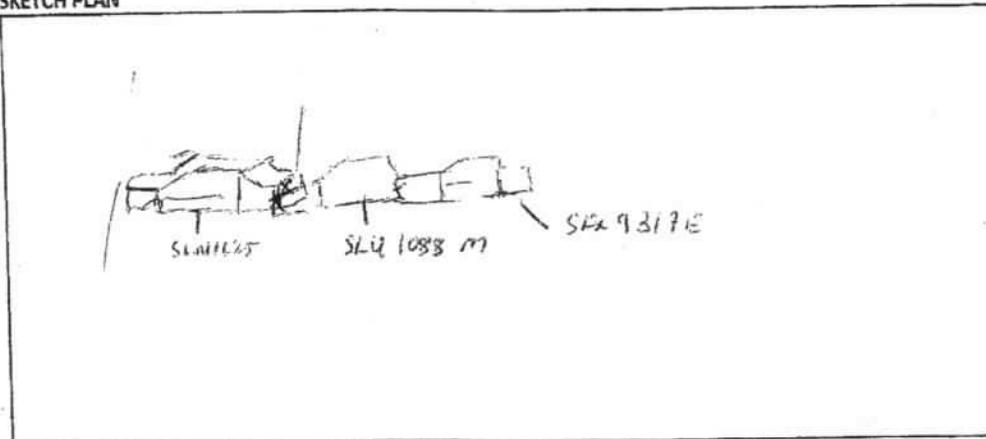
Sketch Plan Pg. 2

Date of accident: 14/11/18 Time: 18:35 Location: UPPER SERANJUN RD
 My Vehicle A: SLN165A Vehicle B: SLV1088 M Vehicle C: SFX 9317E
 SKETCH PLAN

I WAS DRIVING ALONG UPPER SERANJUN RD TOWARD HONGKAY AND IT WAS SLOW TRAFFIC I SLOW DOWN AND ~~STOP~~ SUDDENLY I WAS HIT VERY HARD AND WAS A HEAVY IMPACT THAT MY WIFE S757294H SEPERA INJURED AND SHE ITAILED BACK PAIN AS I COME OUT I SAW SLV1088 M HIT MY BACK OF MY CAR AND THE OTHER SFX 9317E HIT THE SIDE CAR
