SJT 5258S

Make: Hyundai Avante C.C. 1591

- PRE-REPAIR INSPECTION - ACCIDENT INVOLVING OUR INSURE...

VEHICLE DAMAGE INSPECTION REPORT

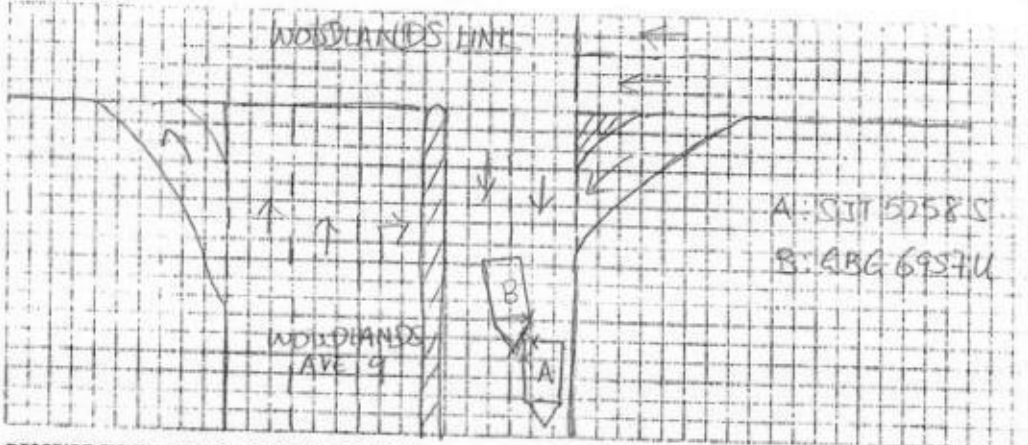
SKETCH PLAN

On 15th November 2018 at about 11:15AM along Junction of Woodlands Ave 9 and Woodlands Link. Heavy rain & ground were wet.

I was travelling in my lane, extreme left. When out of a sudden there was a huge impact at my rear. I stop over my vehicle 'A', look through my side mirror and I saw vehicle 'B' position slanted. I alighted and I saw my vehicle 'A' was badly damage. Vehicle 'B' driver told me that he was making a turn and went up collided onto my vehicle 'A'.
