SHA 1813P - CC4 / TMI 17020388 / K1e93q2

R/Bal. 7 mm R/Bal. 7 mmL/Bal. 7 mm L/Bal. 7 mmD.O.A. 18/11/18 D.O.I. 20/11/18Survey held at CDGE (Loyang)

The U/C / Chassis frame / Body Structure affected due to collision.

VEHICLE DAMAGE INSPECTION REPORT

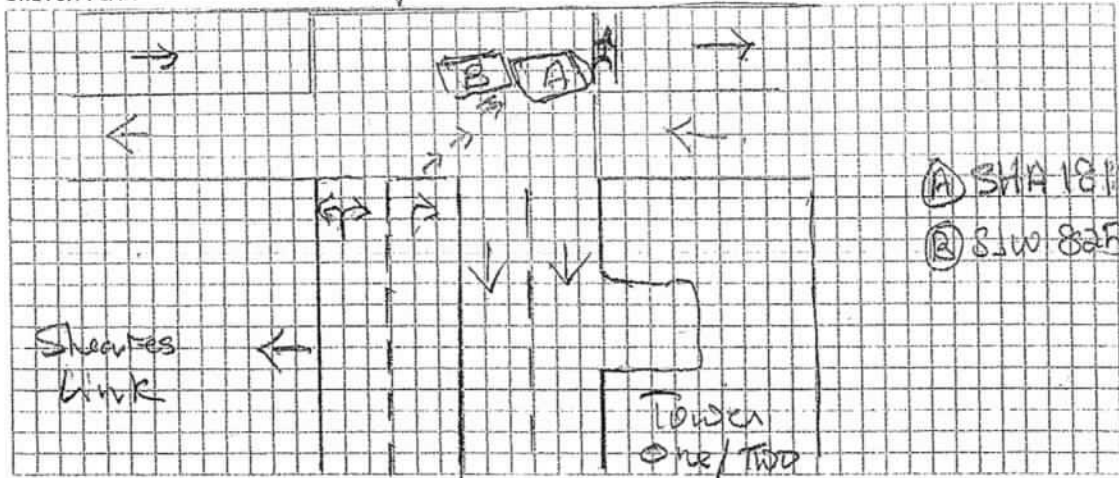
SKETCH PLAN

On 18/11/2018 at about 5350 hrs, I vehicle A was making a right turn into bayfront ave. While I was turning to the right then I stop for pedestrian crossing. A few second later vehicle B came from my back and hit vehicle A rear my vehicle sustain damage

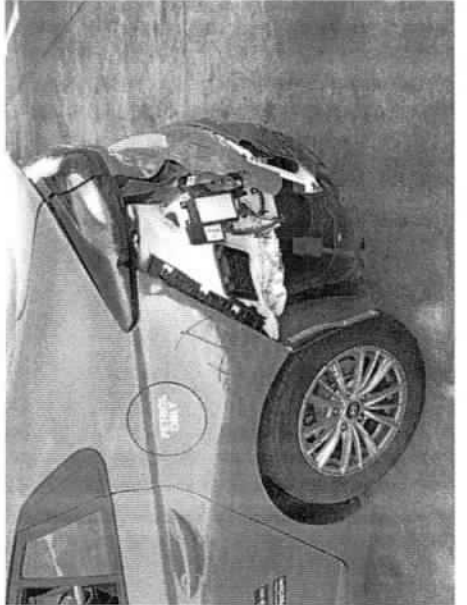
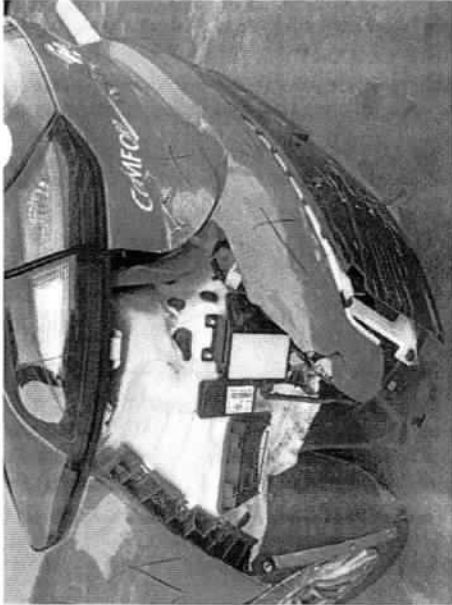
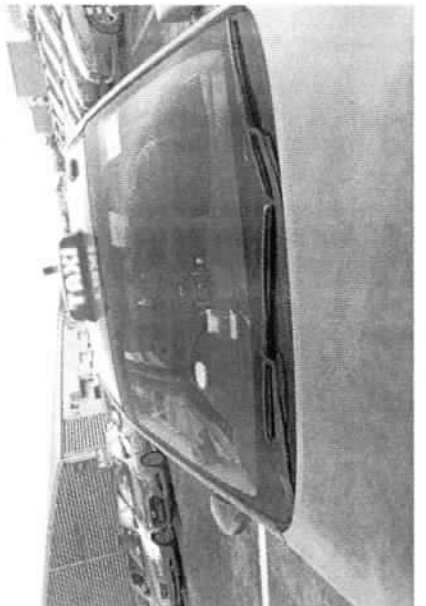
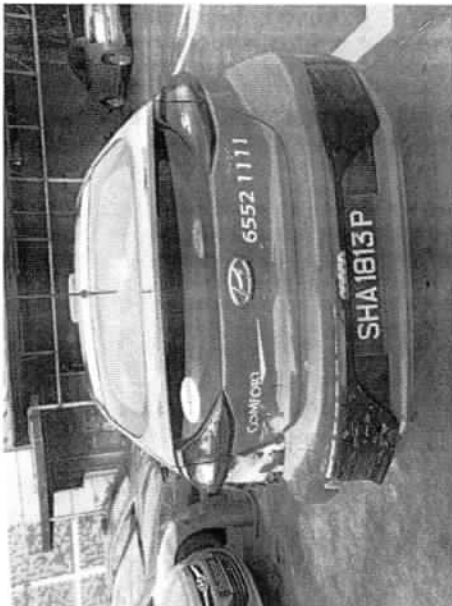
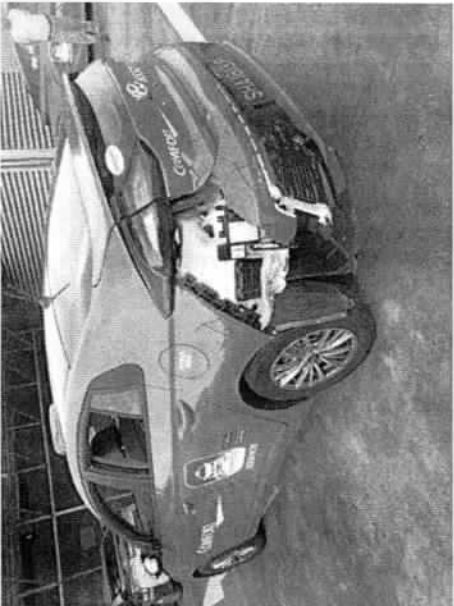
Des. of Damages: Frt / Rear / O/S / N/S / U/C / Rooftop or

Rear m/s.

No.	Qty	Part No.	Particulars	Condition	Repairer's	Amount
1	1		*BOOT LID	Bent	2,480.40 FL	*2,480.40 FL
2	1		*BOOT LID LOCK	Serviceable	224.00 FL	*- FL
3	1		*BOOT LID HANDLE ASSY TAIL GATE RELEASE	Serviceable	47.90 FL	*- FL
4	1		*BOOT LID H EMBLEM	Not Necessary	28.00 FL	*- FL
5	1		*EMBLEM HYBRID	Necessary	24.30 FL	*24.30 FL
6	1		*EMBLEM IONIQ	Necessary	31.30 FL	*31.30 FL
7	1		*EMBLEM -SYMBOL MARK	Not Necessary	28.00 FL	*- FL
8	1		*BOOT LID LAMP LH	Serviceable	794.40 FL	*- FL
9	1		*REAR BUMPER	Deformed	459.40 FL	*459.40 FL
10	1		*REAR BUMPER REINFORCEMENT	Serviceable	294.80 FL	*- FL
11	2		*REAR BUMPER REINFORCEMENT BRACKET LH/RH	Serviceable	276.20 FL	*- FL
12	1		*REAR BUMPER CENTRE MOULDING ASSY	Necessary	451.25 FL	*451.25 FL
13	1		*REAR BUMPER LOWER CENTRE MOULDING ASSY	Serviceable	270.10 FL	*- FL
14	1		*REAR BUMPER SIDE BRACKET LH	Cracked	33.10 FL	*33.10 FL
15	10		*REAR BUMPER COVER CLIPS	Necessary	22.00 FL	*22.00 FL

16	1		*REAR BUMPER UNDER CENTRE	Repair	53.85 FL	*- FL
17	1		*REAR BUMPER REFLECTOR LAMP LH	Cracked	31.90 FL	*31.90 FL
18	1		*REAR BUMPER SIDE UNDER LH	Repair	27.50 FL	*- FL
19	1		*BOOTLID COMFORT LOGO & TEL NO STICKER	Necessary	30.00 FS	*30.00 FS
20	1		*REAR BUMPER REVERSE SENSOR	Serviceable	135.70 FS	*- FS

21	1		*BUMPER TOWING CAP	Missing	51.60 FL	*51.60 FL
22	1		*PANEL ASSY QTR OUTER LH	Buckled	3,556.20 FL	*3,556.20 FL
23	1		*EXTENSION ASSY QTR OUTER LH	Cracked	208.30 FL	*208.30 FL
24	1		*PANEL ASSY BACK	Bent	532.00 FL	*532.00 FL
25	1		*TAIL LAMP -COMB LH	Cut	512.00 FL	*512.00 FL
