VEHICLE DAMAGE INSPECTION REPORT

Our File No: CS3/MSG18021093/T1CBE2

Handling Insurer:	MSIG Insurance (Singapore) Pte. Ltd.	Policy No:	MSD/VCT/18-001016-00
Claimant Vehicle No :	SGS7135R	Insured Vehicle No :	XD781Z
Date of Loss:	17/11/2018	Nature of Claim:	TP
		Claim No:	MSCV/18-001511

Reg No:	SGS7135R	Engine No:	4G18HY2337
Make & Model:	MITSUBISHI LANCER, 1.6 (A)	Chassis No:	JMYSTCS3A7U009352
Reg. Date:	22/03/2007 (Man. Year: 2007)	Odometer:	0 km
Colour:	Silver		
Engine Capacity:	1584 cc		
Market Value/New Car Price:	N/A		
Sum Insured (\$\$):	Market Value/New Car Price

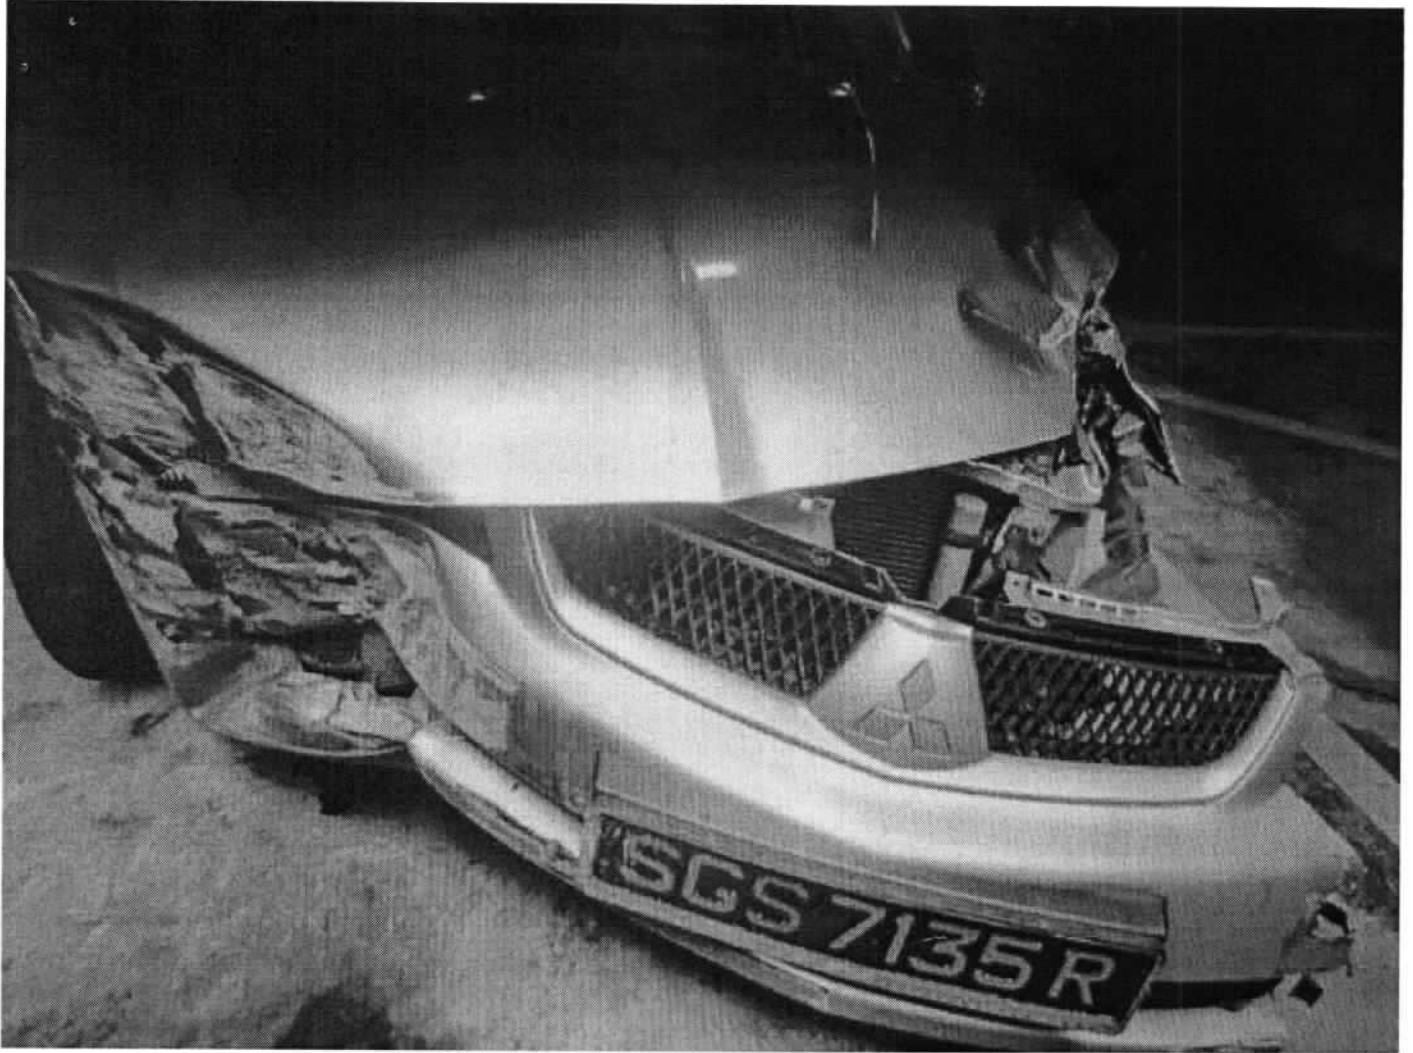
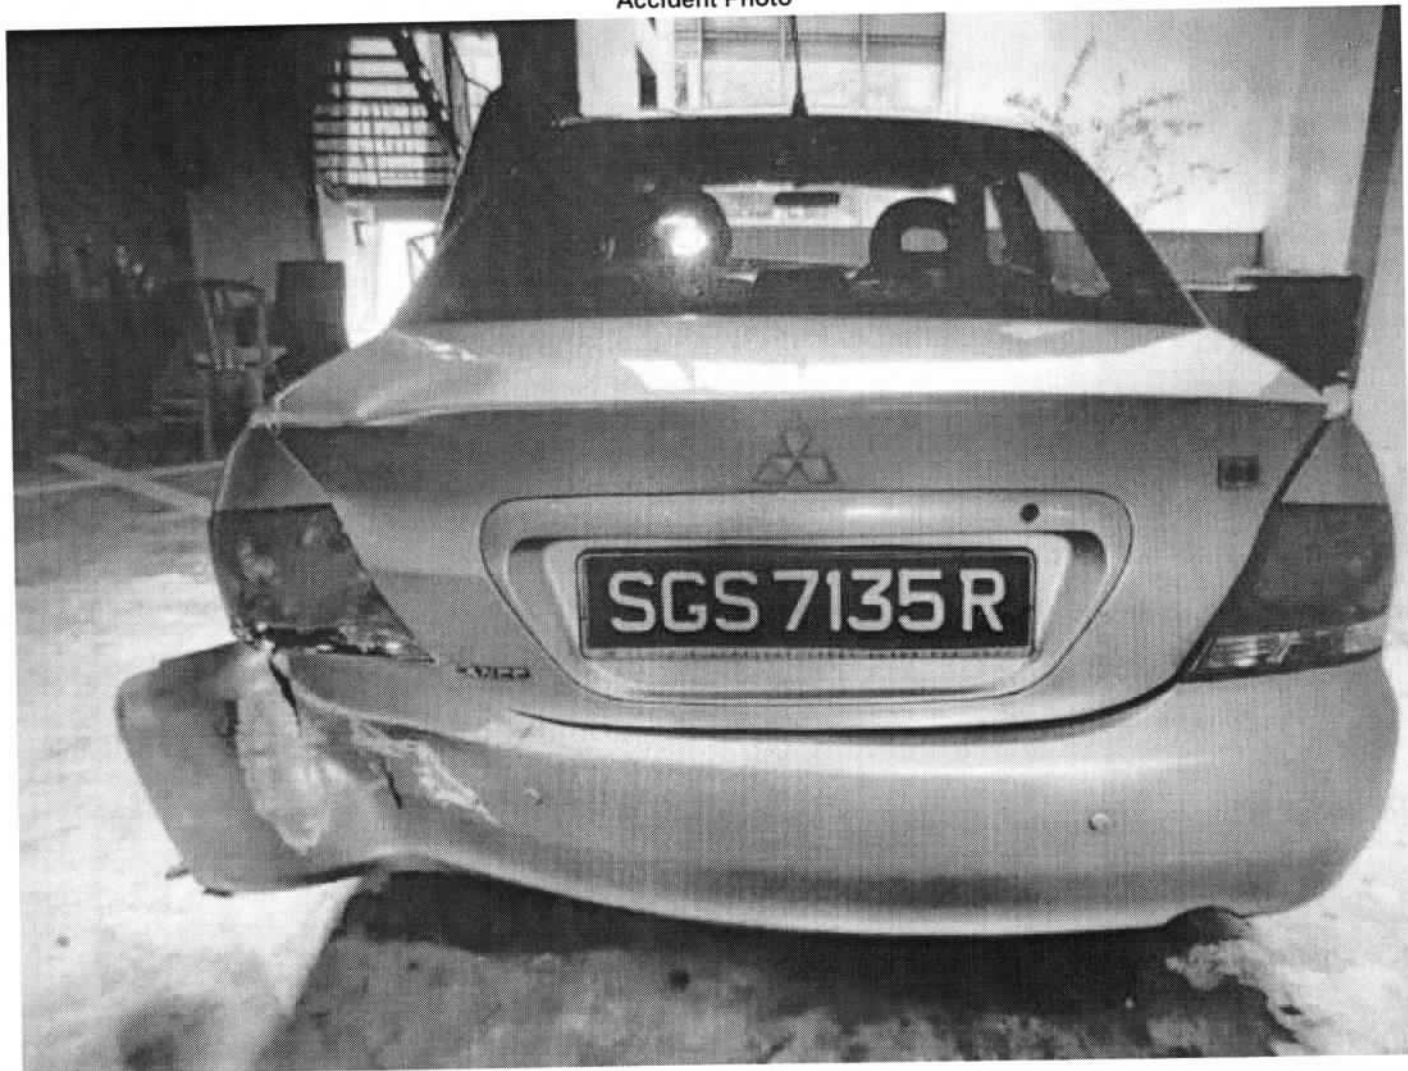
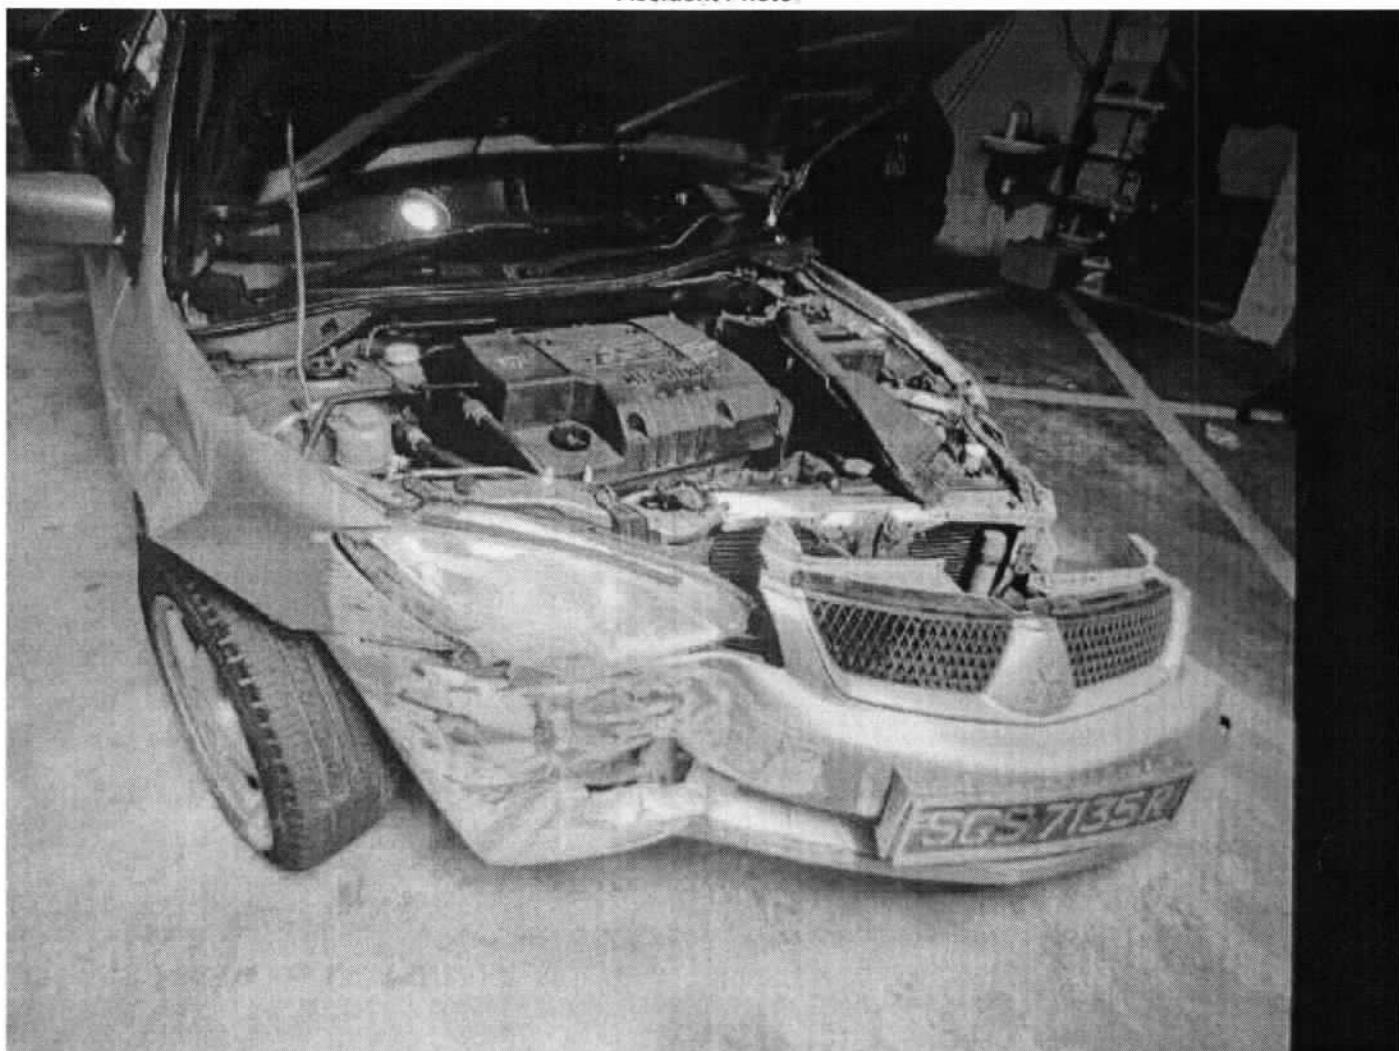
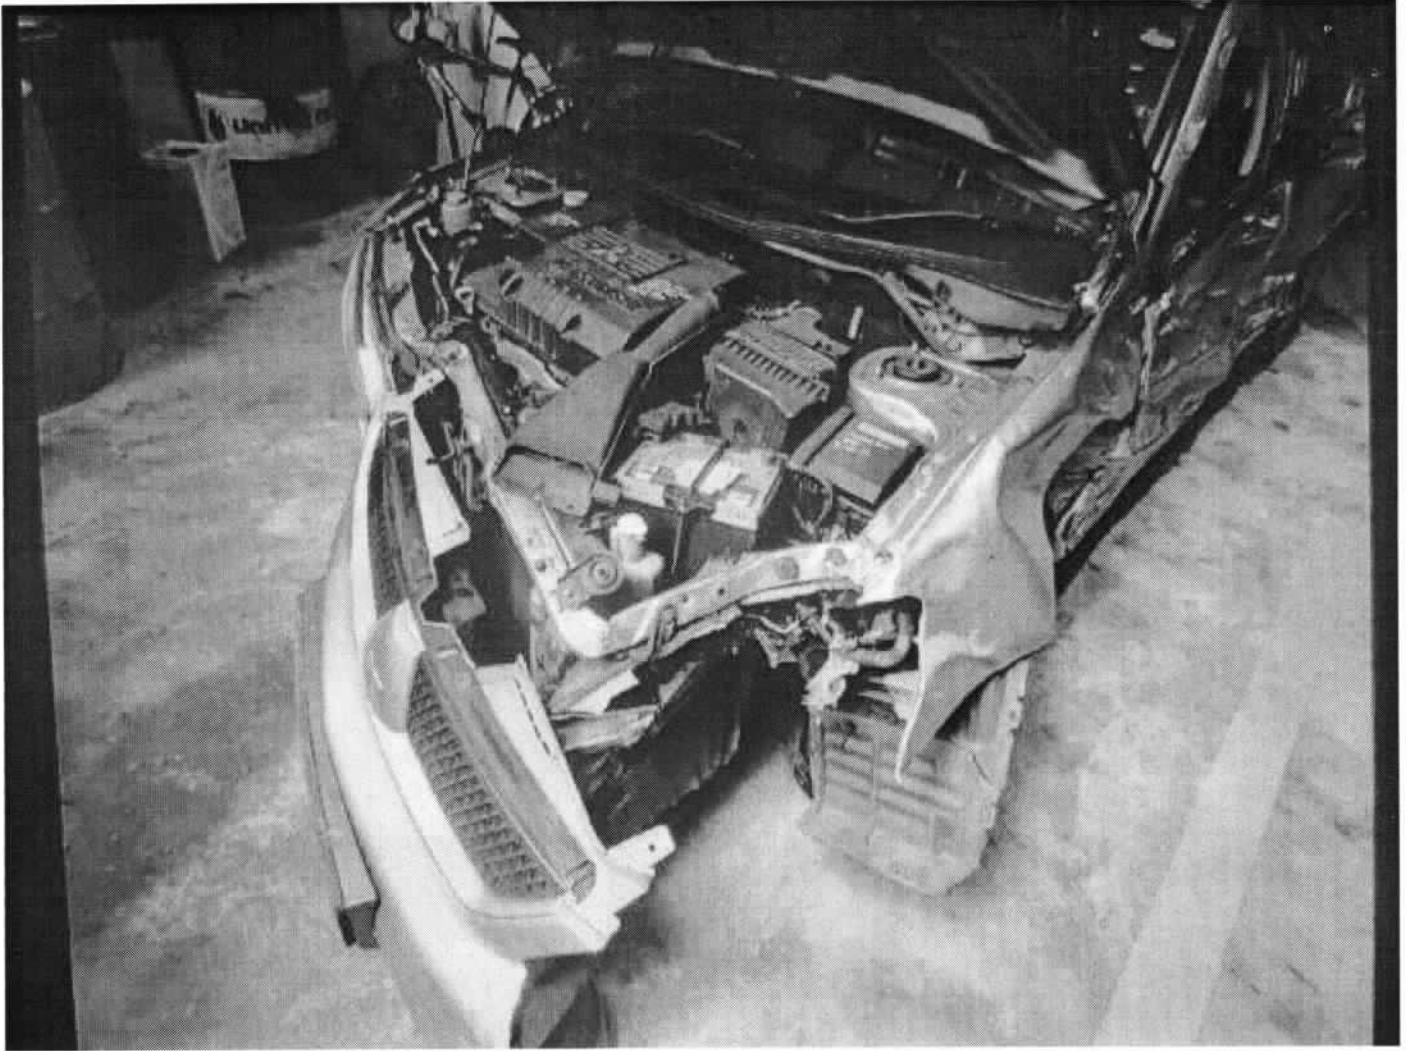
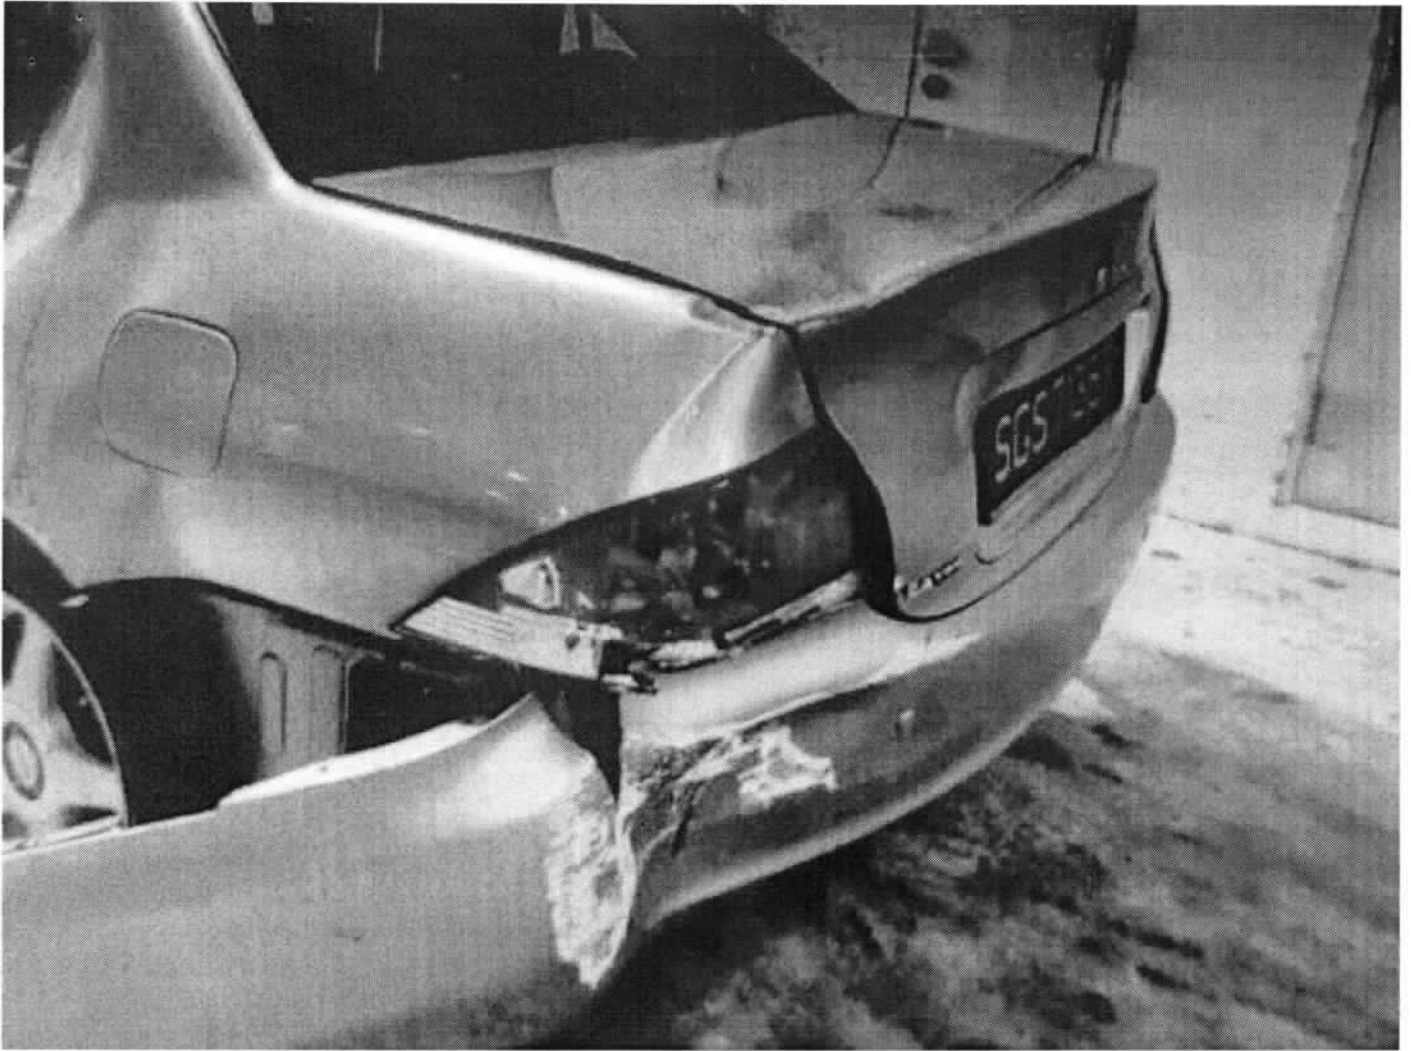
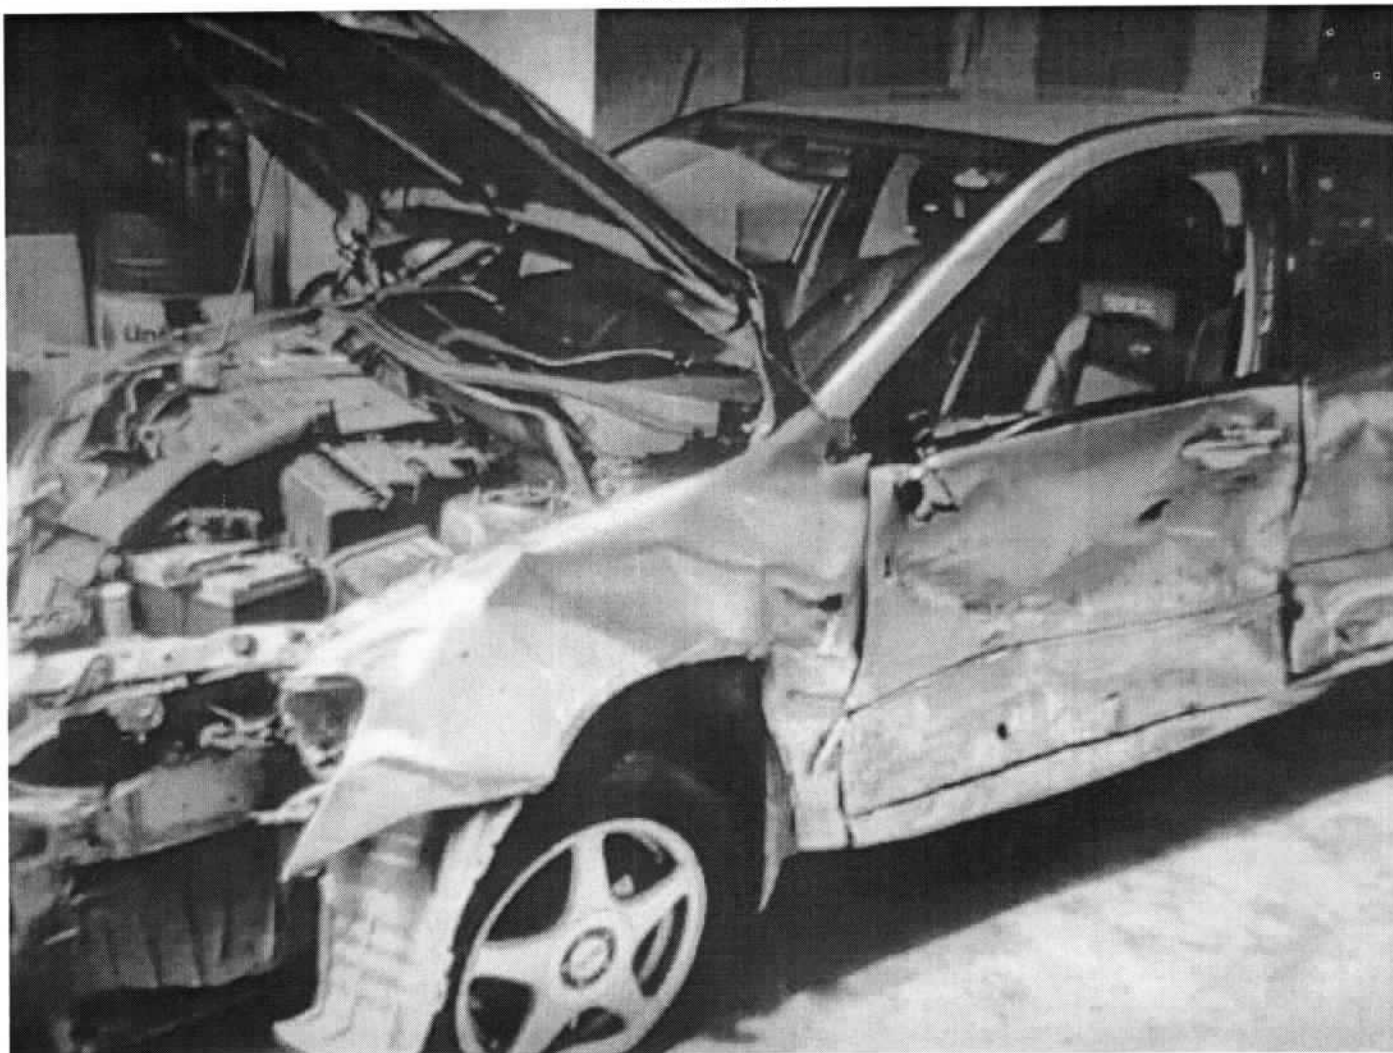
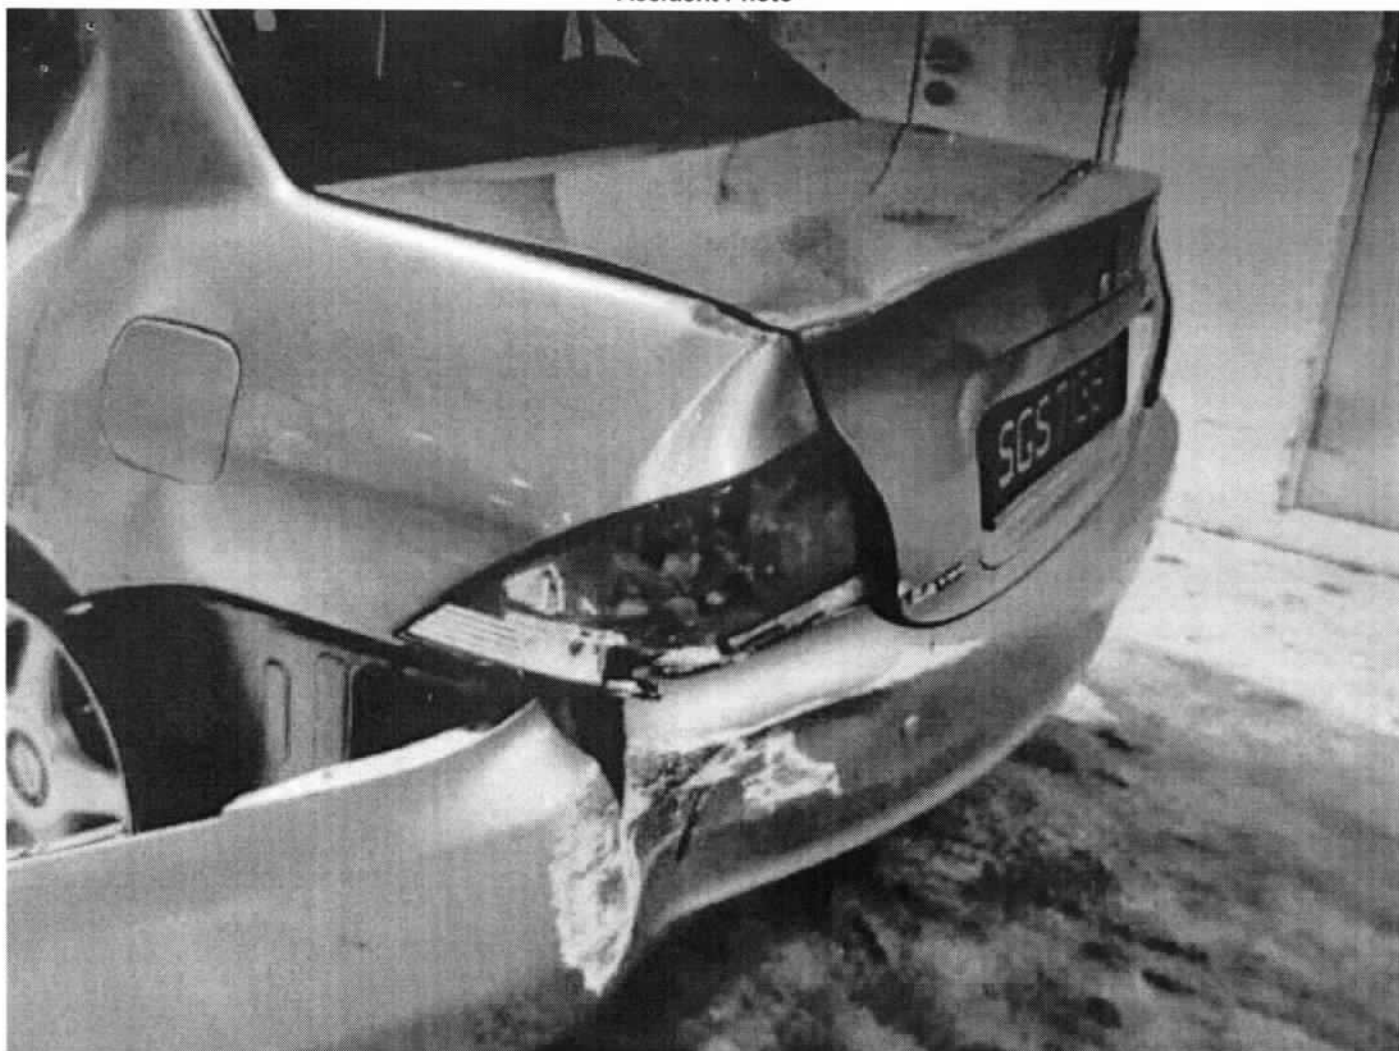
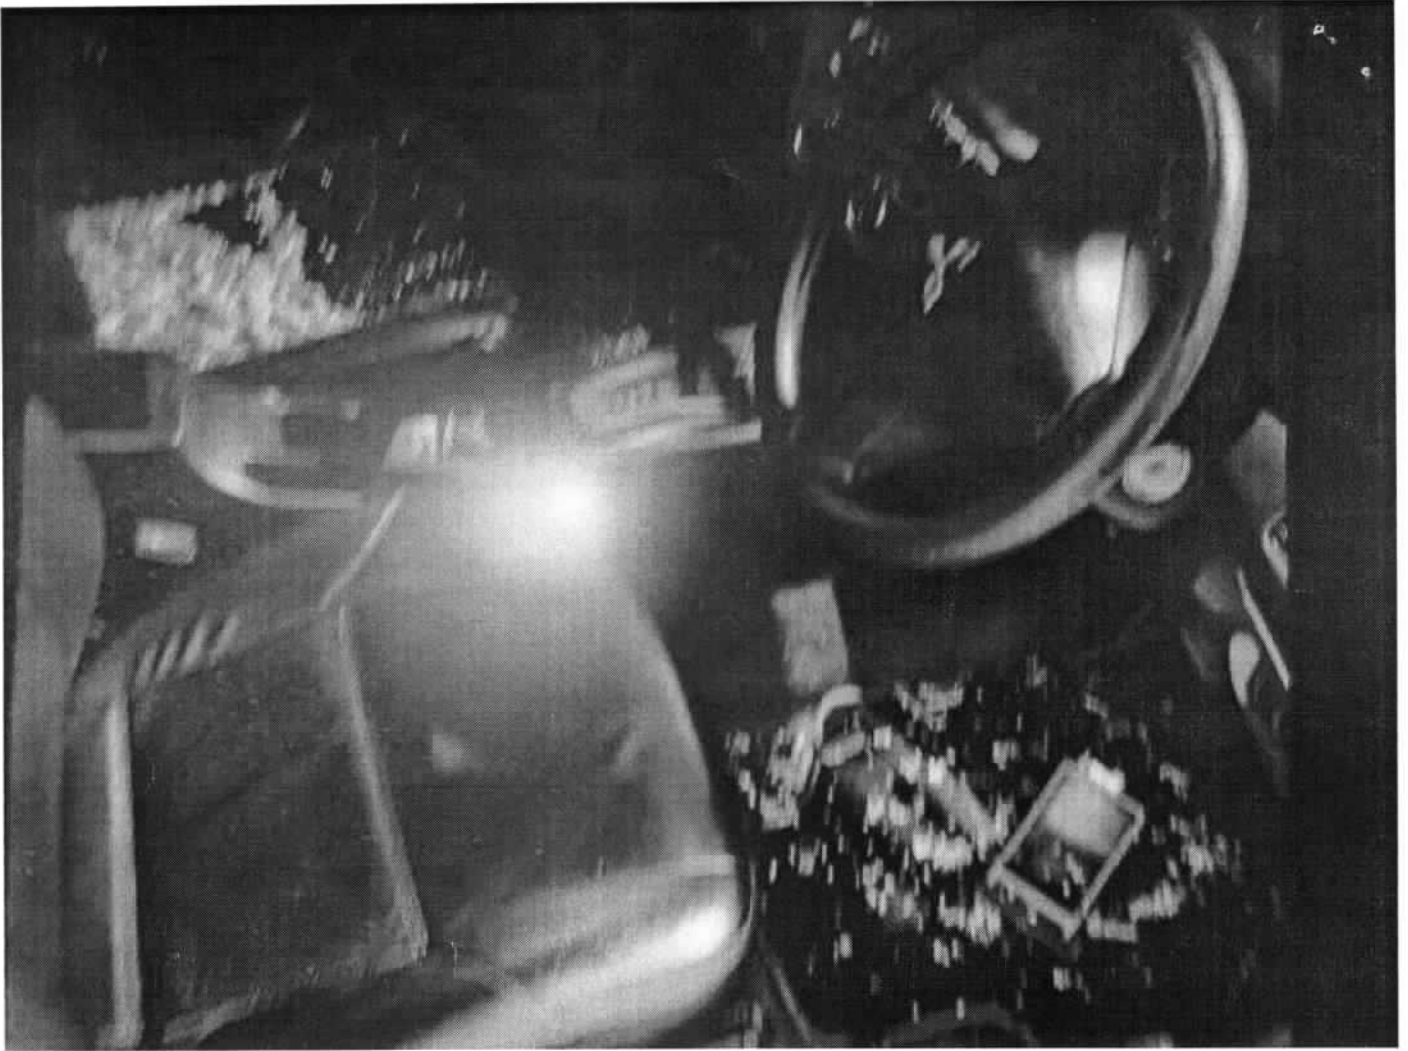
Des. of Damages: Frt / Rear / O/S / N/S / U/C / Rooftop or
Frt o/s, Frt, o/s, 4/C
 The U/C / Chassis frame / Body Structure affected due to collision.

Details of Vehicle Involved						
Vehicle No.	Type	Make	Model	Color	Condition	No of Passenger
SGS7135R	Car				Seriously Damaged	0
XD781Z	Lorry				Seriously Damaged	0

Estimated repair range \$15,000 - \$18,000.

- No economical to repair.

THE ESTIMATED REPAIR COST OF THE DAMAGED VEHICLE IS IN THE REGION OF \$15,000.00 - \$18,000.00
