REF: CS/ATG18021211/Gvber

REPAIR COST FOR VEHICLE NO. SL7858H

DAMAGED VEHICLE (SL 7858 H) INSPECTION REPORT (WITHOUT PREJUDICE)

ADJUSTMENT ON REPAIR COST FOR VEHICLE NO. SL 7858H

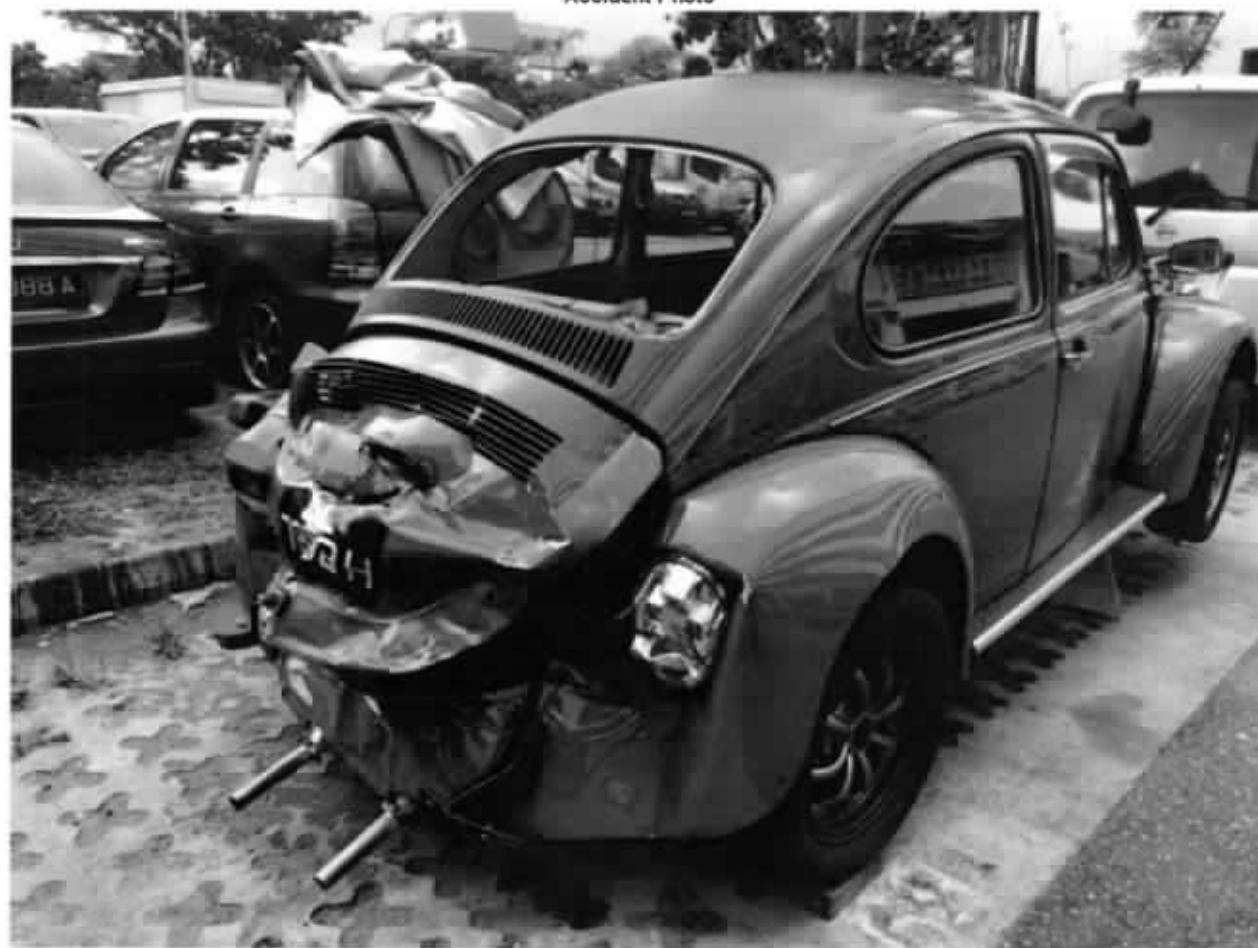
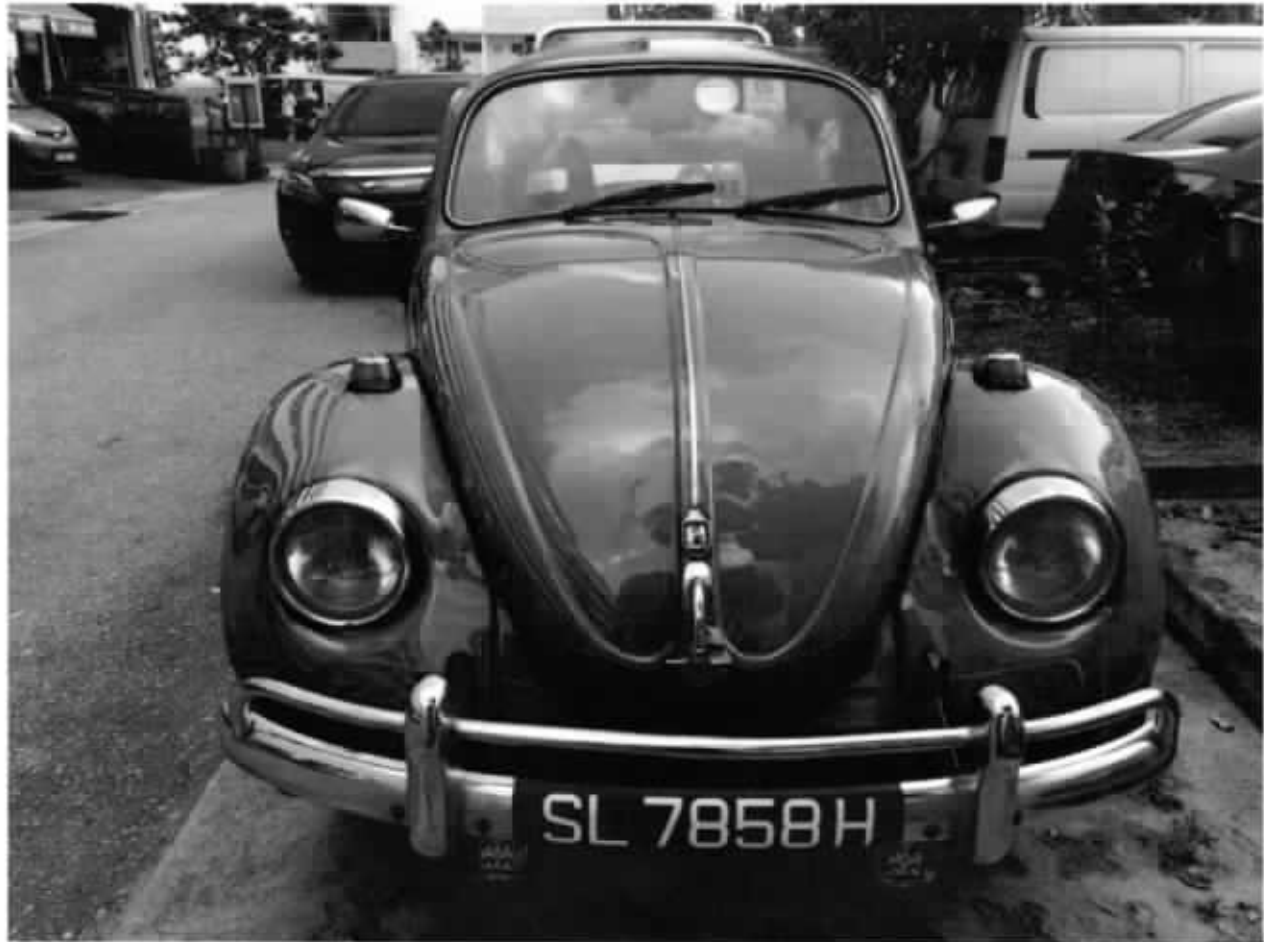
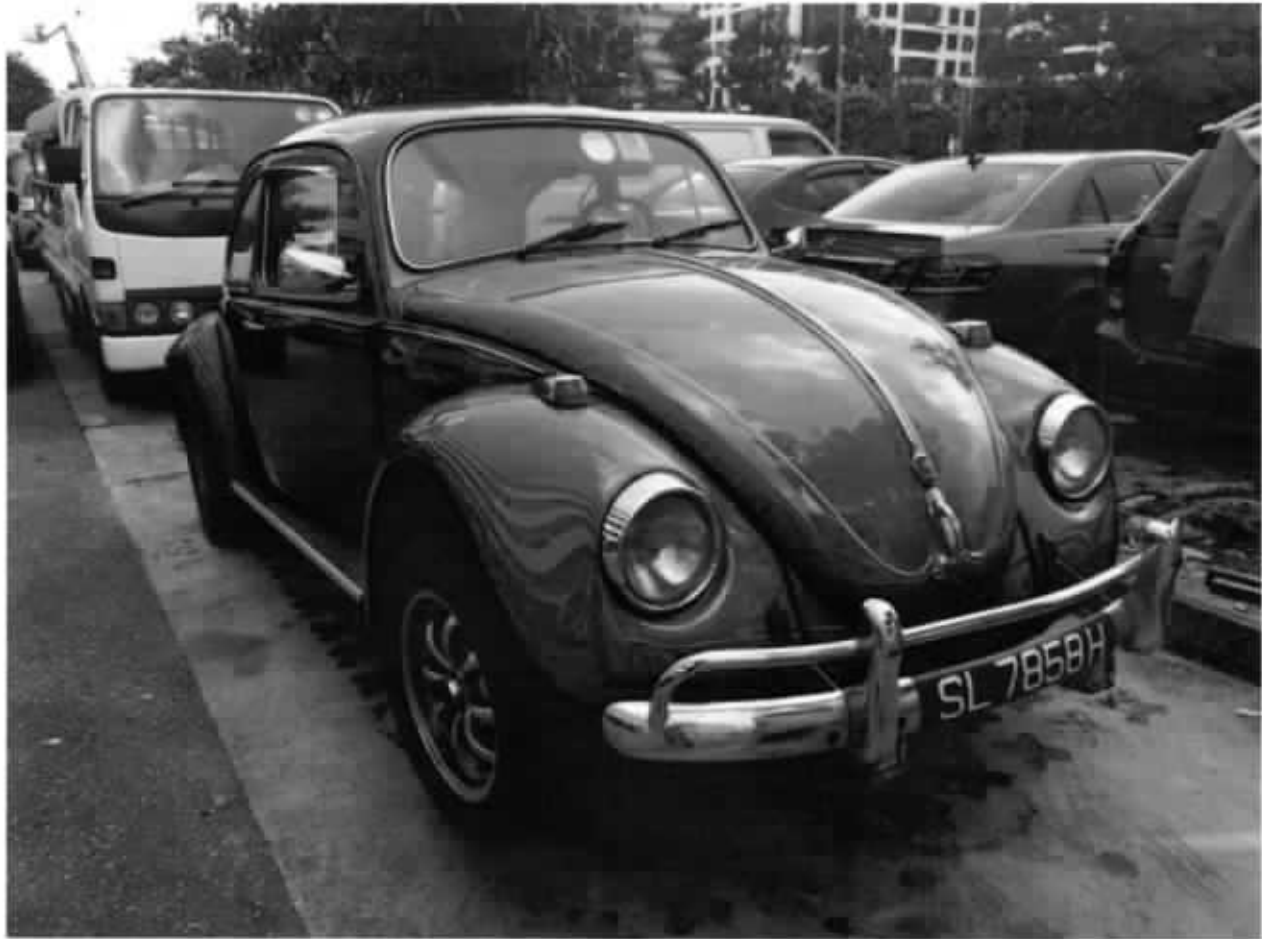
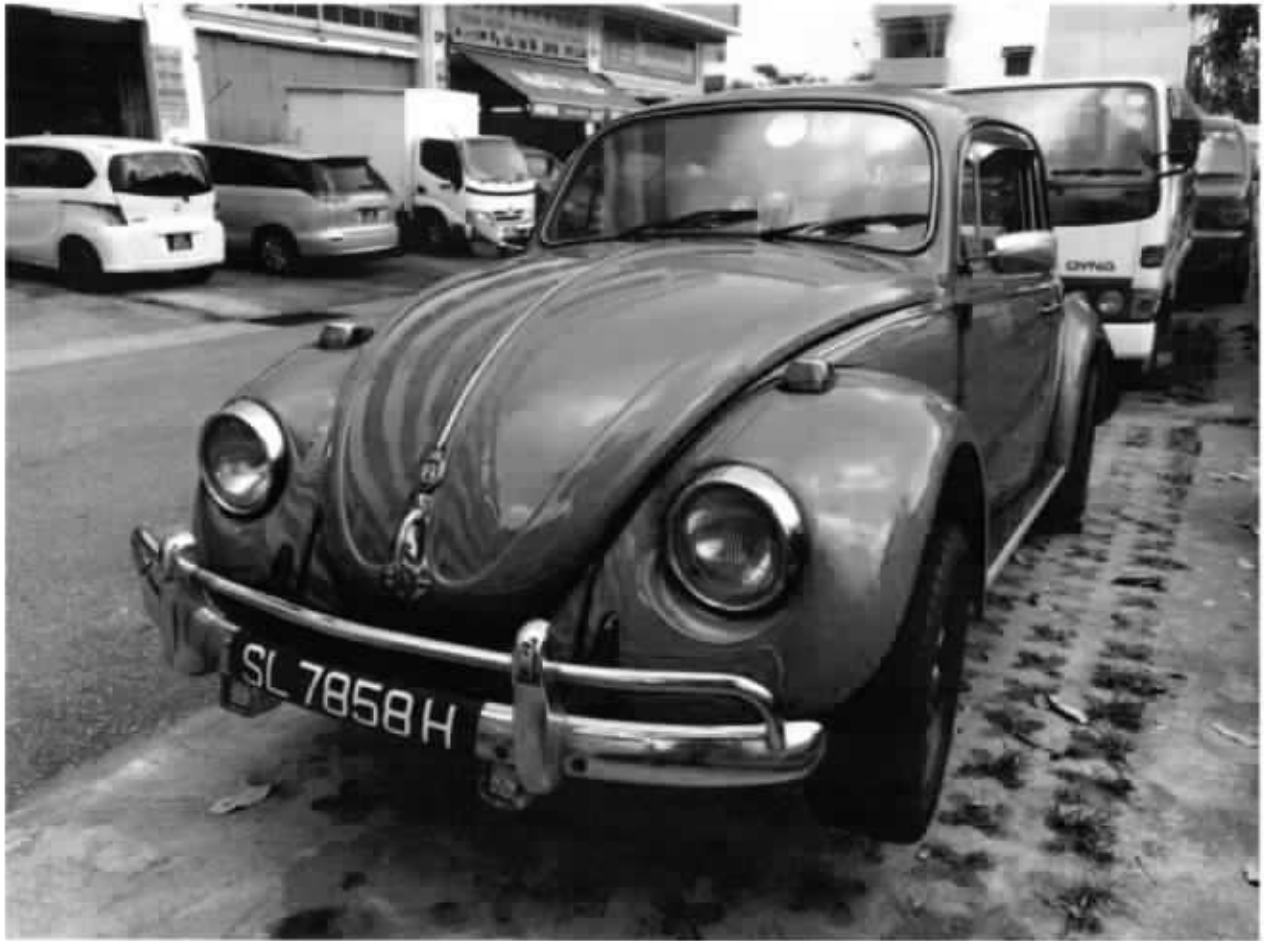
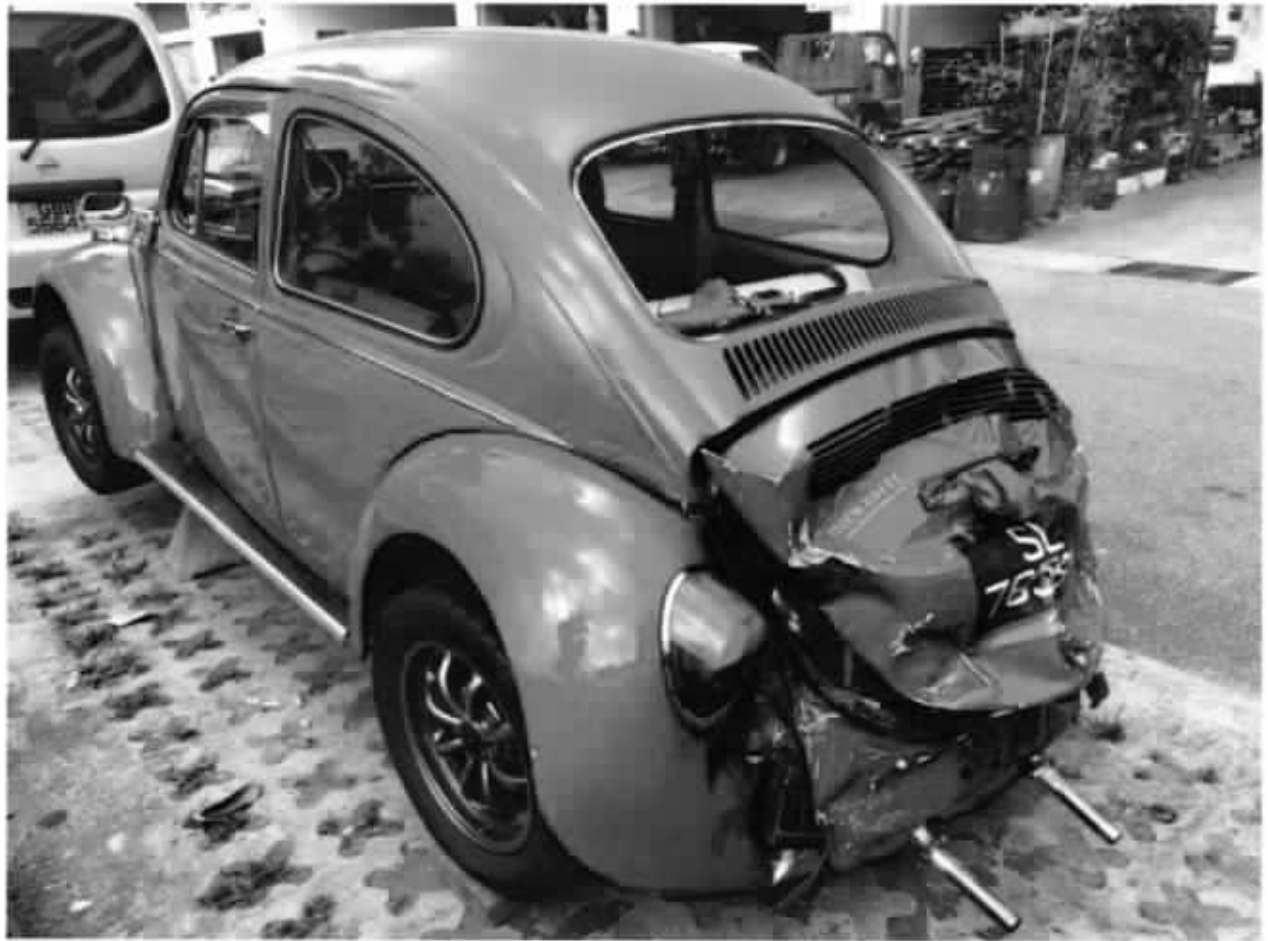
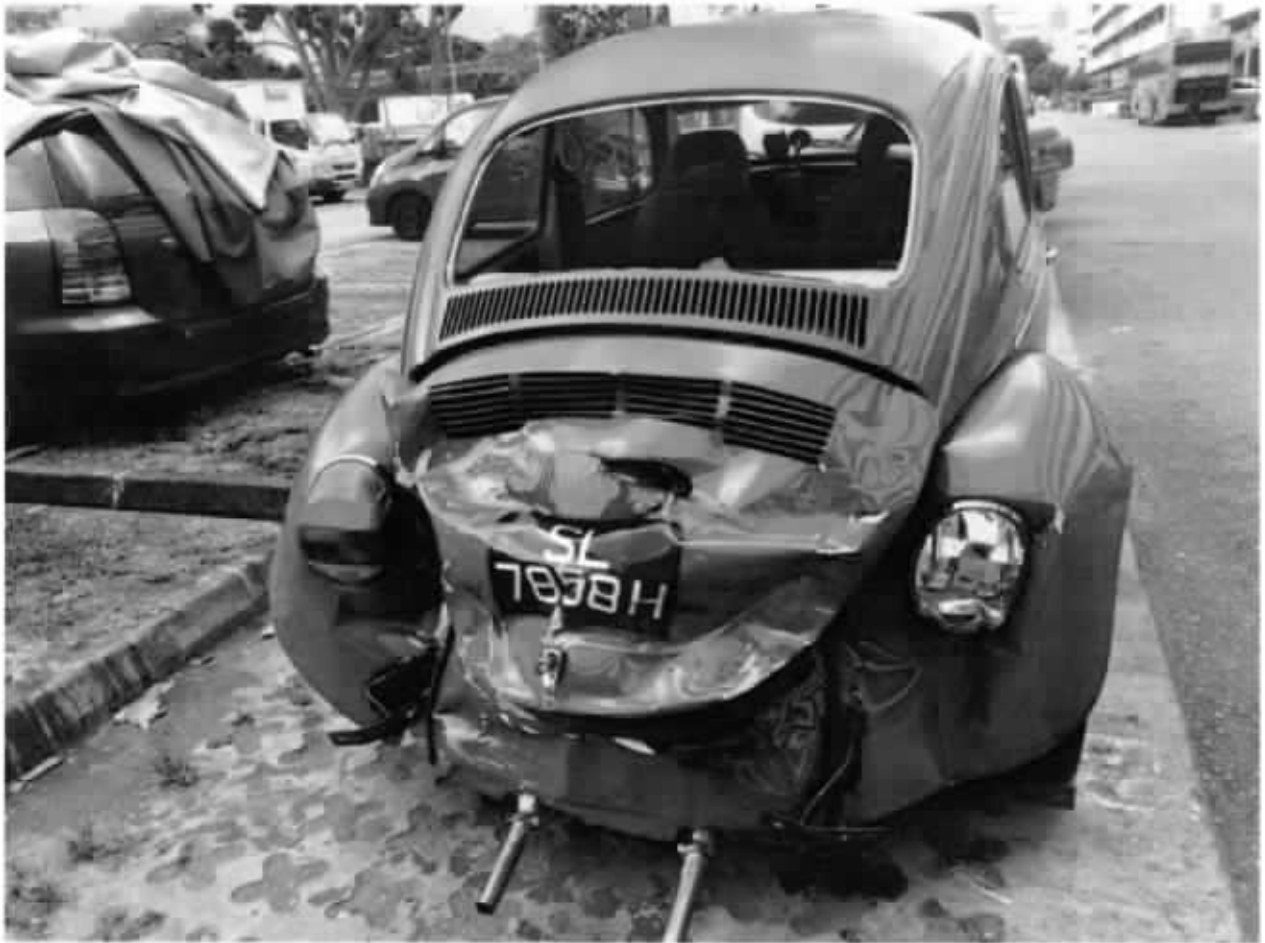
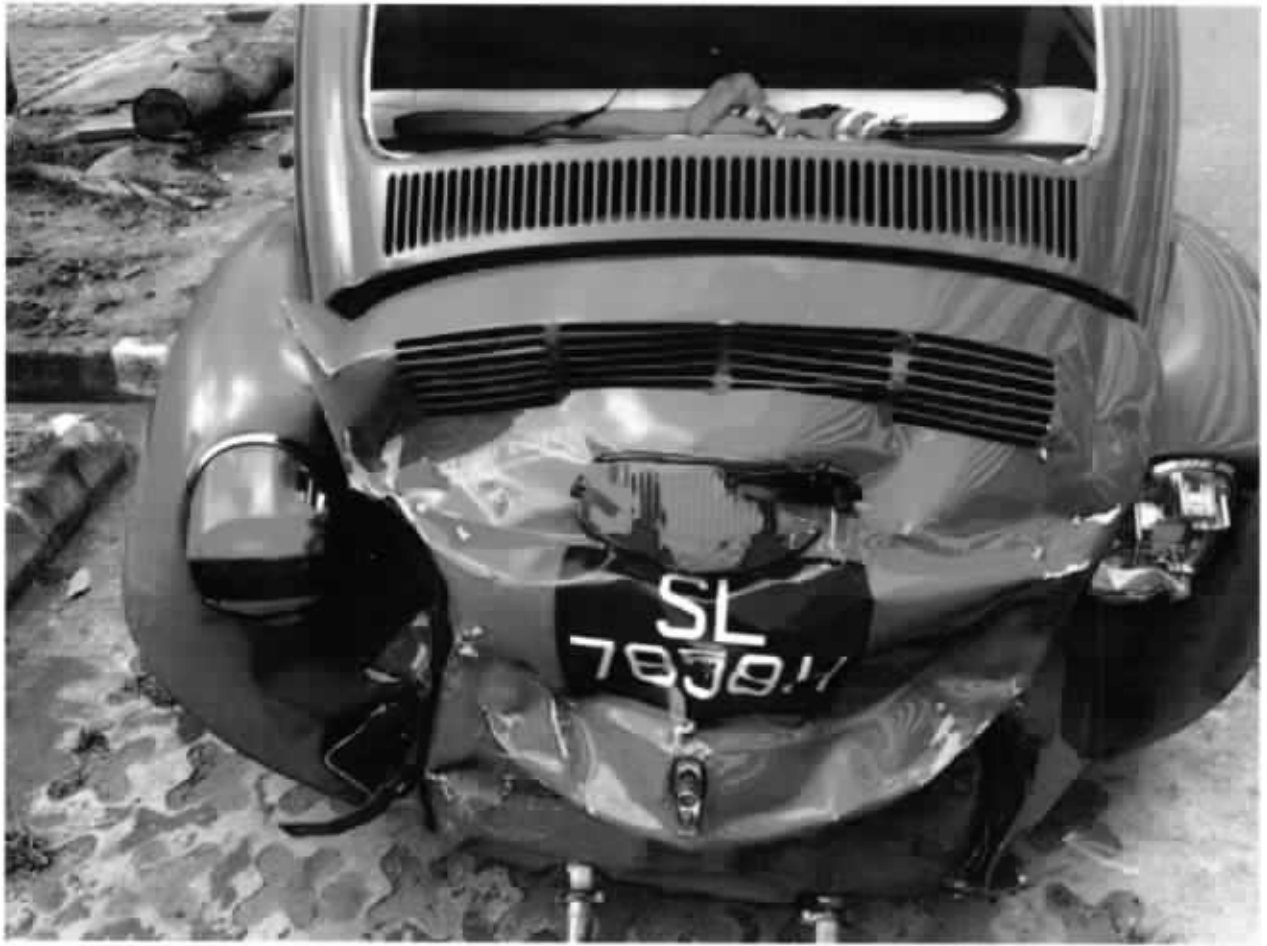
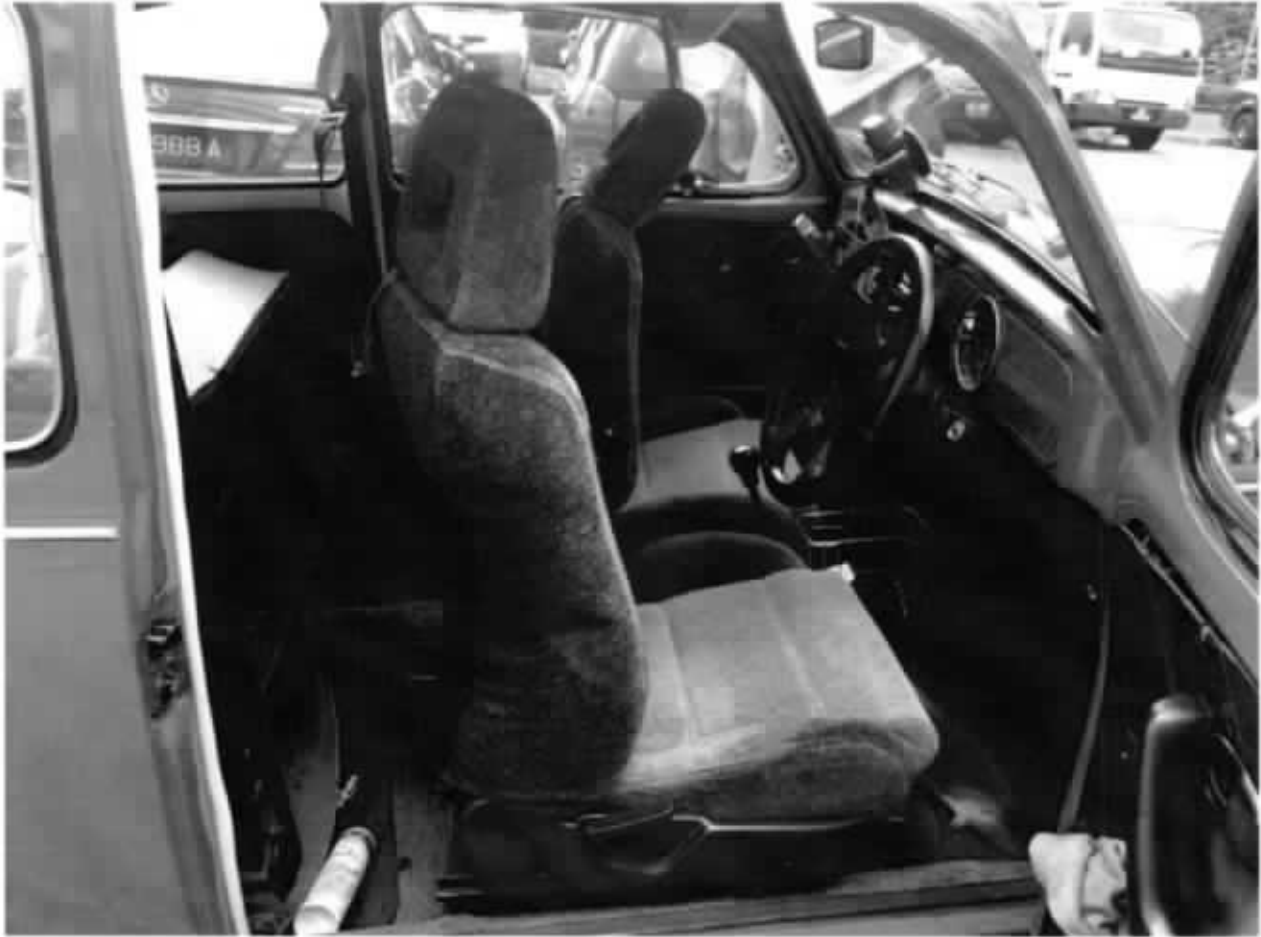
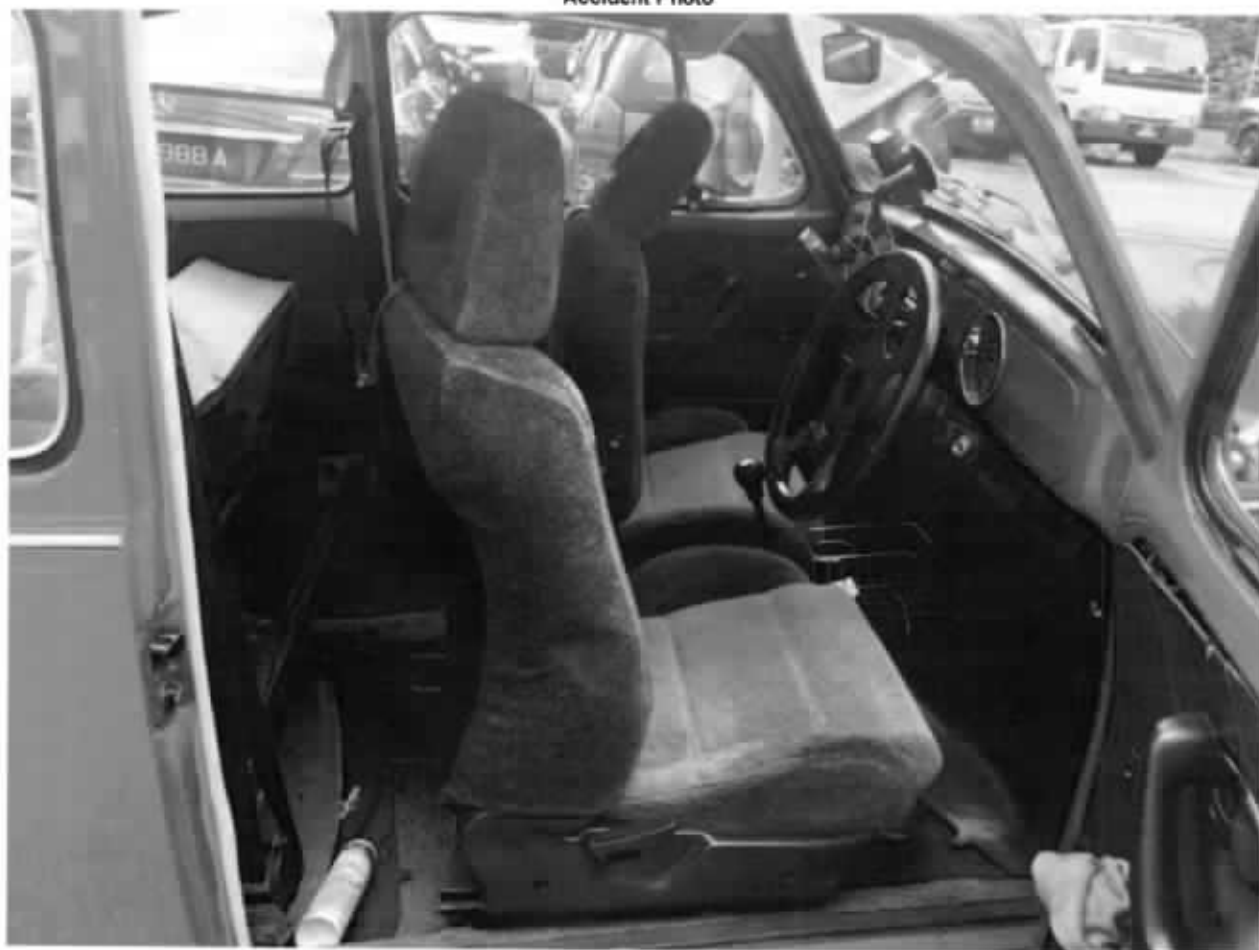
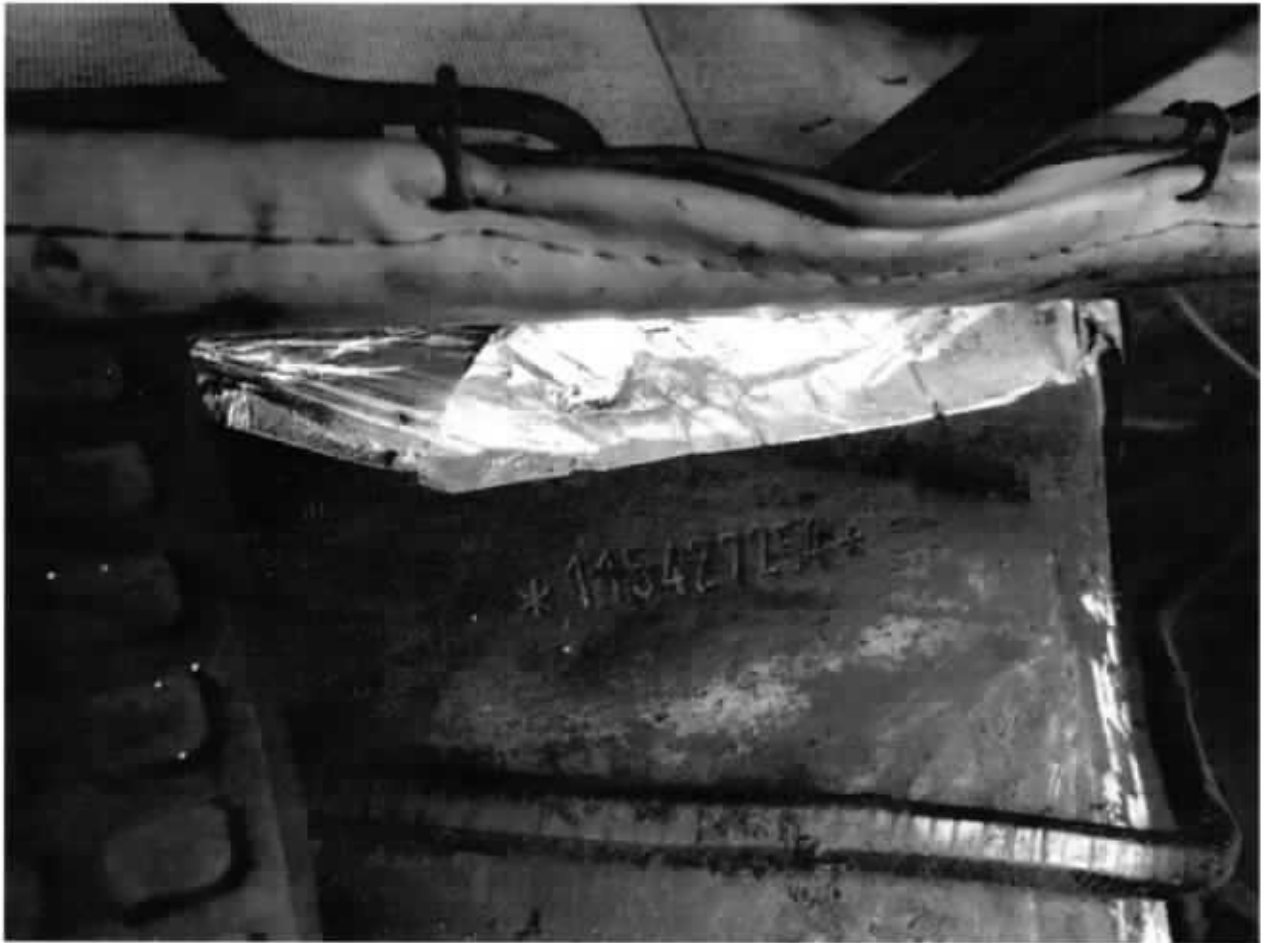
Accident Photo

**(F) General Description of Damages**

The impact of the collision has damaged/affected the rear bumper, hood cover, rear end panel and etc.

Please refer to the Annex for a detailed account of the damages and photographs taken.

(G) Recommendation

We have inspected thoroughly the actual damages found on the vehicle, before we arrived at our recommendation as to whether the parts needed replacement or repairs.

Our adjusted cost of lump sum repair is \$29,000.00 and an estimated 26 days is required to complete the repair. Please refer to the Annex for a detailed account of the cost estimates.
