REF: CS/ATG18021211/Gvber

REPAIR COST FOR VEHICLE NO. SL7858H

DAMAGED VEHICLE (SL 7858 H) INSPECTION REPORT (WITHOUT PREJUDICE)

ADJUSTMENT ON REPAIR COST FOR VEHICLE NO. SL 7858H

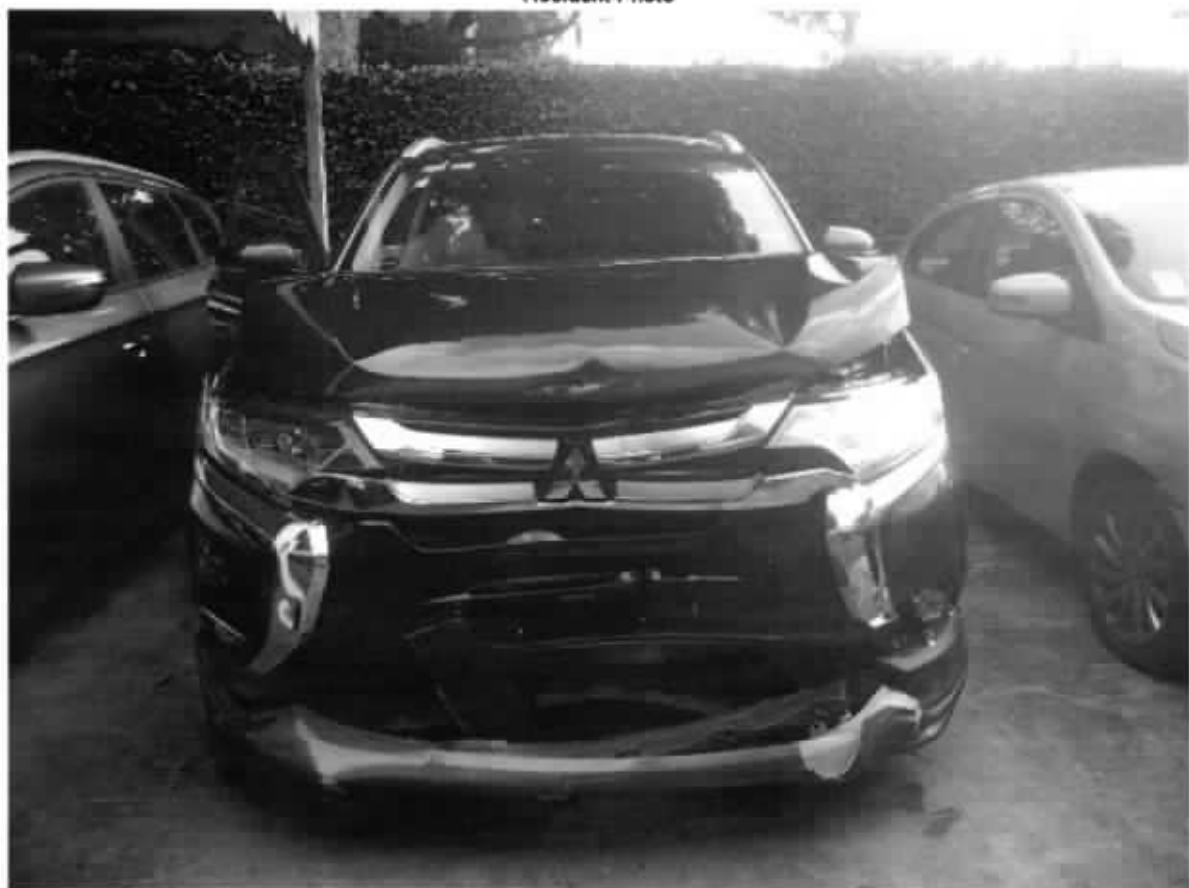
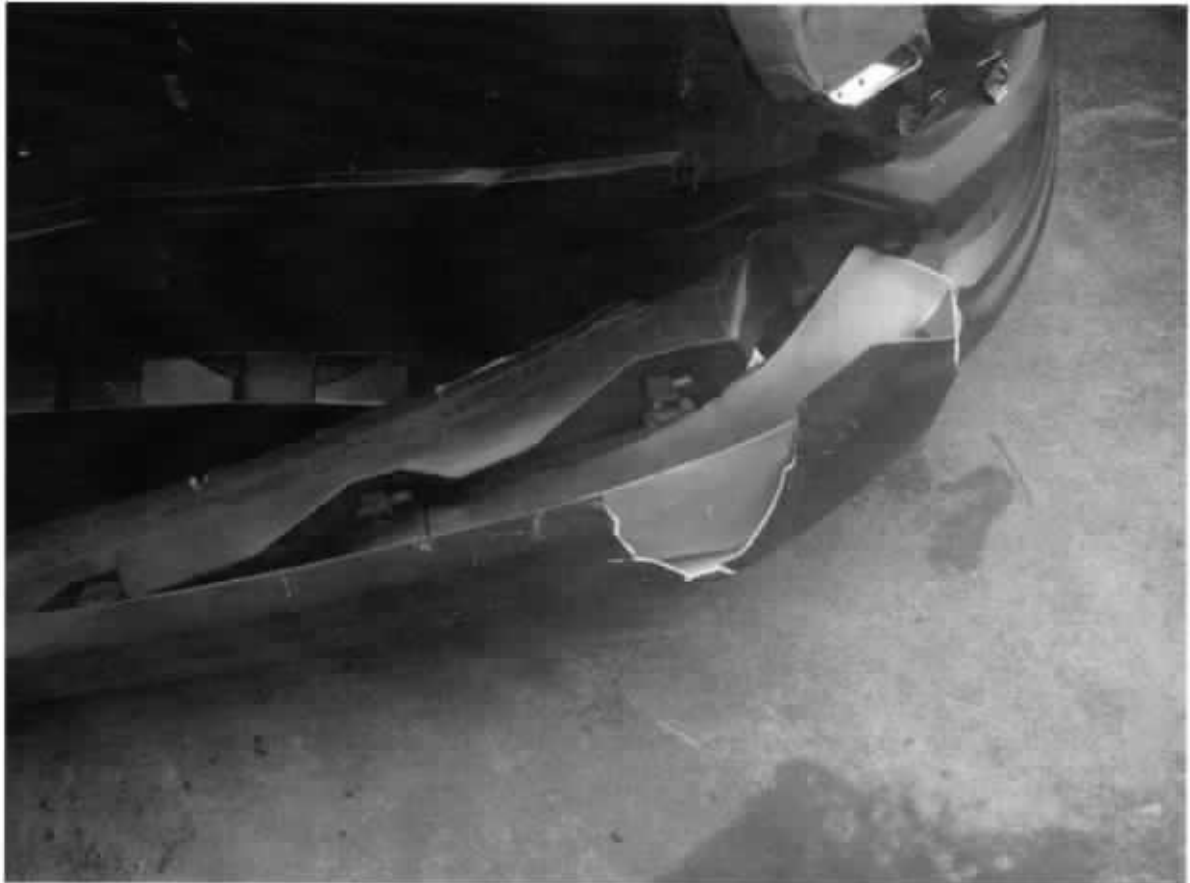
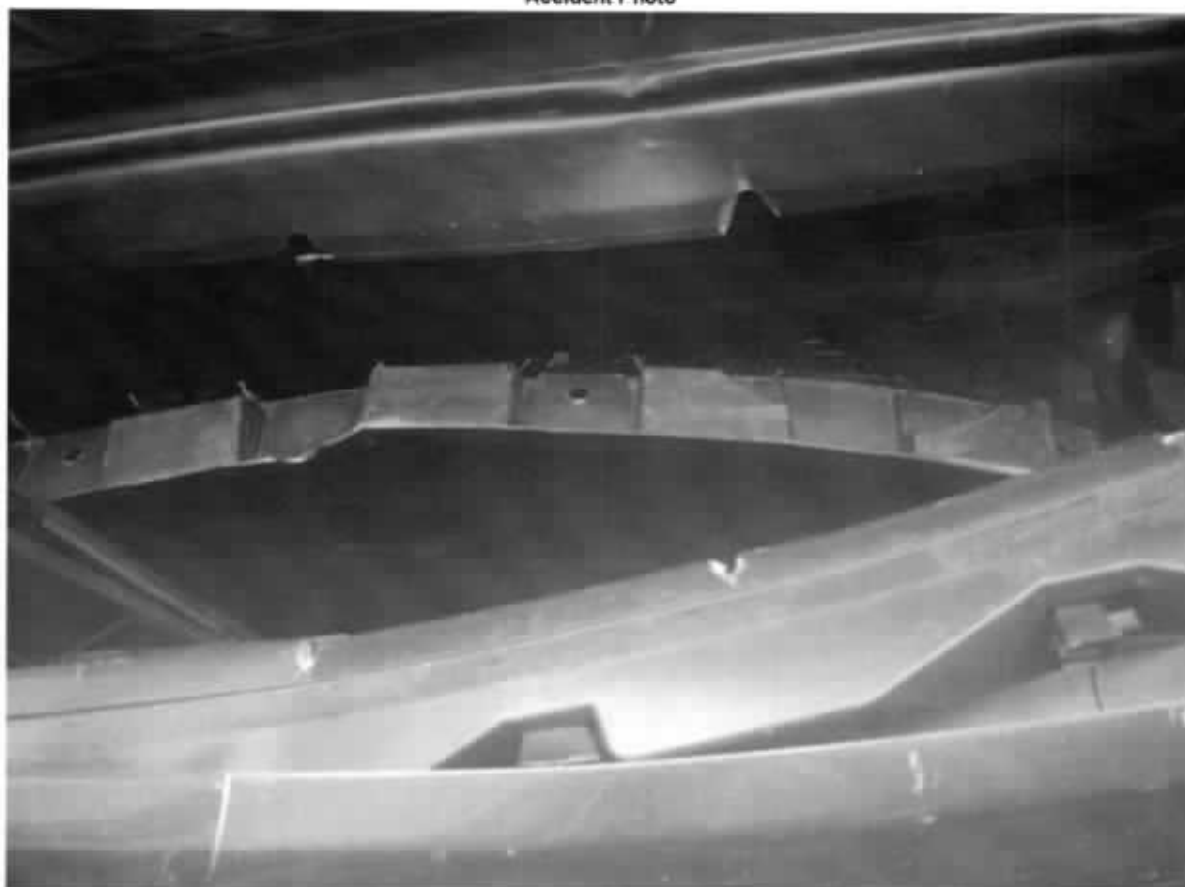
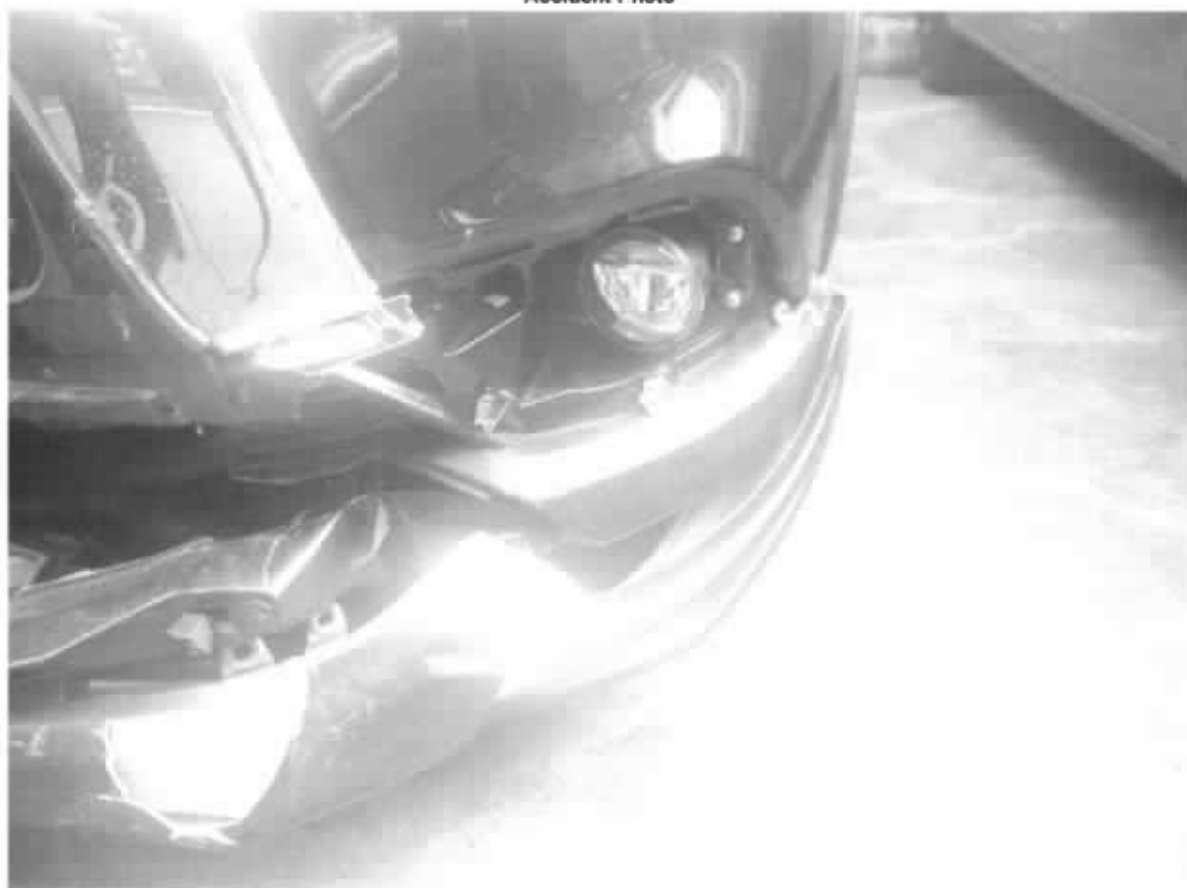
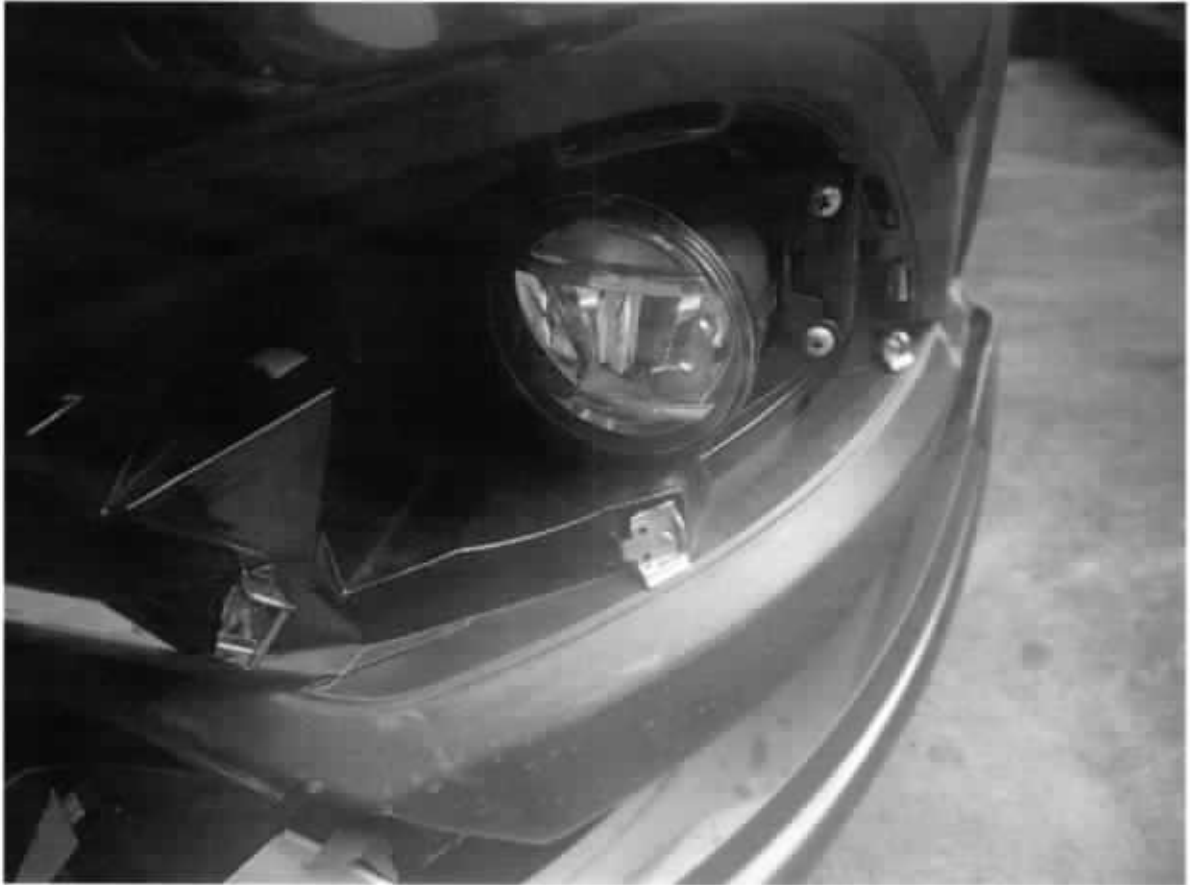
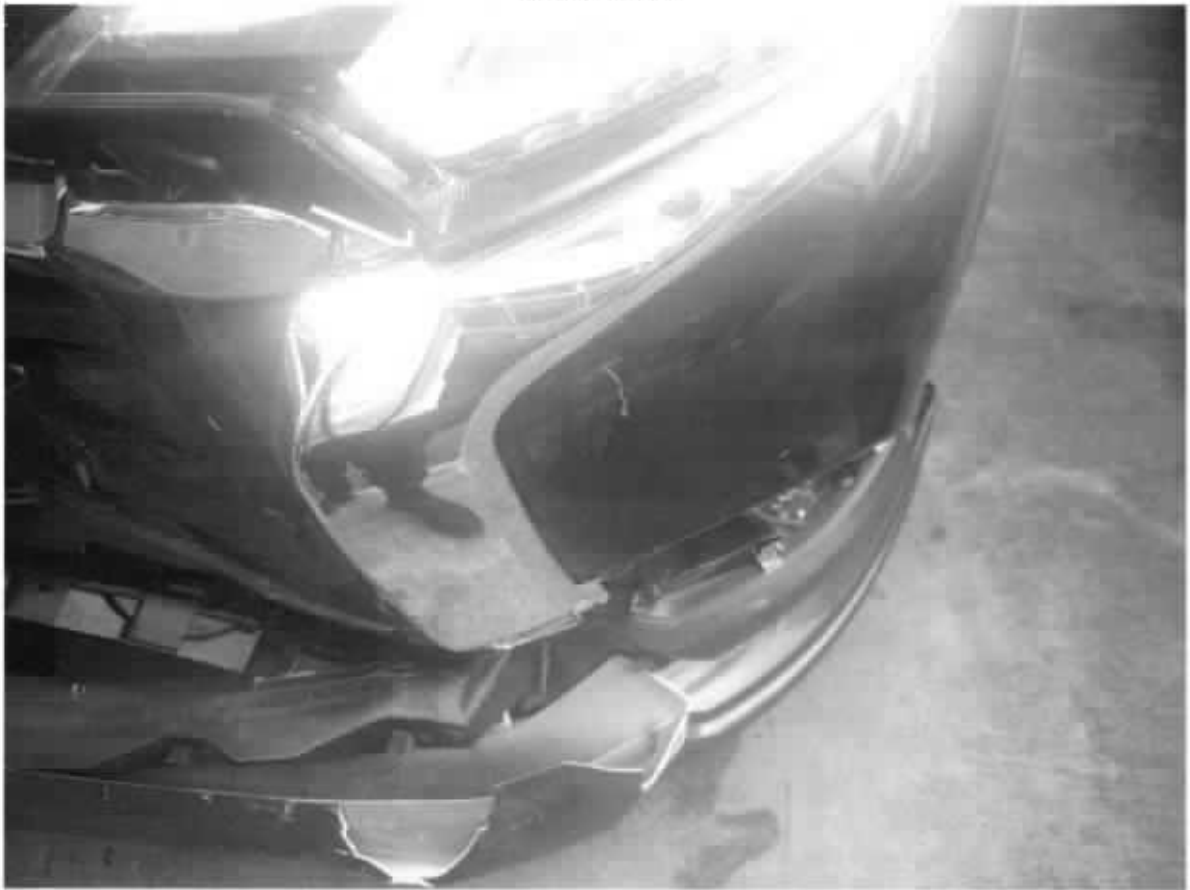
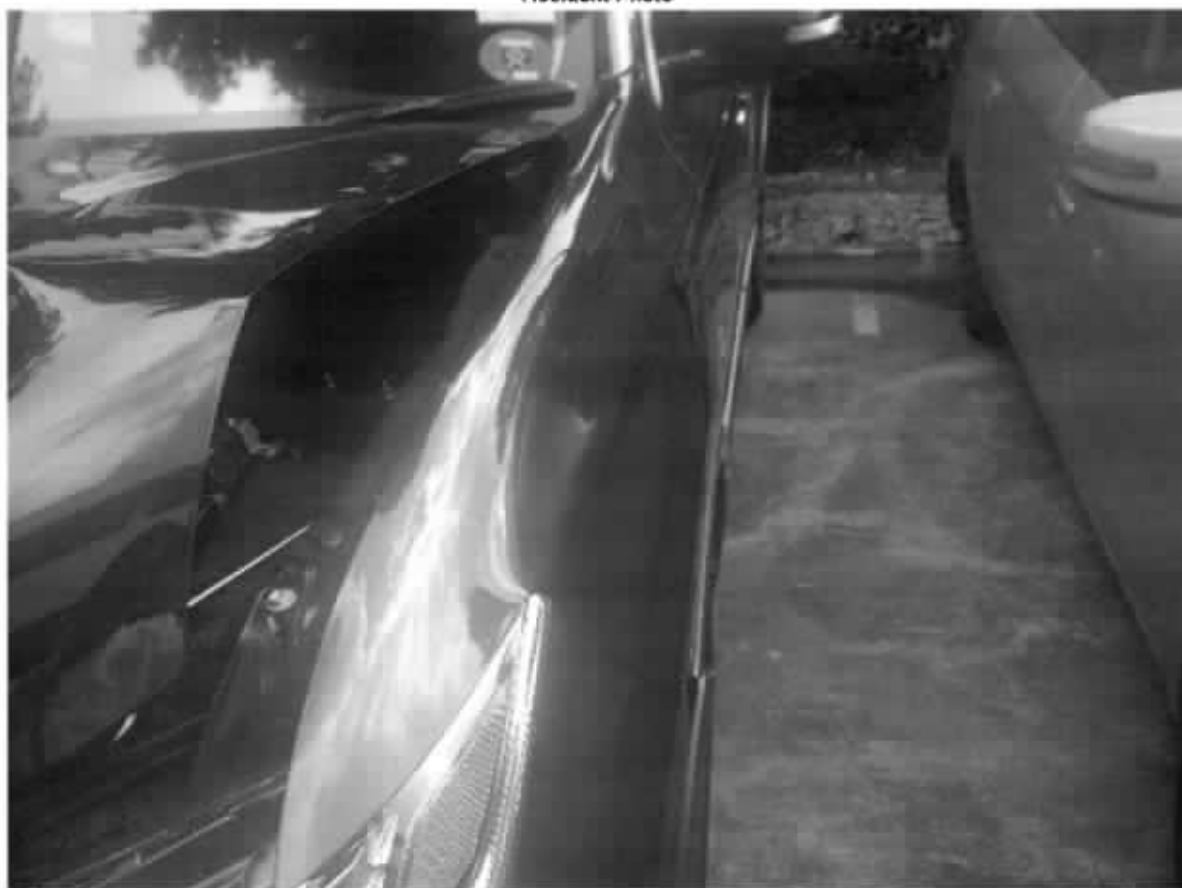
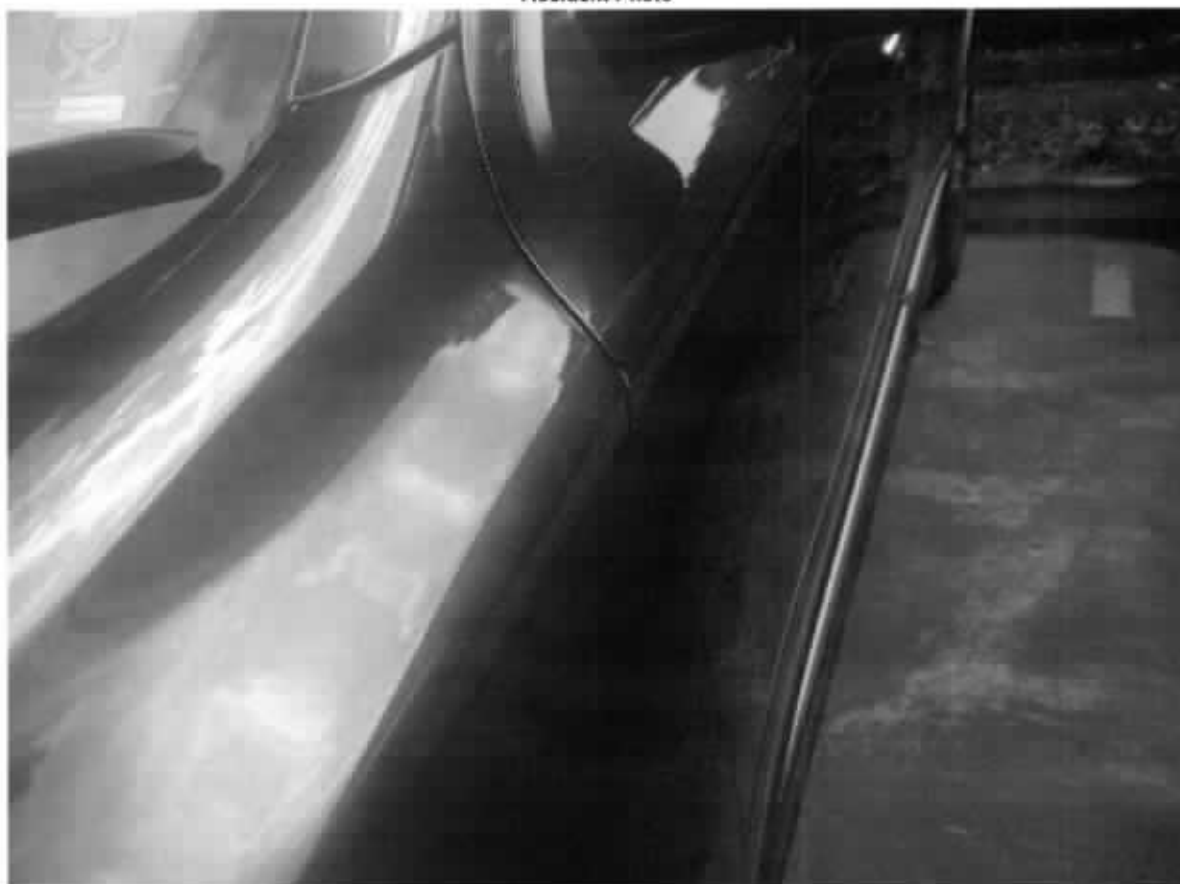
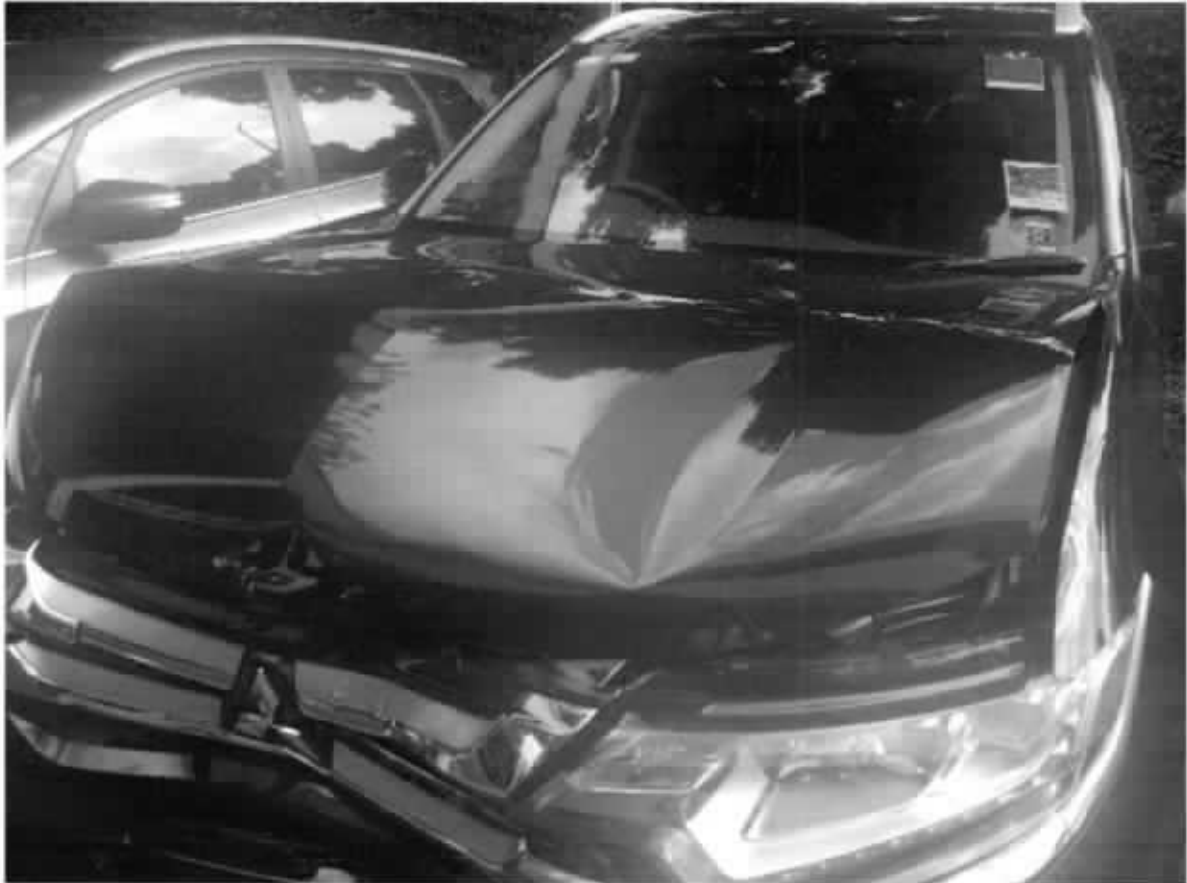
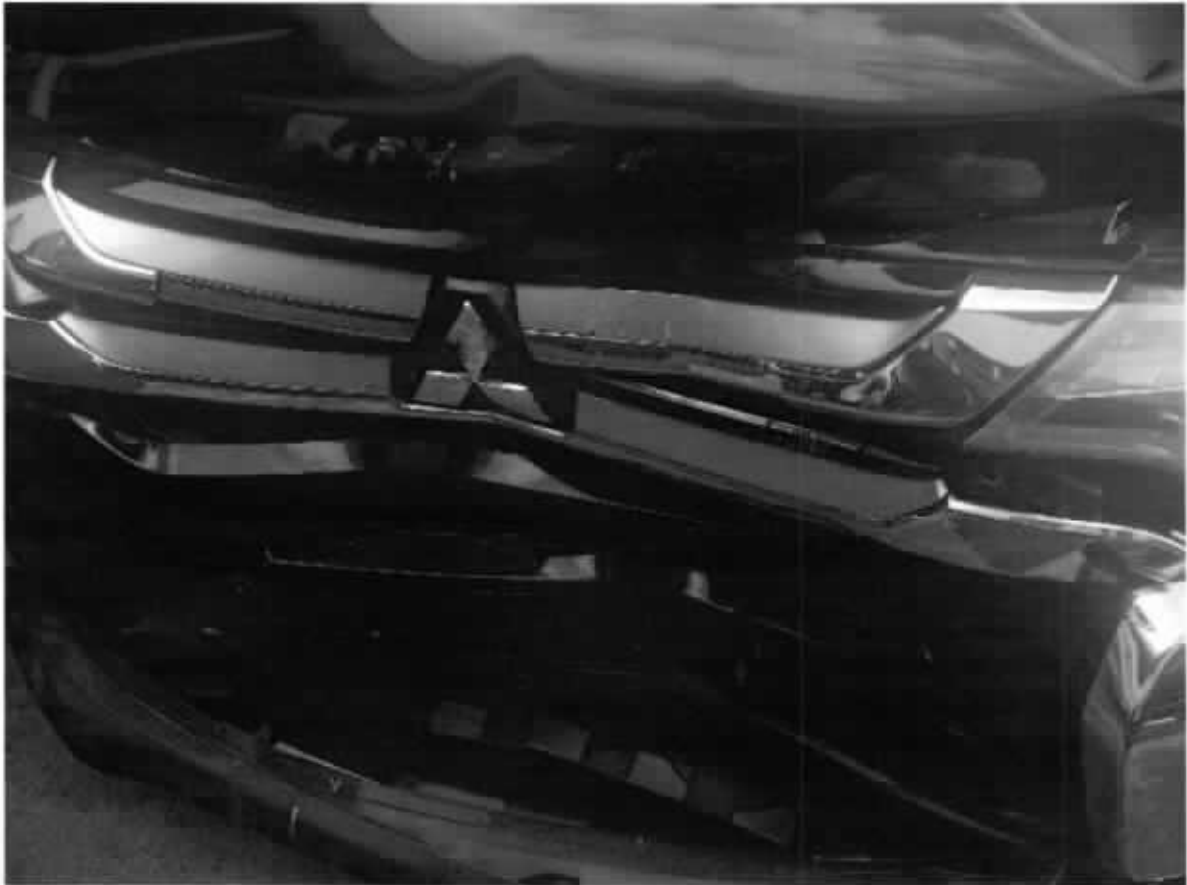
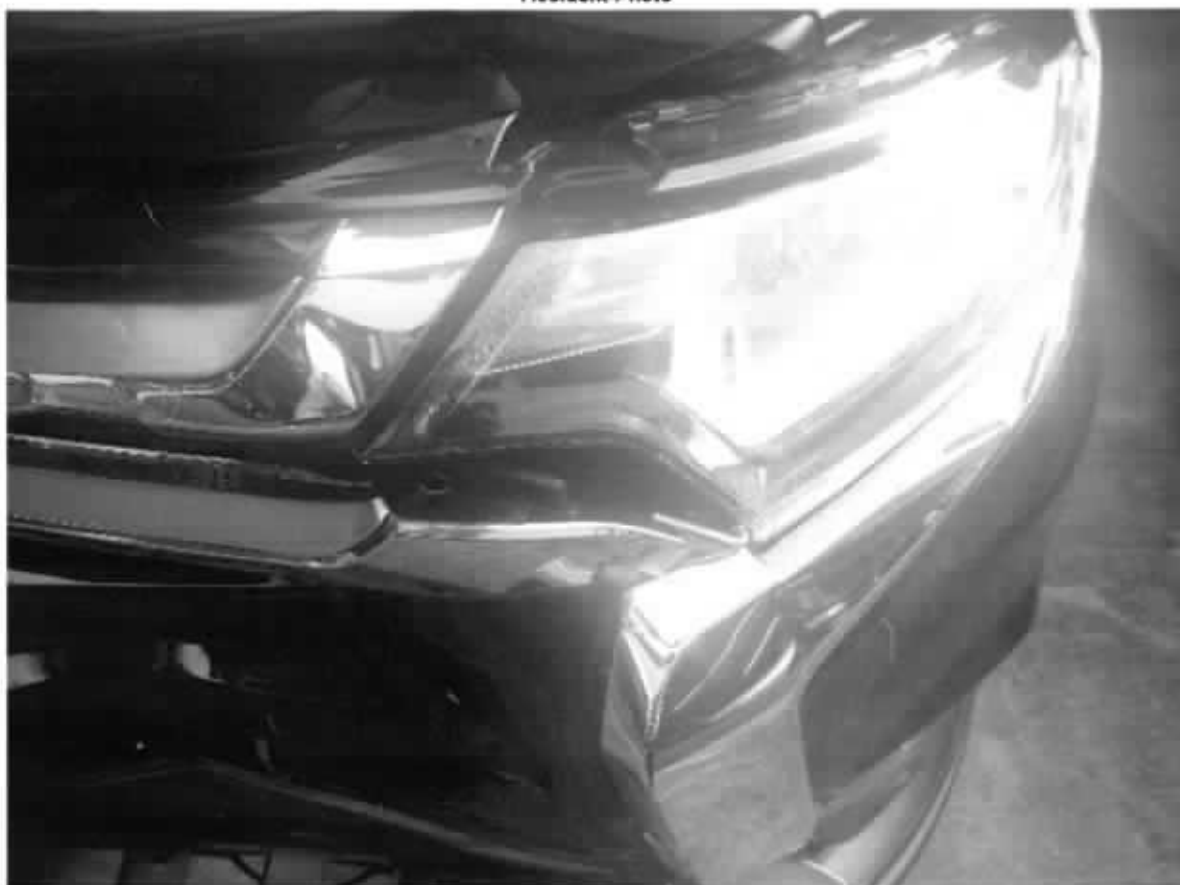
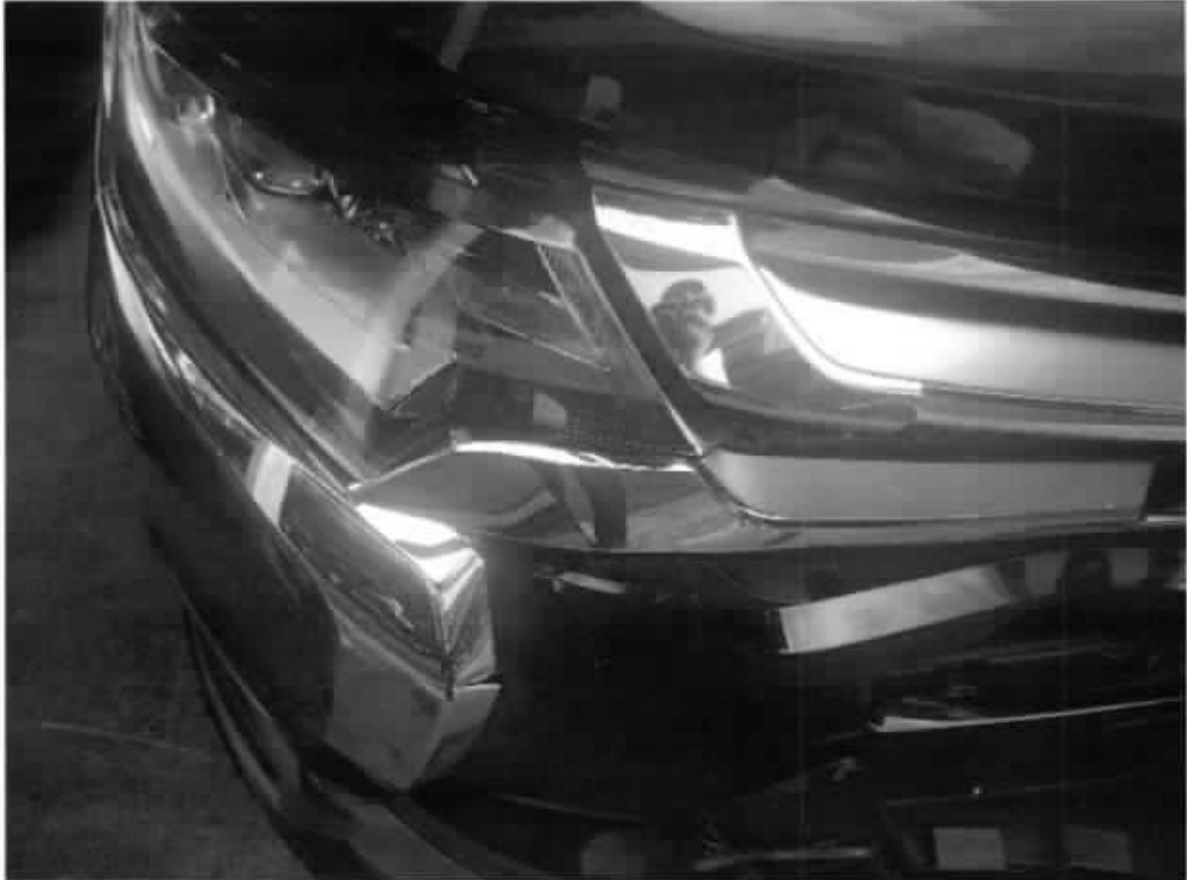
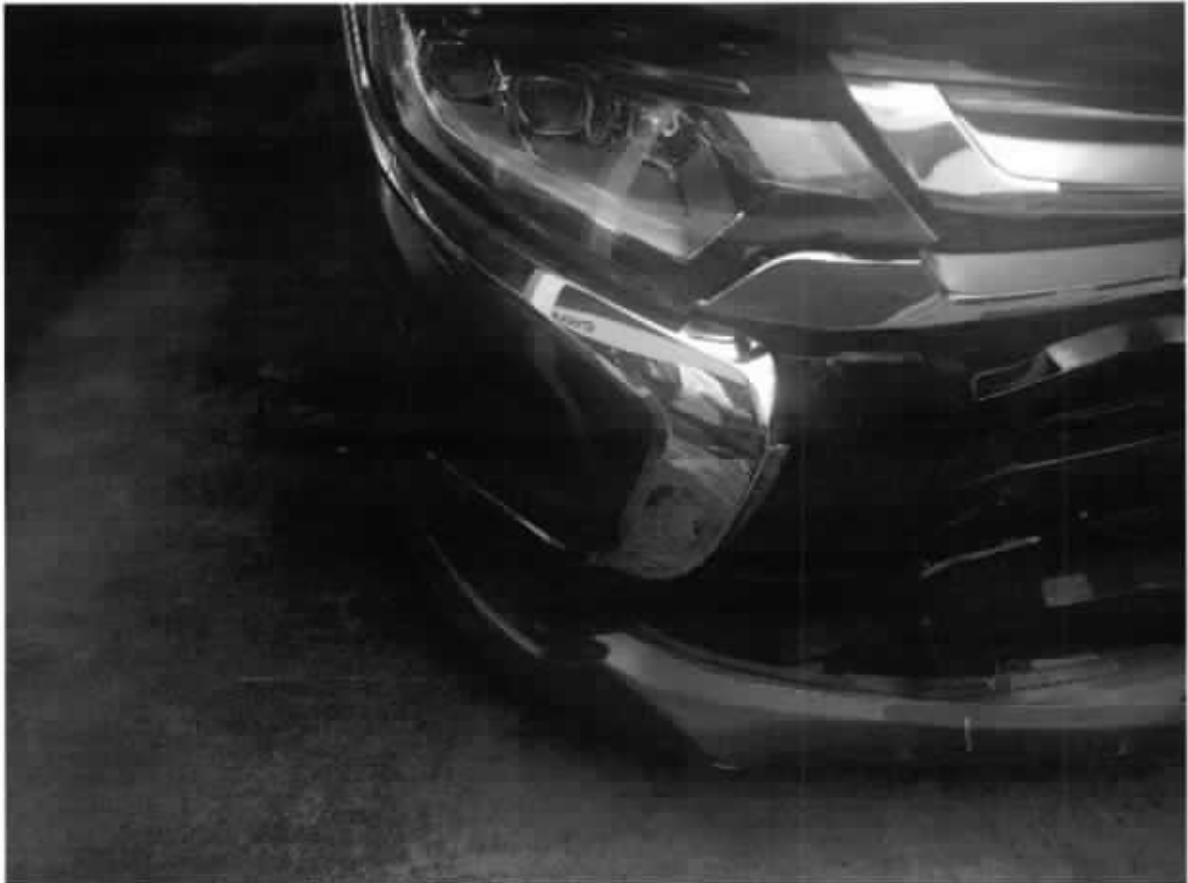
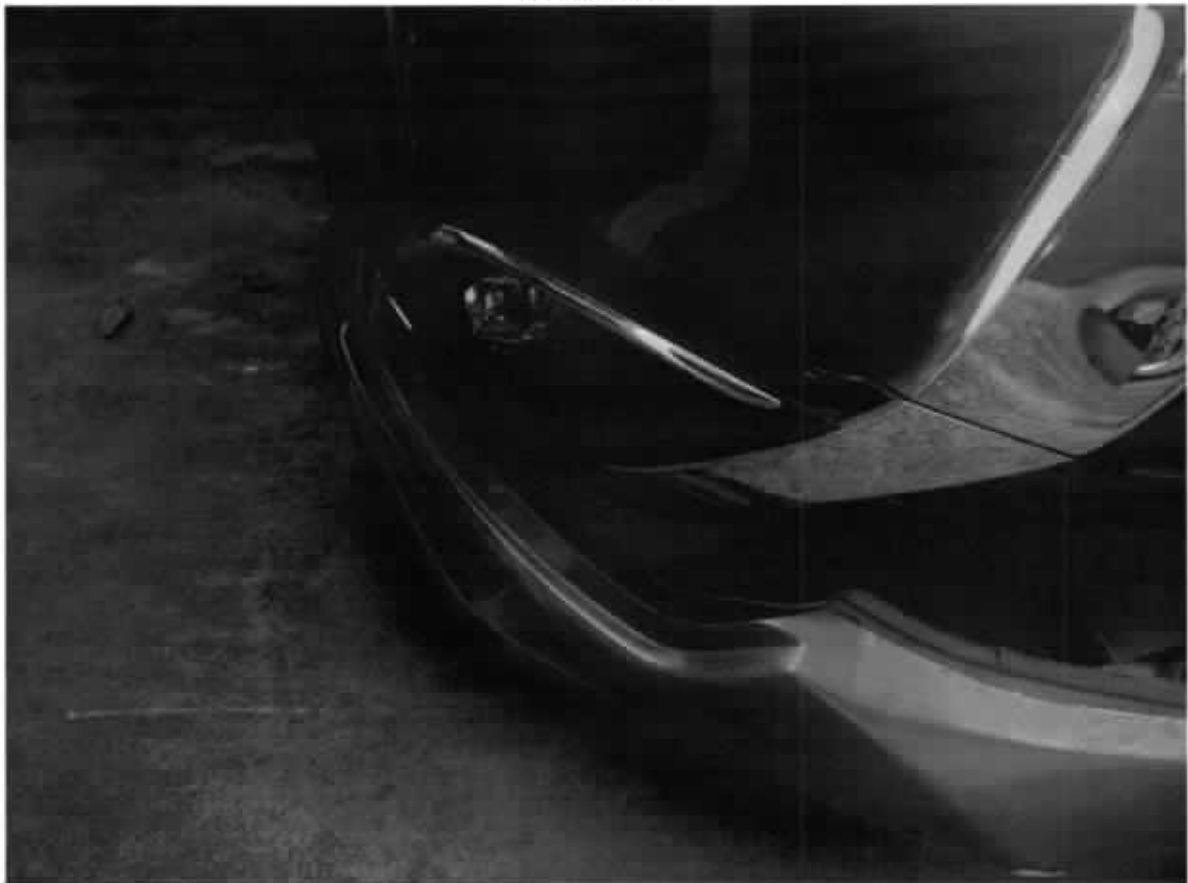
Accident Photo

I noticed that there were no other passengers in the car aside from the female driver who was seated at the driver's seat at the point in time. I was also alone in my vehicle at the point in time. I did not feel any pains from the impact. The impact caused the rear window of the other vehicle to be dislodged and also caused almost the whole rear portion of the vehicle to be dented.

The impact also caused the front bumper of my vehicle to be dislodged and also some dents to my vehicle's front portion. The driver of the other vehicle and I then took photos of the damages to our vehicle and exchanged particulars.
