VEHICLE DAMAGE INSPECTION REPORT

Our File No: CS/CTI18021423/KTD3E2

Claimant Vehicle
No: SLT1220CInsured Vehicle
No: SLJ2780Z

Make & Model: TOYOTA PRIUS, 1.8 HYBRID CVT (A)

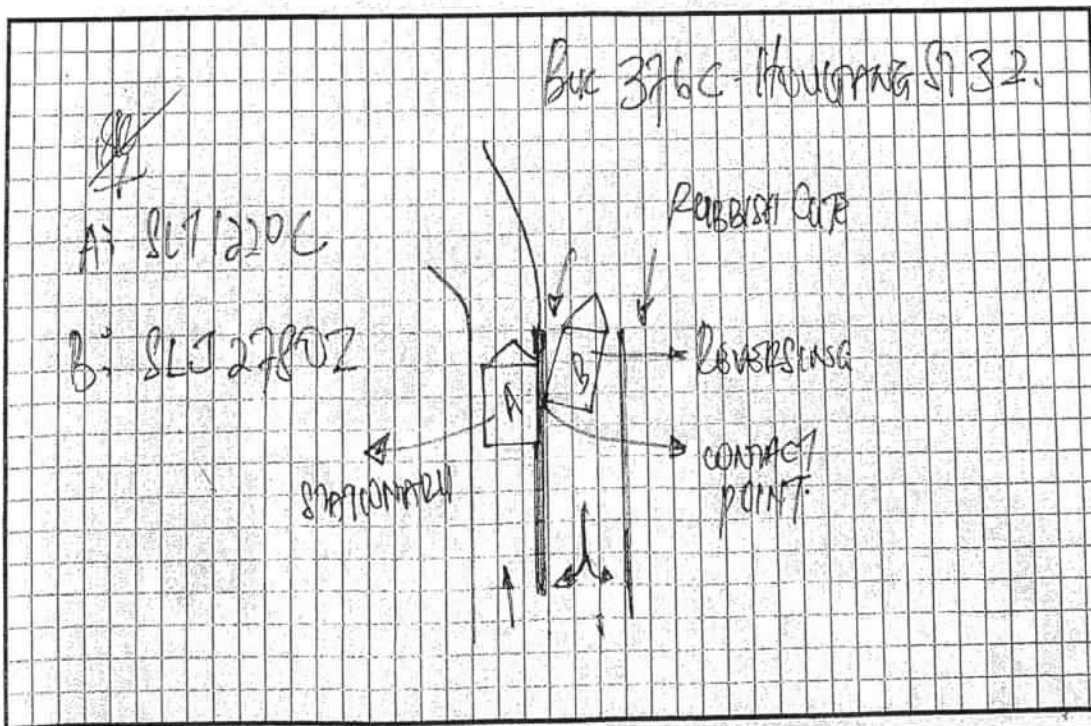
Sketch Plan

ON THE DATE AND TIME MENTIONED, I WAS AT THE MENTIONED LOCATION AND MY CAR WAS STATIONARY WHEN VEHICLE B WAS REVERSING TOWARDS MY VEHICLE AND SEEING THIS, I HONKED AT VEHICLE B, BUT IT KEPT ON REVERSING AND HIT THE REAR RIGHT PORTION OF MY VEHICLE. NO BODY WAS INJURED. STATEMENT WAS READ TO ME AND I ACKNOWLEDGED IT.
