1. Policy Particulars :- THIRD PARTY CLAIM

Insured Veh.	SLV 53P	Veh. Inspected	SH 9198L
Policy No.	5078662213-02	Coverage (\$)	0.00
Claim No.	MT/1022385-002	Excess (\$)	0.00
Assign From		Assign Date	03/12/2018

4. Description of Damages

ADJUSTMENT ON REPAIR COST FOR VEHICLE NO. SH 9198L

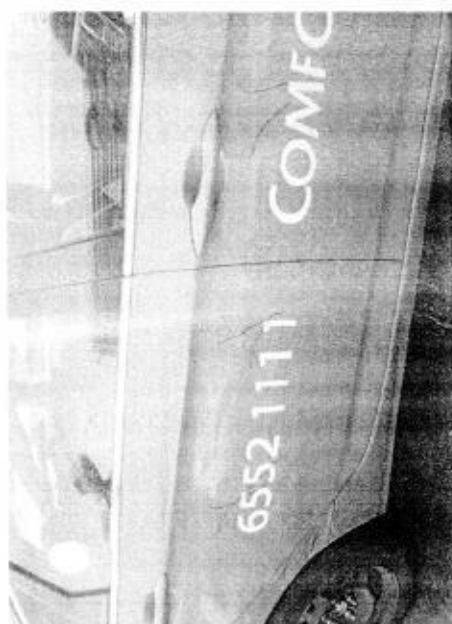
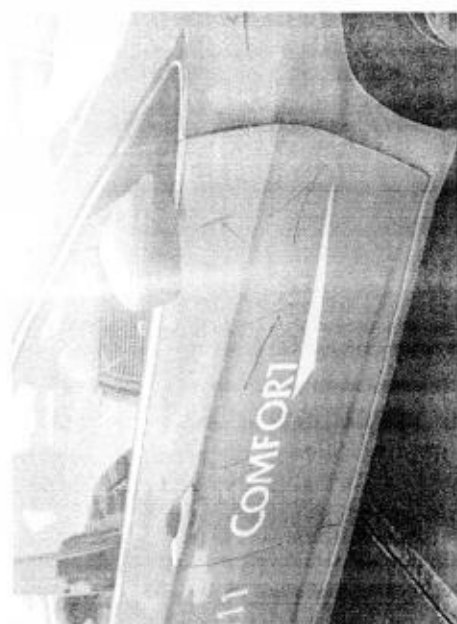
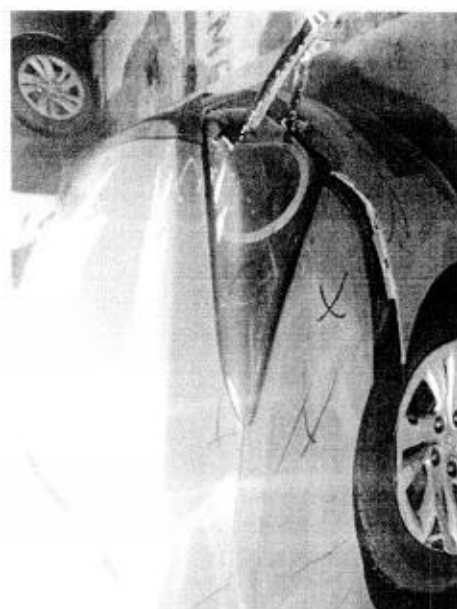
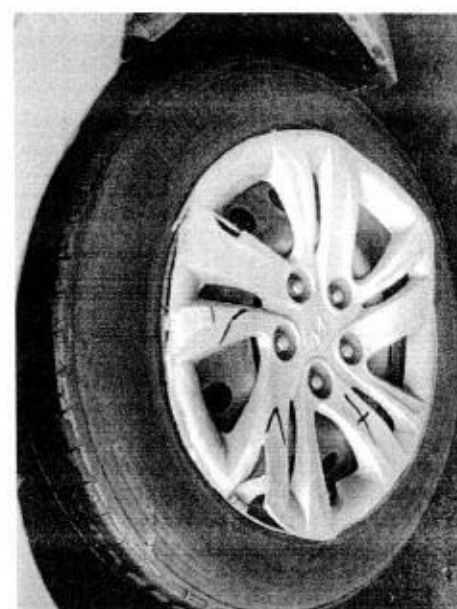
0/s Front.

The U/C / Chassis frame / Body Structure affected due to collision.

THE VEHICLE SUSTAINED DAMAGES AT THE O/S FRONT PORTION. DAMAGES SEE DETAILS.

Qty	Description of Parts	Condition	Estimate By Workshop (\$)	Our Adjusted (\$)
<u>REPLACEMENT OF PARTS</u>				
1	FRONT BUMPER COVER	DEFORMED	544.50	544.50
1	FRONT BUMPER BRACKET TOP (RH)	SERVICEABLE	22.40	-
1	FRONT BUMPER RETAINER MOUNTING	SERVICEABLE	9.20	-
1	HEADLAMP (RH)	CUT	1,388.00	1,388.00
1	FRONT FENDER (RH)	DENTED	566.30	566.30
1	FRONT FENDER SHIELD (RH)	SERVICEABLE	175.90	-
1	FRONT FENDER RETAINER	SERVICEABLE	24.60	-
1	FRONT DOOR (RH)	DENTED	2,256.40	2,256.40
1	FRONT WHEEL RIM (RH)	SERVICEABLE	325.30	-
1	FRONT WHEEL HUB CAP (RH)	CRACKED	107.10	107.10
1	REAR WHEEL HUB CAP (RH)(NPA)	MISSING	-	-
1	REAR DOOR (RH)(NPA)	TO REPAIR SEE LABOUR	-	-
1	REAR FENDER (RH)(NPA)	TO REPAIR SEE LABOUR	-	-
1	REAR BUMPER (RH)(NPA)	TO REPAIR SEE LABOUR	-	-
1	FRONT BONNET (NPA)	TO REPAIR SEE LABOUR	-	-
1	ROCKER PANEL (NPA)	TO REPAIR SEE LABOUR	-	-
	LESS 20% DISCOUNT		-1,083.94	-972.46
			4,335.76	3,889.84
<u>NETT ITEMS</u>

Qty	Description of Parts	Condition	Estimate By Workshop (\$)	Our Adjusted (\$)
	LABOUR			
	PANEL BEATING.INCLUSIVE OF THE REPAIR OF REAR DOOR (RH),REAR FENDER (RH),REAR BUMPER (RH),FRONT BONNET AND ROCKER PANEL.		800.00	600.00
	SPRAY PAINTING CHARGE.		1,800.00	1,600.00
	WIRING CHARGE.		50.00	20.00
	TUFF KOTE.		50.00	20.00
	TRANSFER OF DOOR.		120.00	50.00
	FRT WHEEL ALIGNMENT.		120.00	60.00
			2,940.00	2,350.00
	GRAND TOTAL		7,646.76	6,379.34
	RECOMMENDED COST OF LUMP SUM REPAIRS (TO ITS PRE-ACCIDENT CONDITION) (CONFIRMED)			4,800.00
