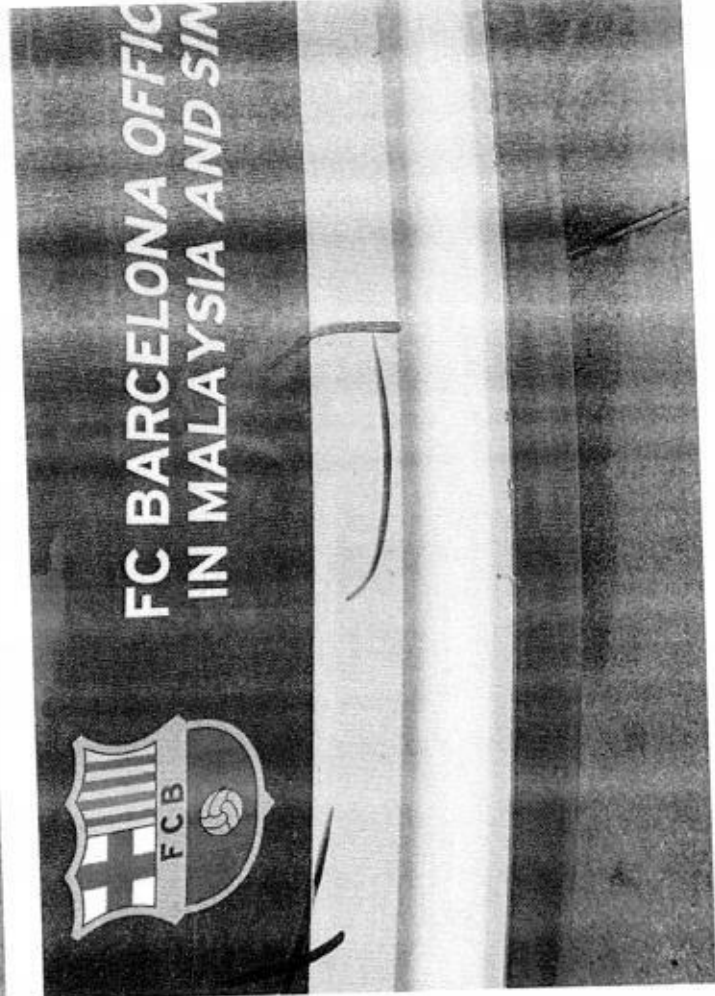
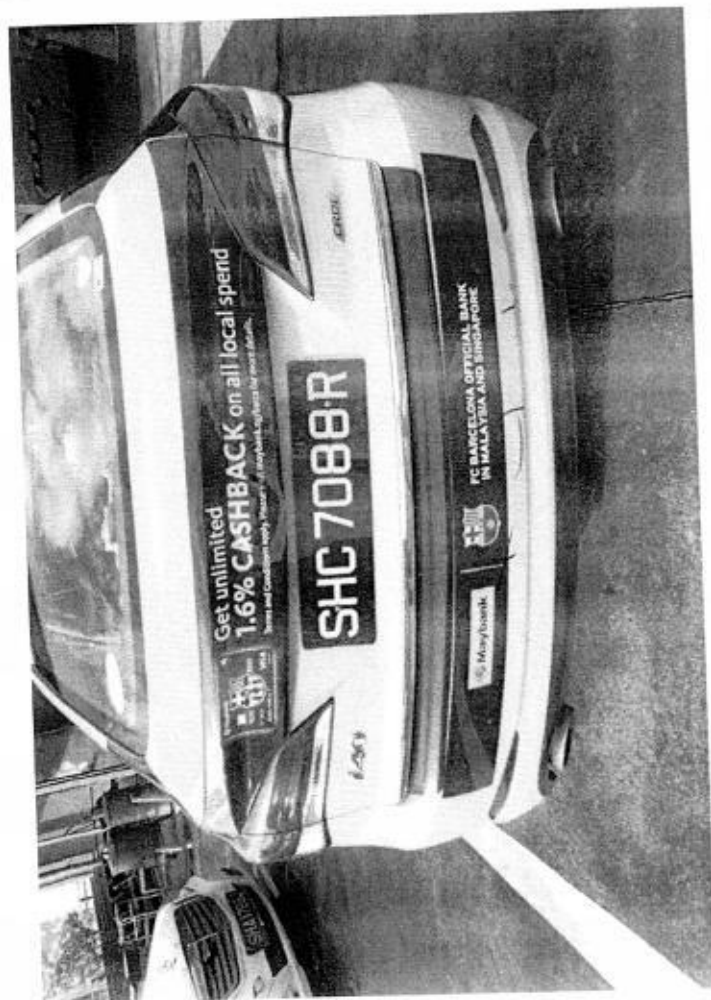
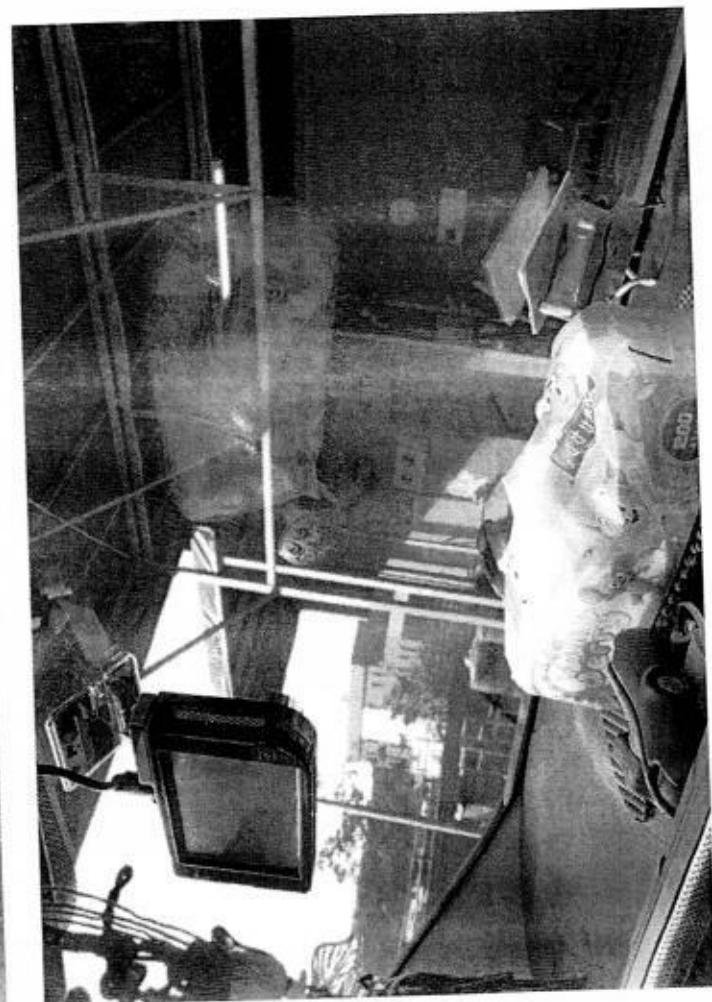
4. Description of Damages			
THE VEHICLE SUSTAINED DAMAGES AT THE REAR PORTION. DAMAGES SEE DETAILS.			
5. General Information			
Accident Date	01/12/2018	Inspection Date	03/12/2018
Survey held at	COMFORTDELGRO ENGINEERING PTE LTD 59 LOYANG DRIVE SINGAPORE 508969		
5a. Remarks			
A)THE INSPECTION WAS CONDUCTED ON A"WITHOUT PREJUDICE" BASIS. B)IN ACCORDANCE TO YOUR INSTRUCTIONS, WE HAVE NOT AUTHORISED REPAIRS.			
5b. Estimate Days of Repair			
ESTIMATED NORMAL PERIOD FOR REPAIR:		2 Working Days

Qty	Description of Parts	Condition	Estimate By Workshop (\$)	Our Adjusted (\$)
<u>REPLACEMENT OF PARTS</u>				
1	REAR BUMPER	DEFORMED	553.00	553.00
1	REAR BUMPER REINFORCEMENT	SERVICEABLE	428.40	-
2	REAR BUMPER REINFORCEMENT BRACKET (LH/RH) @\$80.30	SERVICEABLE	160.60	-
10	REAR BUMPER CLIP	NECESSARY	22.00	22.00
2	REAR BUMPER BRACKET @\$35.60	SERVICEABLE	71.20	-
1	REAR BUMPER SPONGE	SERVICEABLE	103.50	-
1	REAR BUMPER UNDER COVER	CUT	228.00	228.00
	LESS 20% DISCOUNT		-313.34	-160.60
			1,253.36	642.40
<u>SPECIAL NETT ITEMS</u>				
1	REAR BUMPER RUBBER MAT (SN)	NECESSARY	50.00	50.00
1	REAR BUMPER ADVERTISEMENT LOGO (SN)	NECESSARY	50.00	50.00
2	REAR FENDER ADVERTISEMENT LOGO (LH/RH) @\$100.00 (SN)	NECESSARY	200.00	200.00
1	REAR BUMPER REVERSE SENSOR (SN)	SHORTED	135.70	135.70

-		-	-
	-		-	-
	-		-	-
			740.00	430.00
GRAND TOTAL			2,429.06	1,508.10
RECOMMENDED COST OF LUMP SUM REPAIRS (TO ITS PRE-ACCIDENT CONDITION) (CONFIRMED)				1,200.00
