NTUC INCOME INSURANCE CO-OPERATIVE LTD Ref: NS/INC18021742/K1sbn2

1. Policy Particulars :- THIRD PARTY CLAIM

4. Description of Damages

ADJUSTMENT ON REPAIR COST FOR VEHICLE NO. SHD 6643P

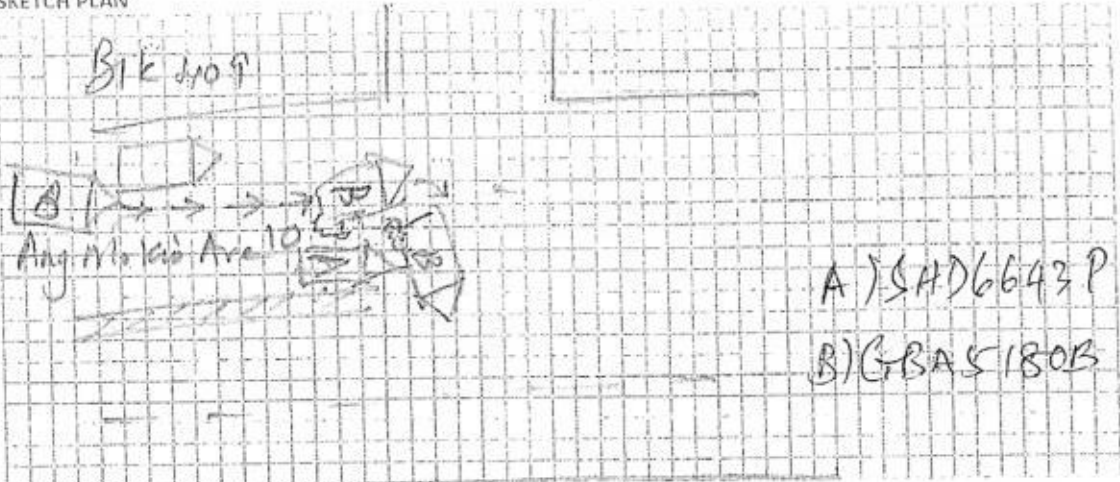
SKETCH PLAN

On 7/12/18 at about 03:15pm while I Veh A was travelling along the right lane, Veh B who was ahead of my vehicle signalled to make a right turn (or U-turn) illegally. I slowed down, but Veh B straddled to the left lane and suddenly straddled to the right lane abruptly and stopped. As the floor was wet, I was just in time to stop. However, because vehicle B moved on and grazed the front portion of my vehicle.

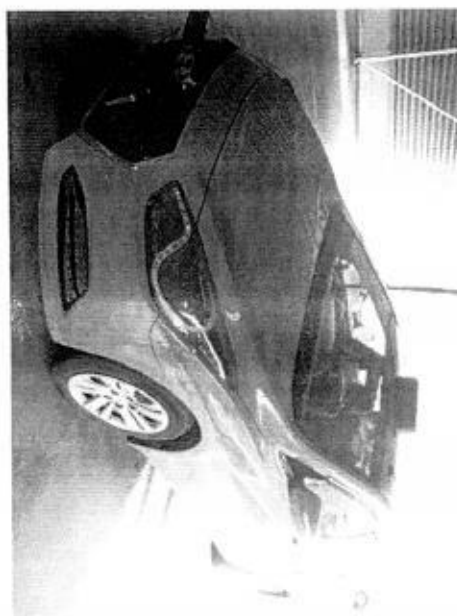
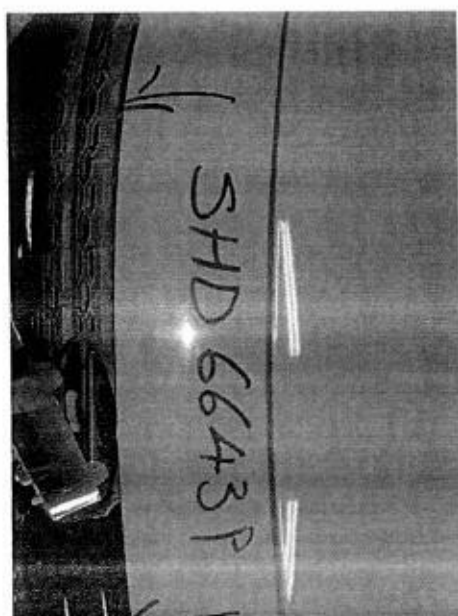
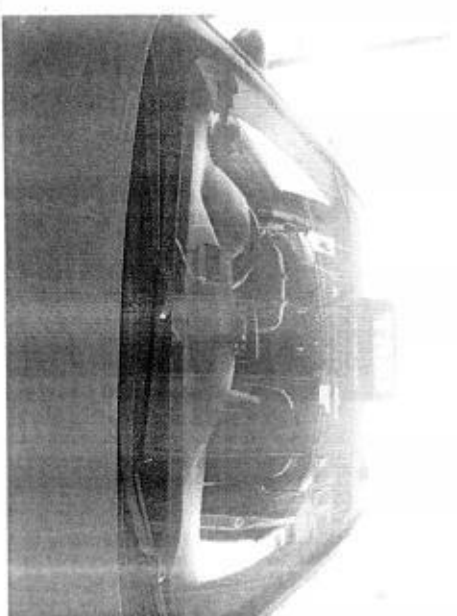
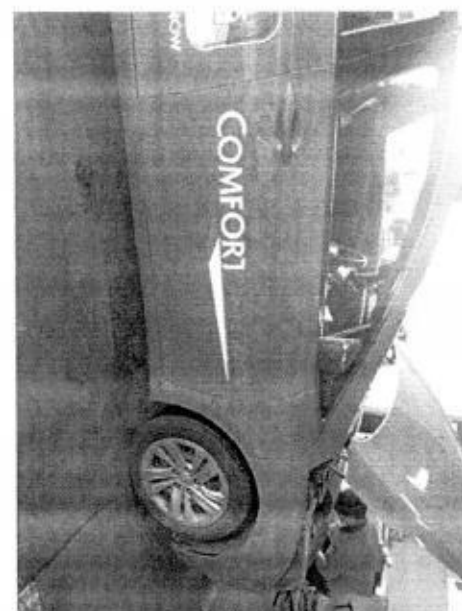
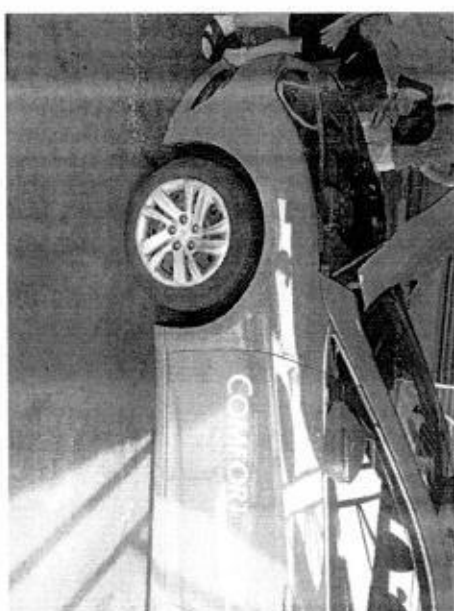
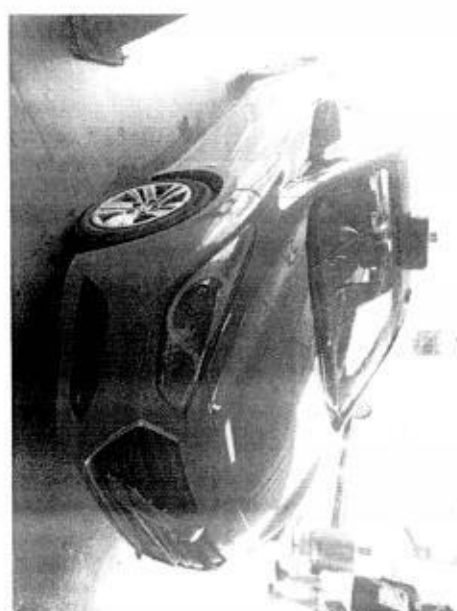
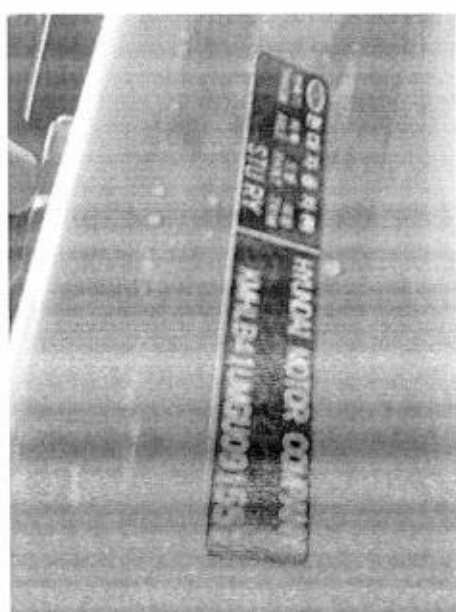
The U/C / Chassis frame / Body Structure affected due to collision.

THE VEHICLE SUSTAINED DAMAGES AT THE FRONT PORTION. DAMAGES SEE DETAILS.

Qty	Description of Parts	Condition	Estimate By Workshop (\$)	Our Adjusted (\$)
<u>REPLACEMENT OF PARTS</u>				
1	RADIATOR GRILLE	CRACKED	1,110.10	1,110.10
1	RADIATOR GRILLE H EMBLEM	CRACKED	39.50	39.50
1	FRONT BUMPER COVER	DEFORMED	1,052.20	1,052.20
1	FRONT BUMPER SPONGE	SERVICEABLE	99.20	-
1	FRONT BUMPER REINFORCEMENT	SERVICEABLE	402.10	-
2	FRONT BUMPER BRACKET TOP (LH/RH) @\$22.40	SERVICEABLE	44.80	-
2	FRONT BUMPER BRACKET (LH/RH) @\$24.60	SERVICEABLE	49.20	-
	LESS 20% DISCOUNT		-559.42	-440.36
			2,237.68	1,761.44
<u>SPECIAL NETT ITEMS</u>				
1	FRONT NUMBER PLATE (SN)	CRACKED	25.00	25.00
1	FRONT NO PLATE TRIM COVER (SN)	CRACKED	30.00	30.00
			55.00	55.00
<u>LABOUR</u>				
	PANEL BEATING.		400.00	200.00
	SPRAY PAINTING CHARGE.		300.00	200.00
			700.00	400.00
GRAND TOTAL			2,992.68	2,216.44
RECOMMENDED COST OF LUMP SUM REPAIRS (TO ITS PRE-ACCIDENT CONDITION) (CONFIRMED)				1,750.00
