1. Policy Particulars :- THIRD PARTY CLAIM

Insured Veh.	SHC 6034C	Veh. Inspected	SHC 1360T
Policy No.	5095103893	Coverage (\$)	0.00
Claim No.	MT/1022888-002	Excess (\$)	0.00
Assign From		Assign Date	07/12/2018

4. Description of Damages

ADJUSTMENT ON REPAIR COST FOR VEHICLE NO. SHC 1360T

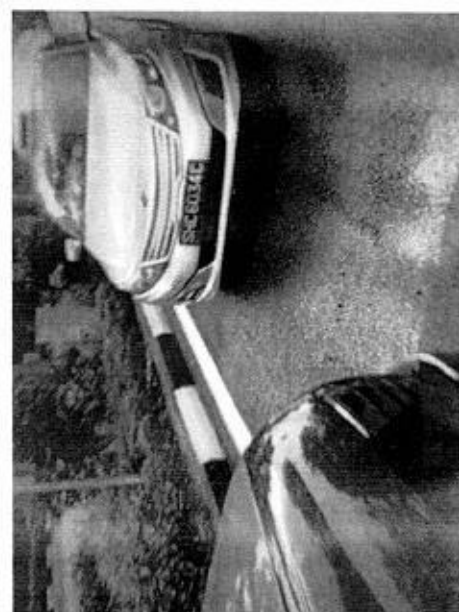
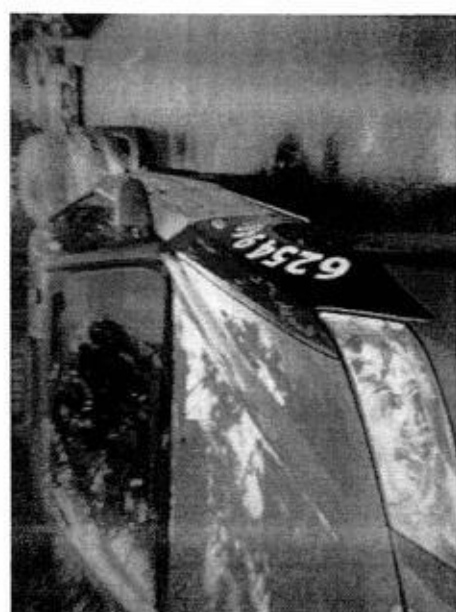
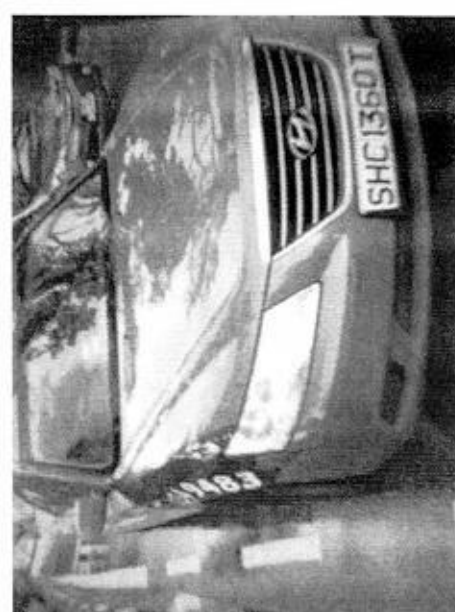
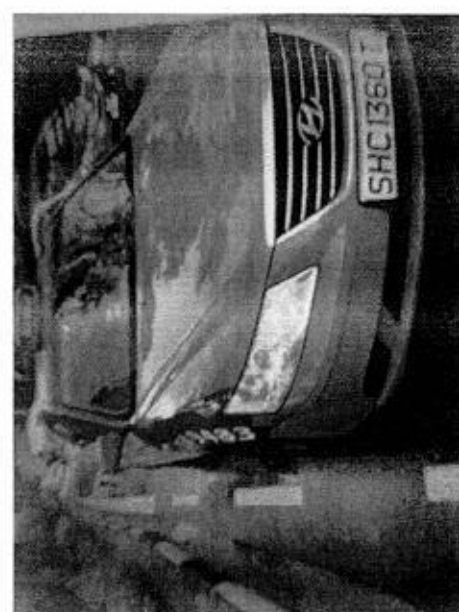
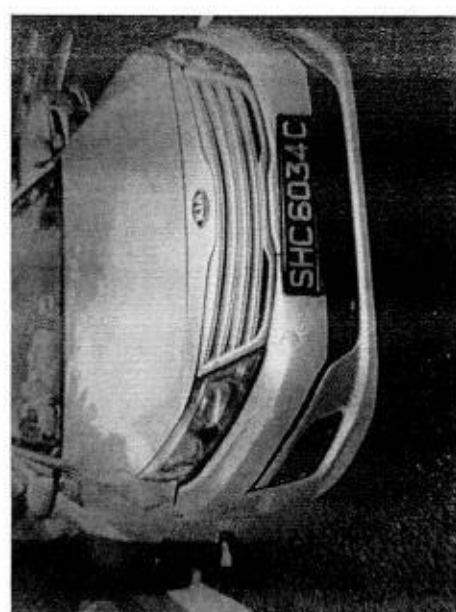
Remark: The veh had commenced its repair at the time of inspection.

THE VEHICLE SUSTAINED DAMAGES AT THE REAR PORTION. DAMAGES SEE DETAILS.

Qty	Description of Parts	Condition	Estimate By Workshop (\$)	Our Adjusted (\$)
<u>REPLACEMENT OF PARTS</u>				
1	BOOT LID	BENT	1,349.50	1,349.50
1	BOOT LID LOCK UPPER	SERVICEABLE	132.10	-
1	BOOT LID LOCK LOWER	SERVICEABLE	30.30	-
1	BOOT LID SONATA PLATE	NECESSARY	43.60	43.60
1	BOOT LID HYUNDAI PLATE	NECESSARY	24.20	24.20
1	BOOT LID "H" EMBLEM	NECESSARY	26.10	26.10
1	BOOT LID CRDI PLATE	NECESSARY	22.70	22.70
1	REAR BUMPER	DEFORMED	578.40	578.40
1	REAR BUMPER REINFORCEMENT	CRACKED	483.30	483.30
10	REAR BUMPER CLIP	NECESSARY	22.00	22.00
1	REAR BUMPER SPONGE	SERVICEABLE	137.40	-
1	REAR BUMPER UNDER COVER	CRACKED	185.80	185.80
2	REAR BUMPER PROTECTOR (LH/RH) @\$38.00	TO REPAIR SEE LABOUR	76.00	-
1	REAR PANEL	BUCKLED	391.80	391.80
1	REAR PANEL GARNISH	CRACKED	95.80	95.80
	LESS 20% DISCOUNT		-719.80	-644.64
			2,879.20	2,578.56
<u>SPECIAL NETT ITEMS</u>				
1	BOOT LID COMFORT LOGO & TEL NO STICKER (SN)	NECESSARY	30.00	30.00

1	BOOT LID ADVERTISEMENT LOGO (SN)	NECESSARY	100.00	100.00
1	REAR BUMPER REVERSE SENSOR (SN)	NOT NECESSARY	135.70	-
1	REAR BUMPER ADVERTISEMENT LOGO (SN)	NECESSARY	50.00	50.00
1	REAR BUMPER RUBBER MAT (SN)	NOT NECESSARY	50.00	-
2	REAR FENDER ADVERTISEMENT LOGO (LH/RH) @\$100.00 (SN)	NECESSARY	200.00	200.00

565.70	380.00
<u>LABOUR</u>				
	PANEL BEATING INCLUSIVE OF THE REPAIR OF REAR BUMPER PROTECTOR (LH/RH).		800.00	600.00

Qty	Description of Parts	Condition	Estimate By Workshop (\$)	Our Adjusted (\$)
	SPRAY PAINTING CHARGE.	NOT NECESSARY	900.00	600.00
	WIRING CHARGE.		50.00	20.00
	TUFF KOTE.		50.00	20.00
	REMOVE/REFIX REVERSE SENSOR.		80.00	-
			1,880.00	1,240.00
GRAND TOTAL			5,324.90	4,198.56
RECOMMENDED COST OF LUMP SUM REPAIRS (TO ITS PRE-ACCIDENT CONDITION) (CONFIRMED)				3,250.00
