1. Policy Particulars :- THIRD PARTY CLAIM			
Insured Veh. SHB 8780Z	Veh. Inspected SHD 6822P		
Policy No. 5095103893	Coverage (\$) 0.00		
Claim No. MT/1022942-002	Excess (\$) 0.00		
Assign From	Assign Date 07/12/2018

2. Vehicle Particulars & Condition			
Make & Model MERCEDES BENZ E220	c.c 2143		
Engine No. HIDDEN	Year of Reg. 2016		
Chassis No. WDD2120012B318546	Colour WHITE		
Odometer 493912	Steering IN ORDER		
Brakes IN ORDER	Modification STANDARD ALLOY RIM		
General FAIR

4. Description of Damages			
THE VEHICLE SUSTAINED DAMAGES AT THE N/S BODY. DAMAGES SEE DETAILS.			
5. General Information			
Accident Date 06/12/2018	Inspection Date 07/12/2018		
Survey held at	COMFORTDELGRO ENGINEERING PTE LTD 59 LOYANG DRIVE SINGAPORE 508969		
5a. Remarks			
A)THE INSPECTION WAS CONDUCTED ON A"WITHOUT PREJUDICE" BASIS. B)IN ACCORDANCE TO YOUR INSTRUCTIONS, WE HAVE NOT AUTHORISED REPAIRS.			
5b. Estimate Days of Repair			
ESTIMATED NORMAL PERIOD FOR REPAIR:		3 Working Days

ADJUSTMENT ON REPAIR COST FOR VEHICLE NO. SHD 6822P

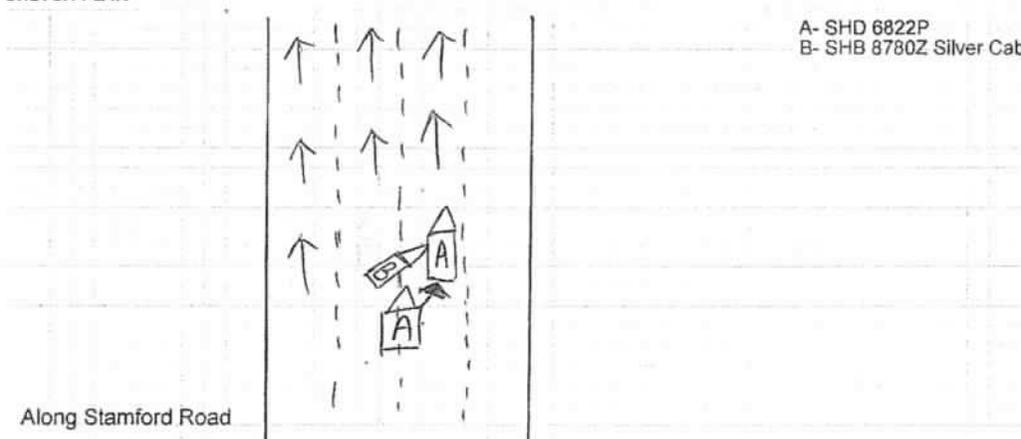
SKETCH PLAN

On 06 DEC 18 @ 1845 HRS I was travelling along Stamford Road with one male passenger onboard.
As I was travelling on the third lane from right. I filtered to the second lane and suddenly veh (B) SHB 8780Z cut into my lane and hit my taxi (A) whole left portion. As the accident took place too fast I could not take evasive action to prevent the accident.
I have company video and photos at scene to support my claim.
No one was conveyed by ambulance.
After the accident I suffered pain on my neck and back will consult doctor later on.
Veh (B) SHB 8780Z Mr Tan Lian Hock S7214742A
