REF: NS/INC18022116/K1td352

TP Claims against NTUC Income: Follow-Through Survey

NTUC INCOME INSURANCE CO-OPERATIVE LTD Ref: NS/INC18022116/K1td3s2			
73 BRAS BASAH ROAD		 	
#05-01 NTUC TRADE UNION HOUSESINGAPORE 189556			
		Date: 28-12-2018	
		Code: INC4	
<b>1. Policy Particulars :- THIRD PARTY CLAIM</b>			
Insured Veh.	SJN 7699X	Veh. Inspected	SHC 8080E
Policy No.	5104360479	Coverage (\$)	0.00
Claim No.	MT/1023043-002	Excess (\$)	0.00
Assign From		Assign Date	07/12/2018
<b>2. Vehicle Particulars &amp; Condition</b>			
Make & Model	MERCEDES BENZ E220	c.c	2143
Engine No.	HIDDEN	Year of Reg.	2015
Chassis No.	WDD2120012B168650	Colour	WHITE
Odometer	611192	Steering	IN ORDER
Brakes	IN ORDER	Modification	STANDARD ALLOY RIM
General	FAIR		
<b>3. Conditions of Tyres</b>			
	Size	Make	Balance
R/H Front Tyre	225/55R16	WEST LAKE	7 mm
L/H Front Tyre	225/55R16	WEST LAKE	7 mm
R/H Rear Tyre	225/55R16	WEST LAKE	7 mm
L/H Rear Tyre	225/55R16	WEST LAKE	7 mm
<b>4. Description of Damages</b>			
THE VEHICLE SUSTAINED DAMAGES AT THE REAR PORTION.

**ADJUSTMENT ON REPAIR COST FOR VEHICLE NO. SHC 8080E**

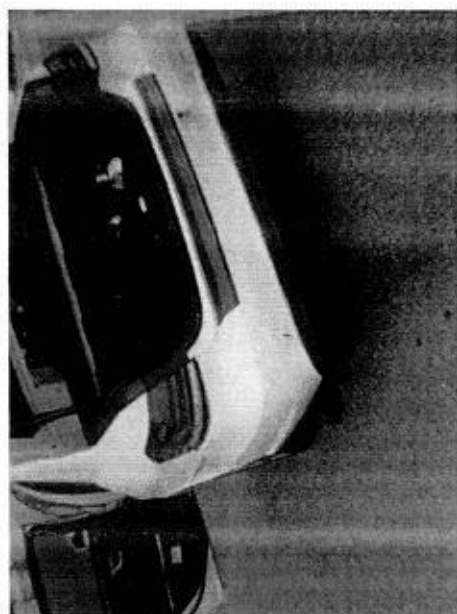
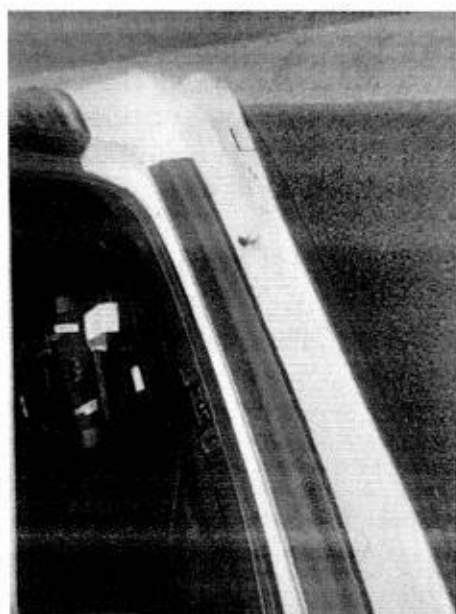
DAMAGES SEE DETAILS.			
<b>5. General Information</b>			
Accident Date	05/12/2018	Inspection Date	07/12/2018
Survey held at	COMFORTDELGRO ENGINEERING PTE LTD 59 LOYANG DRIVE SINGAPORE 508969		
<b>5a. Remarks</b>			
A)THE INSPECTION WAS CONDUCTED ON A"WITHOUT PREJUDICE" BASIS. B)IN ACCORDANCE TO YOUR INSTRUCTIONS, WE HAVE NOT AUTHORISED REPAIRS.			
<b>5b. Estimate Days of Repair</b>			
ESTIMATED NORMAL PERIOD FOR REPAIR:		5 Working Days

Qty	Description of Parts	Condition	Estimate By Workshop (\$)	Our Adjusted (\$)
<b><u>REPLACEMENT OF PARTS</u></b>				
1	REAR BUMPER	DEFORMED	1,510.00	1,510.00
1	REAR BUMPER REINFORCEMENT	BENT	1,150.00	1,150.00
2	REAR BUMPER BRACKET LOWER (LH/RH) @ \$135.00	CRACKED	270.00	270.00
2	REAR BUMPER BRACKET TOP (LH/RH) @ \$125.00	SERVICEABLE	250.00	-
2	REAR BUMPER RETAINER MOUNTING (LH/RH) @\$115.00	SERVICEABLE	230.00	-
1	REAR BUMPER LOWER COVER	CUT	325.00	325.00
1	REAR PANEL END	TO REPAIR SEE LABOUR	1,380.00	-
10	REAR PANEL INNER GARNISH CLIP	NECESSARY	40.00	40.00
1	BOOT LID (NPA)	TO REPAIR SEE LABOUR	-	-
1	REAR PANEL TOP GARNISH	CRACKED	240.00	240.00
1	REAR SEAT BELT - LH	JAMMED	1,650.00	1,650.00
1	REAR SEAT BELT - RH	JAMMED	1,650.00	1,650.00
1	FRONT SEAT BELT - RH	JAMMED	1,650.00	1,650.00
	LESS 20% DISCOUNT		-2,069.00	-1,697.00
			8,276.00	6,788.00
<b><u>NETT ITEMS</u></b>				
1	REAR BUMPER SENSOR (N)	SHORTED	388.00	388.00

LESS 10% DISCOUNT		-	-38.80
			388.00	349.20
<b><u>SPECIAL NETT ITEMS</u></b>				
1	REAR BUMPER RUBBER MAT (SN)	NECESSARY	50.00	50.00
			50.00	50.00
<b><u>LABOUR</u></b>				
	PANEL BEATING. INCLUSIVE OF THE REPAIR OF REAR PANEL END AND BOOT LID.		600.00	400.00
	SPRAY PAINTING CHARGE.		600.00	400.00
	WIRING CHARGE.	NOT NECESSARY	30.00	-
	REMOVE / REFIX REVERSE SENSOR.		120.00	40.00

Qty	Description of Parts	Condition	Estimate By Workshop (\$)	Our Adjusted (\$)
	ONLINE MERC PROGRAMMING.		510.00	150.00
			1,860.00	990.00
	GRAND TOTAL		10,574.00	8,177.20
RECOMMENDED COST OF LUMP SUM REPAIRS (TO ITS PRE-ACCIDENT CONDITION) (CONFIRMED)				6,400.00
