**ACCIDENT INVOLVING SLL 6954C & SKR 4596X ALONG JUNCTION OF
BAYFRONT AVNUE AND CENTRAL BOLEVARD ON 30 NOVEMBER 2018 AT
ABOUT 1440 HOURS**

VEHICLE DAMAGE INSPECTION REPORT

Our File No: CS3/AIG18022127/GCD3S2
Date: 26/12/2018

Handling Insurer:	AIG Asia Pacific Insurance Pte. Ltd.	Policy No:	2100402541
Claimant Vehicle No :	SLL6954C	Insured Vehicle No :	SKR4596X
Date of Loss:	30/11/2018	Nature of Claim:	TP
		Claim No:	0944026289SG

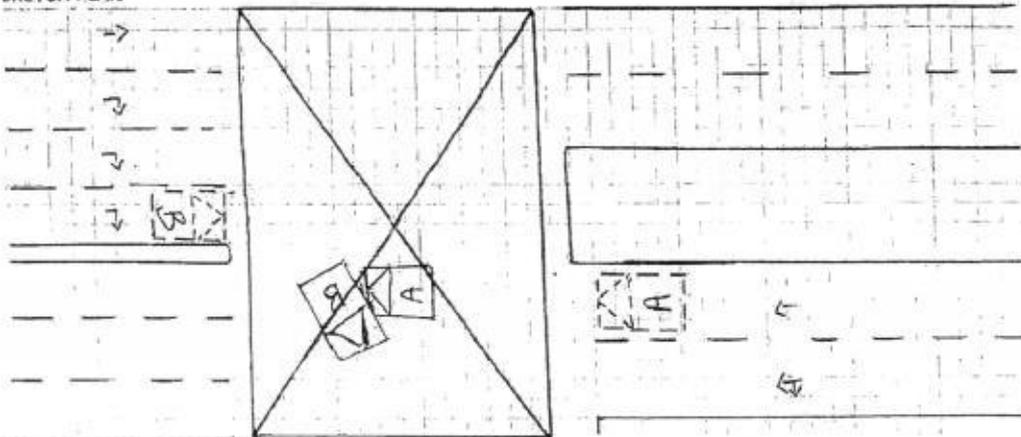
SKETCH PLAN

BAYFRONT AVE & CENTRAL BLVD JUNCTION
 VEH A: SLL 6954C
 VEH B: SKR 4596X

ON THE STATED DATE & TIME, I VEH A (SLL 6954C) WAS WAITING AT THE JUNCTION OF BAYFRONT AVE & CENTRAL BLVD FOR THE TRAFFIC LIGHT TO TURN GREEN & MOVE TOWARD JABS. AS THE TRAFFIC LIGHT TURN GREEN I MOVE OFF, JUST WHEN I MOVE OFF AT A VERY SLOW SPEED, AS I JUST PICK UP, VEH B (SKR 4596X) DID A RIGHT TURN ON THE OPP LANE INTO CENTRAL BLVD, AS VEH. B DIDNT TURN ON GREEN ARROW, VEH B HIT ONTO MY FRONT & DAMAGE MY VEH WHOLE FRONT PORTION MAKING MY VEH UNABLE TO START PLUS BADLY DAMAGE.
