Veh No: SHD 4870M Yr Regn: 6 Mar, 2014

# TP Claims against NTUC Income: Follow-Through Survey

NTUC INCOME INSURANCE CO-OPERATIVE LTD Ref: NS/INC18022188/K1tbe2			
73 BRAS BASAH ROAD #05-01 NTUC TRADE UNION HOUSESINGAPORE 189556		Date: 21-12-2018

**ADJUSTMENT ON REPAIR COST FOR VEHICLE NO. SHD 4870M**

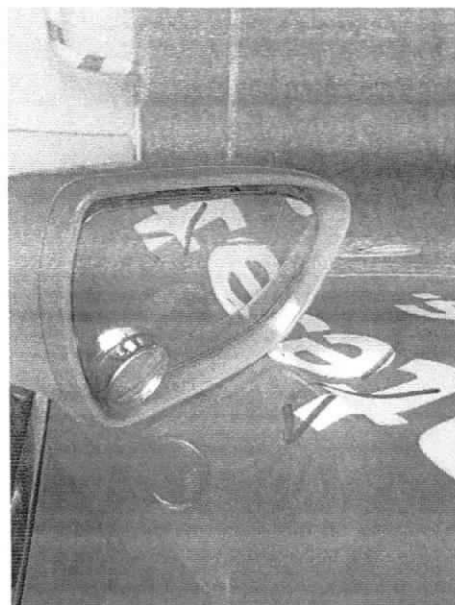
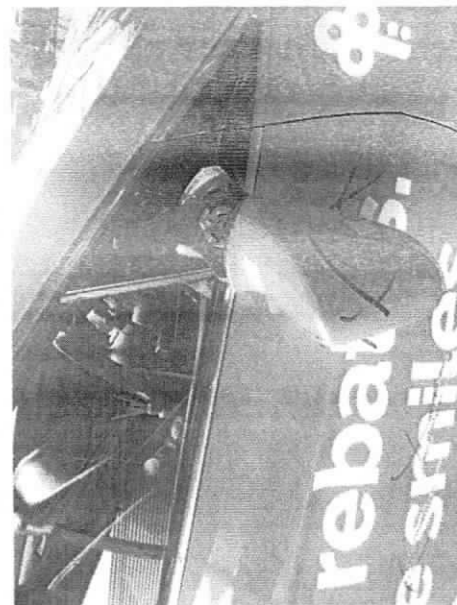
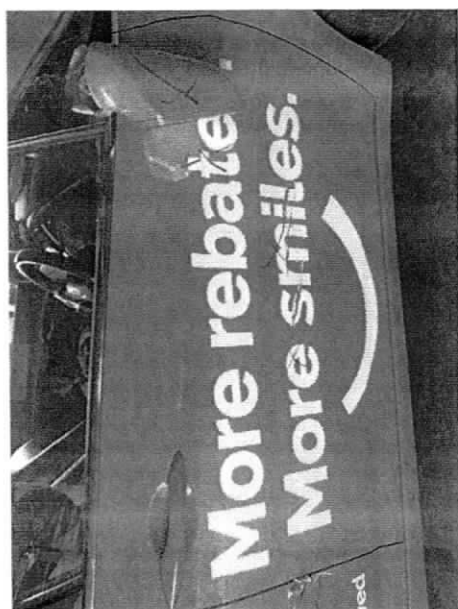
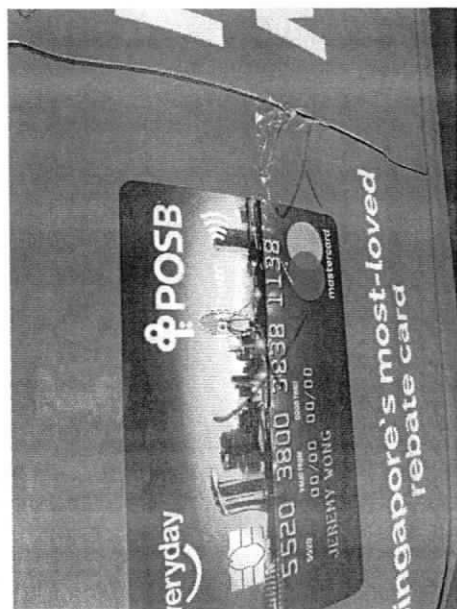
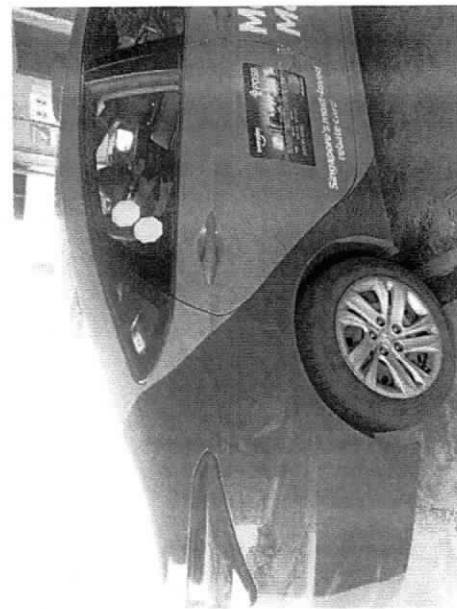
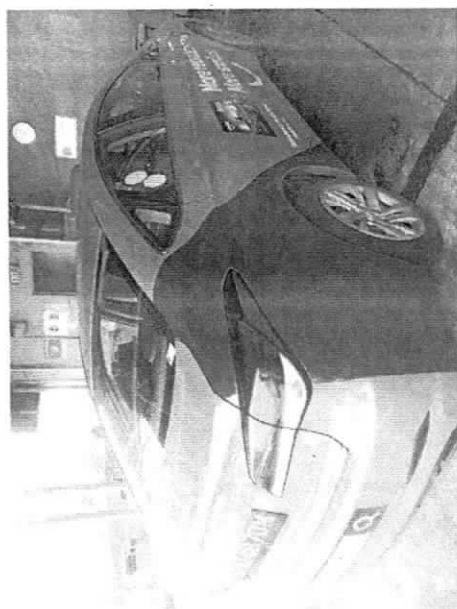
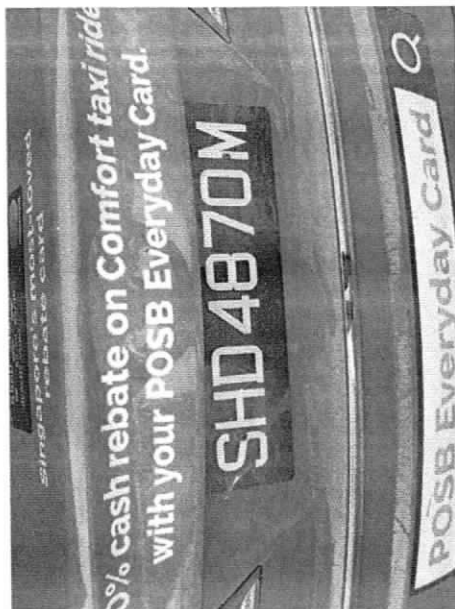
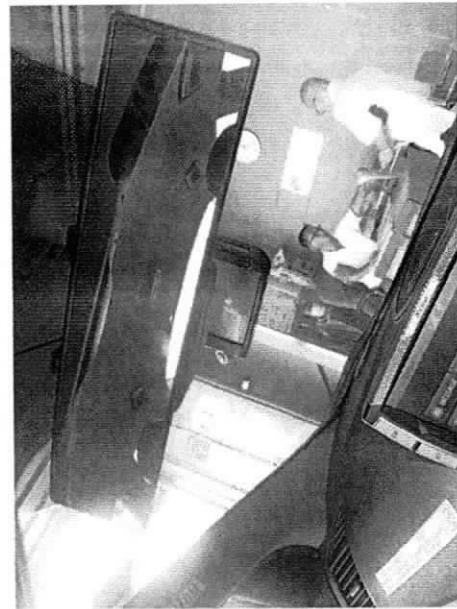
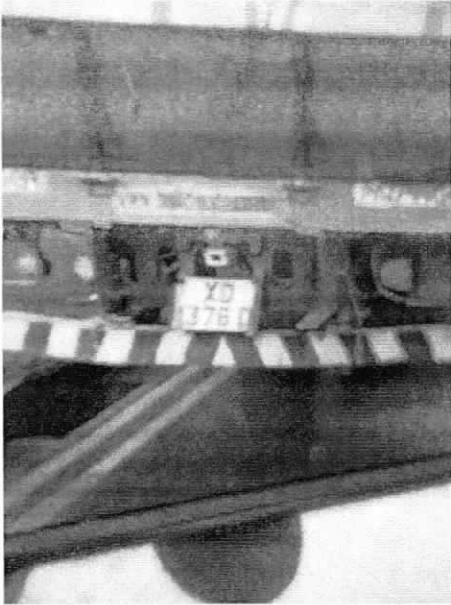
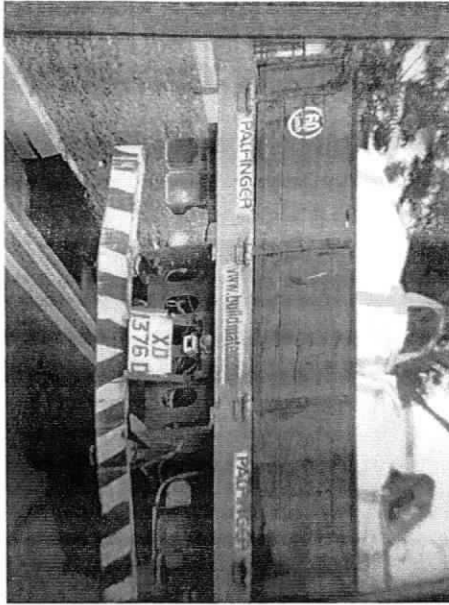
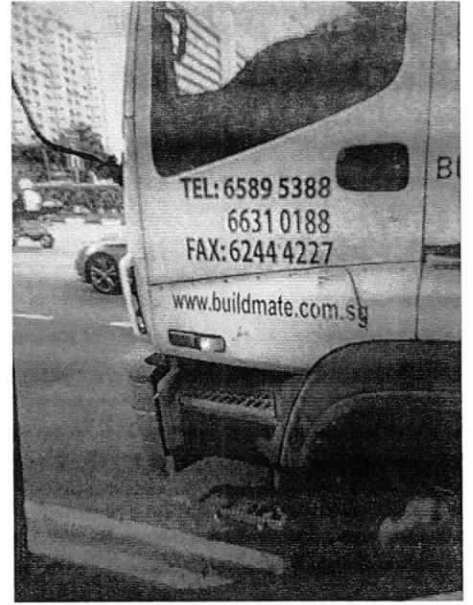
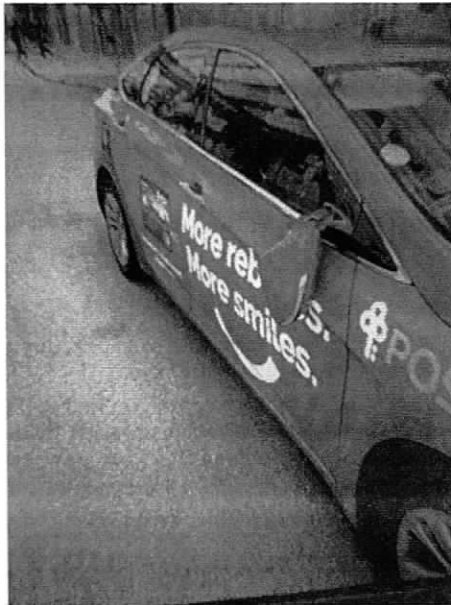
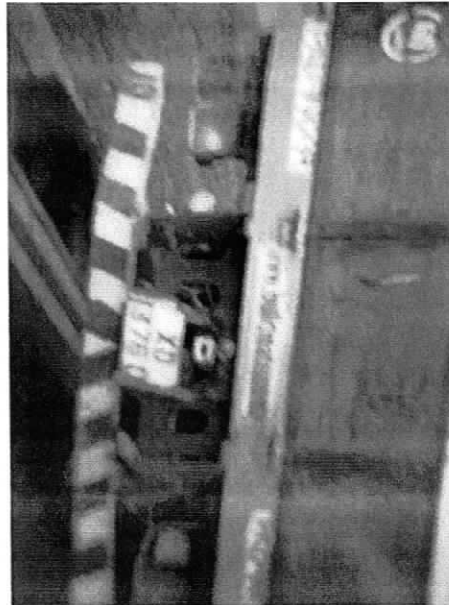
Just after Jln Awang junction suddenly the lorry XD1376D encroached onto my lane and grazed onto my right wing mirror, front and rear door, rear right portion of my taxi.

Code: INC4			
<b>1. Policy Particulars :- THIRD PARTY CLAIM</b>			
Insured Veh.	XD 1376D	Veh. Inspected	SHD 4870M
Policy No.	5072281554-03	Coverage (\$)	0.00
Claim No.	MT/1023016-002	Excess (\$)	0.00
Assign From		Assign Date	10/12/2018
<b>2. Vehicle Particulars &amp; Condition</b>			
Make & Model	HYUNDAI I40	c.c	1685
Engine No.	HIDDEN	Year of Reg.	2014
Chassis No.	KMHLB41UMEU048622	Colour	BLUE
Odometer	729024	Steering	IN ORDER
Brakes	IN ORDER	Modification	STANDARD ALLOY RIM
General	FAIR		
<b>3. Conditions of Tyres</b>			
	Size	Make	Balance
R/H Front Tyre	205/60 R16	HANKOOK	7 mm
L/H Front Tyre	205/60 R16	HANKOOK	7 mm
R/H Rear Tyre	205/60 R16	HANKOOK	7 mm
L/H Rear Tyre	205/60 R16	HANKOOK	7 mm
<b>4. Description of Damages</b>			
THE VEHICLE SUSTAINED DAMAGES AT THE O/S BODY. DAMAGES SEE DETAILS.

Qty	Description of Parts	Condition	Estimate By Workshop (\$)	Our Adjusted (\$)
<b><u>REPLACEMENT OF PARTS</u></b>				
1	REAR DOOR (RH)	TO REPAIR SEE LABOUR	2,201.10	-
1	FRONT DOOR (RH)	DENTED	2,256.40	2,256.40
1	FRONT DOOR MIRROR ASSY (RH)	BROKEN	670.00	670.00
1	REAR BUMPER (NPA)	TO REPAIR SEE LABOUR	-	-
1	FRONT WINDSCREEN PILLAR (RH)(NPA)	TO REPAIR SEE LABOUR	-	-
	LESS 20% DISCOUNT		-1,025.50	-585.28
			4,102.00	2,341.12
<b><u>SPECIAL NETT ITEMS</u></b>				
1	REAR DOOR ADVERTISEMENT LOGO (RH)(SN)	NECESSARY	100.00	100.00
1	REAR DOOR COMFORTDELGRO & APPS STICKER (RH)(SN)	NECESSARY	80.00	80.00
1	FRONT DOOR COLOURED COMFORT LOGO (RH)(SN)	NECESSARY	75.00	75.00
1	FRONT DOOR ADVERTISEMENT LOGO (RH)(SN)	NECESSARY	100.00	100.00

355.00	355.00
<b><u>LABOUR</u></b>				
	PANEL BEATING.INCLUSIVE OF THE REPAIR OF REAR DOOR (RH),REAR BUMPER AND FRONT WINDSCREEN PILLAR (RH).		700.00	400.00
	SPRAY PAINTING CHARGE.		1,000.00	800.00
	WIRING CHARGE.		30.00	20.00
	TUFF KOTE.		50.00	20.00
	TRANSFER OF DOOR.		160.00	50.00

RECOMMENDED COST OF LUMP SUM REPAIRS (TO ITS PRE-ACCIDENT CONDITION) (CONFIRMED)			3,200.00
--	--	--	----------
