NTUC INCOME INSURANCE CO-OPERATIVE LTD Ref: NS/INC18022213/K1tbs2

1. Policy Particulars :- THIRD PARTY CLAIM

THE VEHICLE SUSTAINED DAMAGES AT THE O/S FRONT PORTION. DAMAGES SEE DETAILS.

ADJUSTMENT ON REPAIR COST FOR VEHICLE NO. SHB 4061S

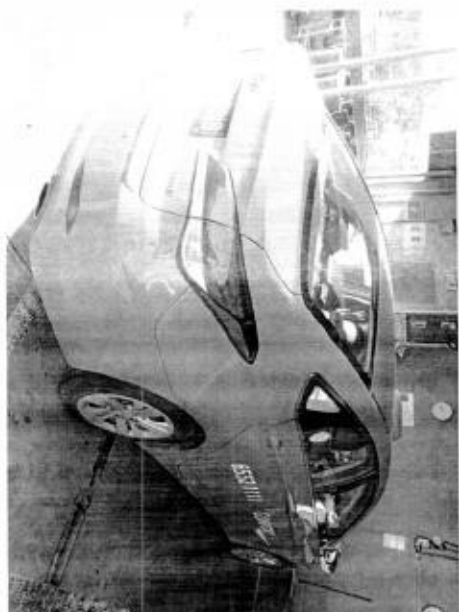
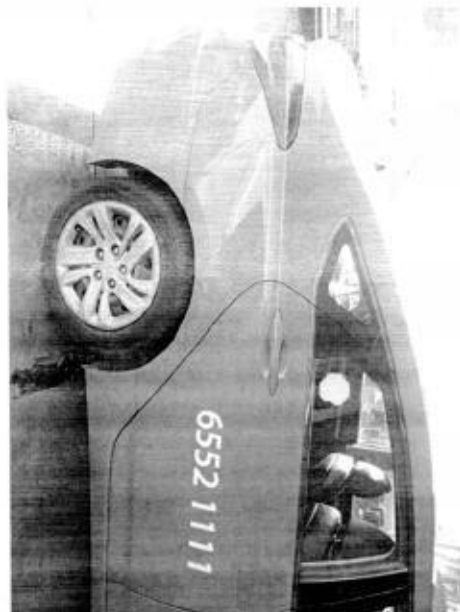
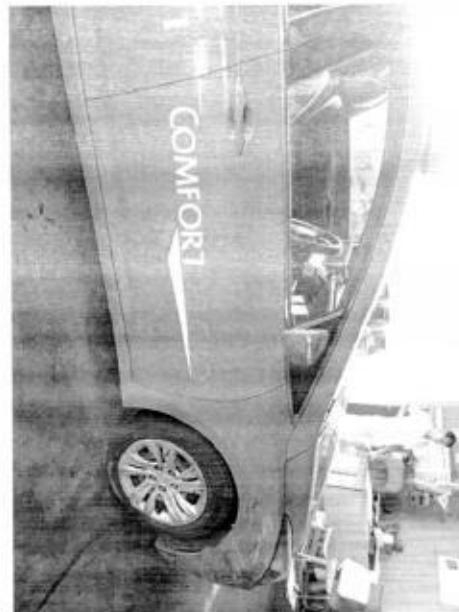
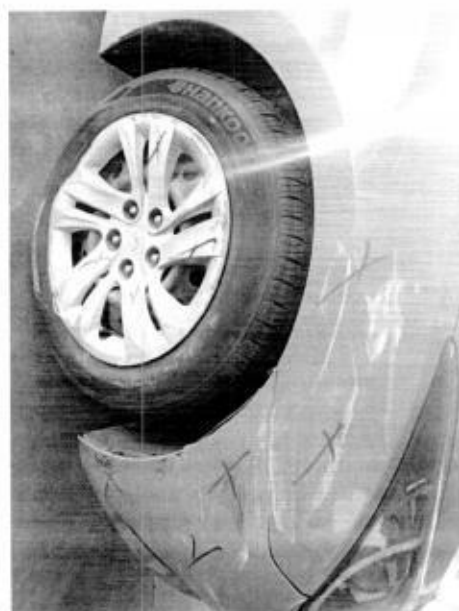
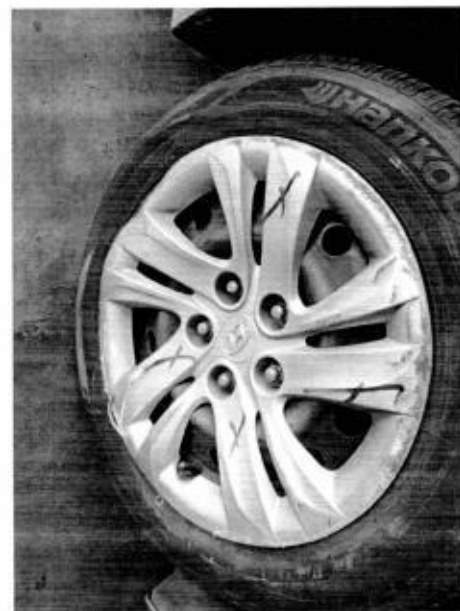
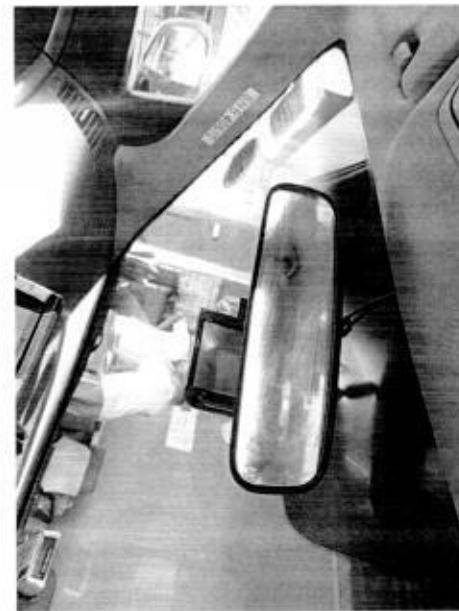
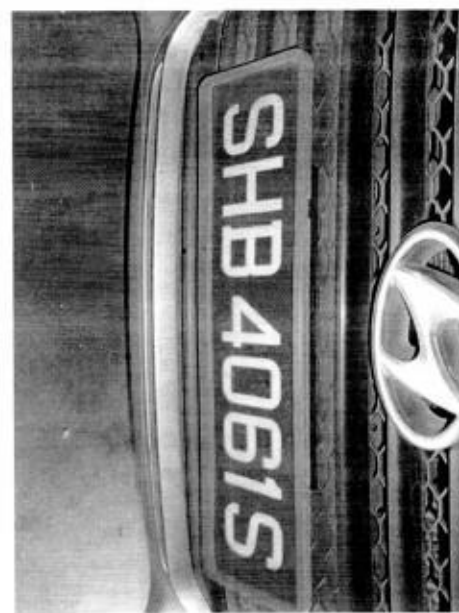
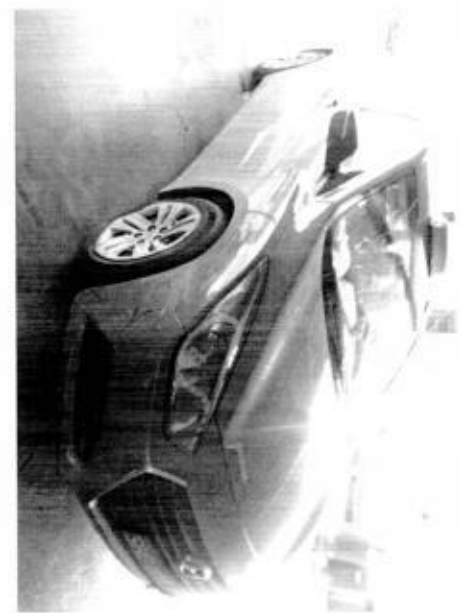
Qty	Description of Parts	Condition	Estimate By Workshop (\$)	Our Adjusted (\$)
REPLACEMENT OF PARTS				
1	FRONT BUMPER COVER	DEFORMED	1,052.20	1,052.20
1	FRONT BUMPER BRACKET TOP (RH)	SERVICEABLE	22.40	-
1	FRONT BUMPER BRACKET (RH)	SERVICEABLE	24.60	-
1	FRONT FENDER (RH)	DENTED	566.30	566.30
1	FRONT FENDER SHIELD (RH)	SERVICEABLE	175.90	-
1	FRONT FENDER RETAINER	SERVICEABLE	24.60	-
1	FRONT WHEEL HUB CAP (RH)	GRAZED	107.10	107.10
	LESS 20% DISCOUNT		-394.62	-345.12
			1,578.48	1,380.48
LABOUR				
	PANEL BEATING.		400.00	200.00
	SPRAY PAINTING CHARGE.		600.00	400.00
	TUFF KOTE.		50.00	20.00
	FRT WHEEL ALIGNMENT.	NOT NECESSARY	80.00	-
			1,130.00	620.00
GRAND TOTAL			2,708.48	2,000.48
RECOMMENDED COST OF LUMP SUM REPAIRS (TO ITS PRE-ACCIDENT CONDITION) (CONFIRMED)				1,600.00
