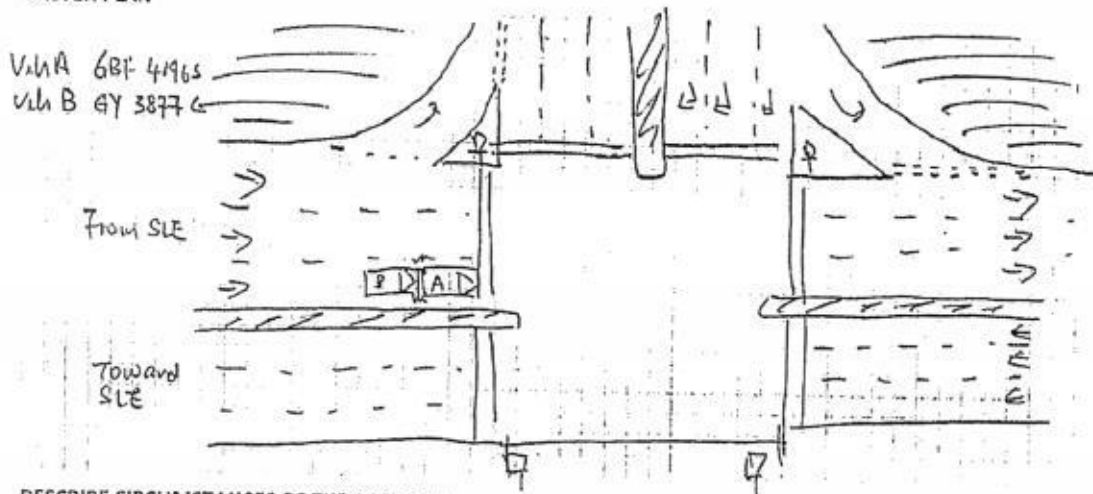
SKETCH PLAN

I was driving along Woodland Ave 12 from SLE on the right most lane of a 3-lane road. Somewhere before Junction of Woodland Ave 12 and Ave 5, I stopped at the traffic light due to traffic light turning red. Moments after I stopped, I suddenly felt a strong impact from the rear portion of my vehicle. After the accident, I managed to see that vehicle B front portion collided into the rear portion of my vehicle. Hence I was involved in an accident of 2 vehicles. My body hit against the dashboard and I experienced body pain from the accident and will be seeking medical attention. Veh A: GBF 4196S.  
Veh B: GY 3877C.
