REF: NS/INC18022395/K1sd3n2

4. Description of Damages

THE VEHICLE SUSTAINED DAMAGES AT THE REAR PORTION. DAMAGES SEE DETAILS.

ADJUSTMENT ON REPAIR COST FOR VEHICLE NO. SHA 4073M

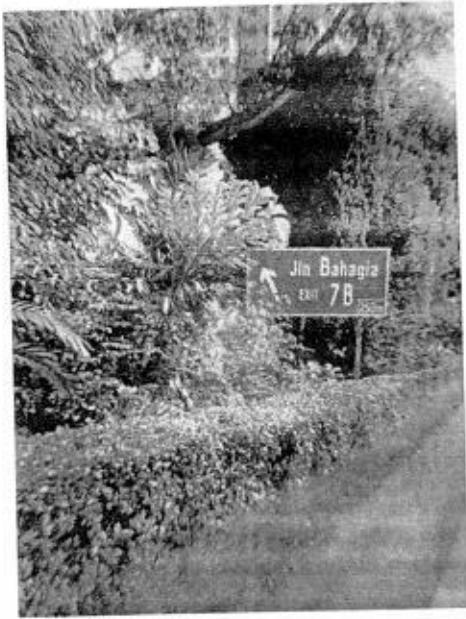
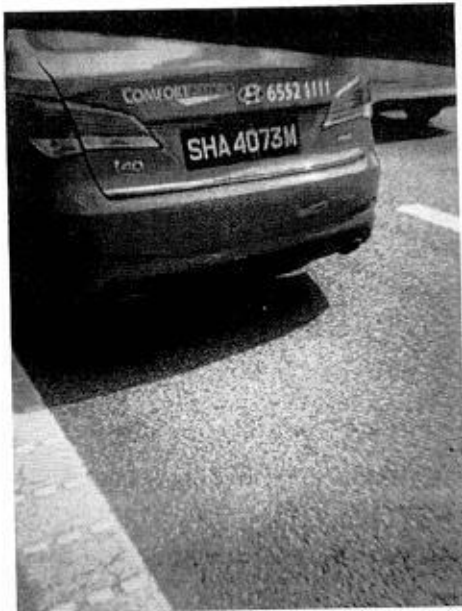
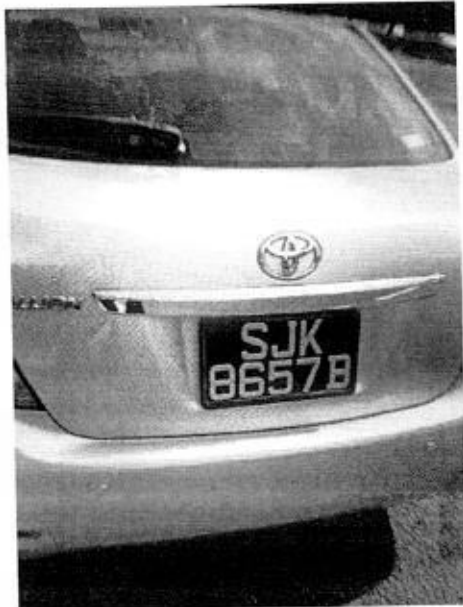
The UIC / Chassis frame / Body Structure affected due to collision.

Qty	Description of Parts	Condition	Estimate By Workshop (\$)	Our Adjusted (\$)
REPLACEMENT OF PARTS				
1	REAR BUMPER	DEFORMED	553.00	553.00
1	REAR BUMPER REINFORCEMENT	SERVICEABLE	428.40	-
2	REAR BUMPER REINFORCEMENT BRACKET (LH/RH) @\$80.30	SERVICEABLE	160.60	-
10	REAR BUMPER CLIP	NECESSARY	22.00	22.00
2	REAR BUMPER BRACKET @\$35.60	SERVICEABLE	71.20	-
1	REAR BUMPER SPONGE	SERVICEABLE	103.50	-
1	REAR BUMPER UNDER COVER	CUT	228.00	228.00
	LESS 20% DISCOUNT		-313.34	-160.60
			1,253.36	642.40
SPECIAL NETT ITEMS				
1	REAR BUMPER REVERSE SENSOR (SN)	SHORTED	135.70	135.70
			135.70	135.70
LABOUR				
	PANEL BEATING.		350.00	200.00
	SPRAY PAINTING CHARGE.		250.00	200.00
	WIRING CHARGE.	NOT NECESSARY	30.00	-
	REMOVE/REFIX REVERSE SENSOR.		80.00	30.00
			710.00	430.00
GRAND TOTAL			2,099.06	1,208.10
RECOMMENDED COST OF LUMP SUM REPAIRS (TO ITS PRE-ACCIDENT CONDITION) (CONFIRMED)				950.00
