REF: NS/INC18022396/K1sd3n2

1. Policy Particulars :- THIRD PARTY CLAIM				
Insured Veh.	SLR 5082T	Veh. Inspected	SHD 6635M	
Policy No.	5093263476-01	Coverage (\$)	0.00	
Claim No.	MT/1023486-002	Excess (\$)	0.00	
Assign From		Assign Date	12/12/2018

4. Description of Damages				
THE VEHICLE SUSTAINED DAMAGES AT THE REAR PORTION. DAMAGES SEE DETAILS.				
5. General Information				
Accident Date	10/12/2018	Inspection Date	12/12/2018	
Survey held at	COMFORTDELGRO ENGINEERING PTE LTD 59 LOYANG DRIVE SINGAPORE 508969			
5a. Remarks				
A)THE INSPECTION WAS CONDUCTED ON A"WITHOUT PREJUDICE" BASIS. B)IN ACCORDANCE TO YOUR INSTRUCTIONS, WE HAVE NOT AUTHORISED REPAIRS.				
5b. Estimate Days of Repair				
ESTIMATED NORMAL PERIOD FOR REPAIR:		2 Working Days

ADJUSTMENT ON REPAIR COST FOR VEHICLE NO. SHD 6635M

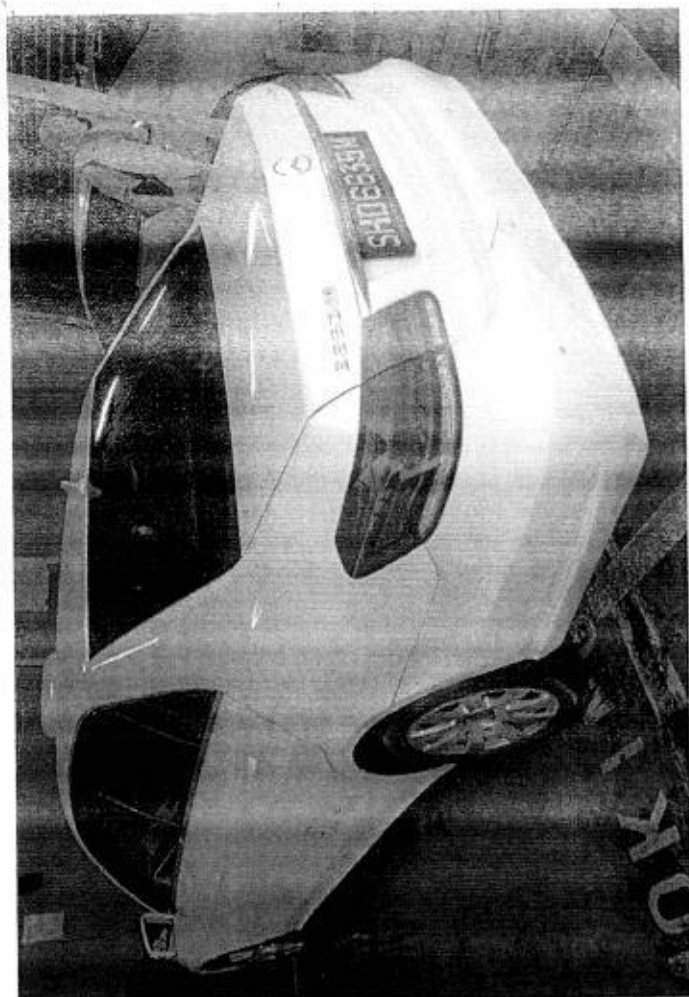
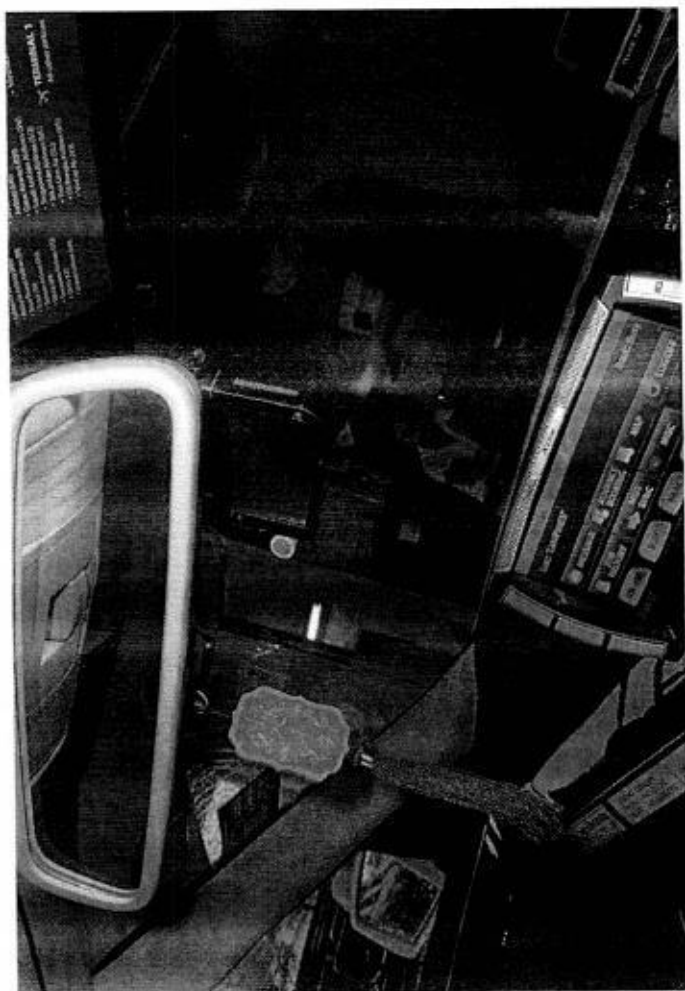
Qty	Description of Parts	Condition	Estimate By Workshop (\$)	Our Adjusted (\$)
REPLACEMENT OF PARTS				
1	REAR BUMPER	DEFORMED	1,510.00	1,510.00
1	REAR BUMPER REINFORCEMENT	SERVICEABLE	1,150.00	-
2	REAR BUMPER BRACKET LOWER (LH/RH) @\$135.00	SERVICEABLE	270.00	-
2	REAR BUMPER BRACKET TOP (LH/RH) @\$125.00	SERVICEABLE	250.00	-
2	REAR BUMPER RETAINER MOUNTING (LH/RH) @\$115.00	SERVICEABLE	230.00	-
	LESS 20% DISCOUNT		-682.00	-302.00
			2,728.00	1,208.00
SPECIAL NETT ITEMS				
1	REAR BUMPER SENSOR (SN)	SERVICEABLE	388.00	-
			388.00	-
LABOUR				
	PANEL BEATING.		400.00	200.00
	SPRAY PAINTING CHARGE.		300.00	200.00
	WIRING CHARGE.	NOT NECESSARY	30.00	-
	REMOVE/REFIX REVERSE SENSOR.		120.00	30.00
			850.00	430.00
GRAND TOTAL			3,966.00	1,638.00
RECOMMENDED COST OF LUMP SUM REPAIRS (TO ITS PRE-ACCIDENT CONDITION) (CONFIRMED)				1,300.00
