NTUC INCOME INSURANCE CO-OPERATIVE LTD Ref: NS/INC18022398/K1qd3n2	
73 BRAS BASAH ROAD #05-01 NTUC TRADE UNION HOUSESINGAPORE 189556	Date: 18-12-2018
Code: INC4

1. Policy Particulars :- THIRD PARTY CLAIM

THE VEHICLE SUSTAINED DAMAGES AT THE REAR O/S PORTION.
DAMAGES SEE DETAILS.

ADJUSTMENT ON REPAIR COST FOR VEHICLE NO. SHA 7582R

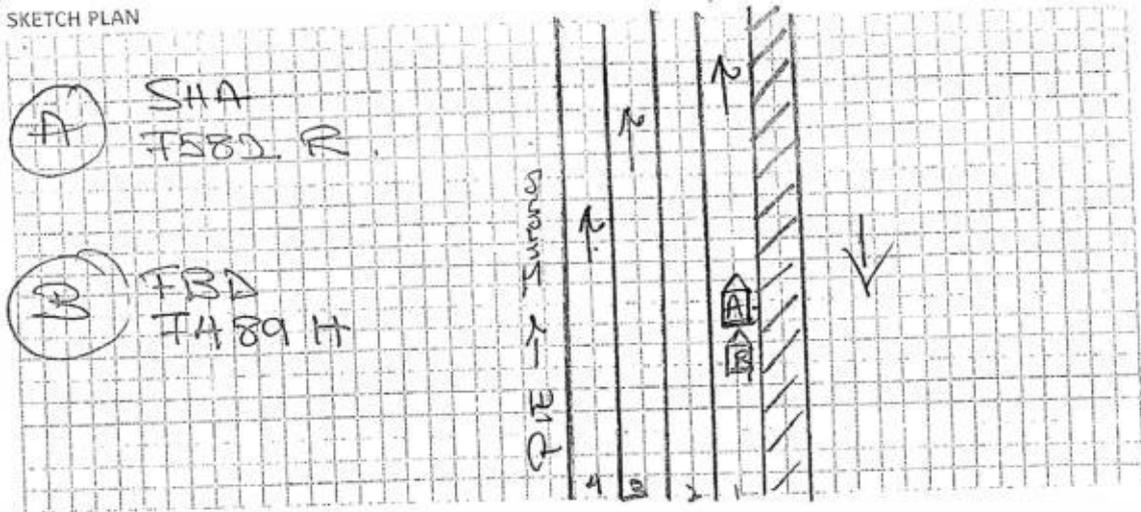
SKETCH PLAN

GN. 00V 11 Dec 2018 @ 16.40hr I

veh A was driving along the above location at one point whilst vehicle

Stop - I veh A slow down and stop.

After few sec. veh B from rear hit veh A

Rear. at the point of accident

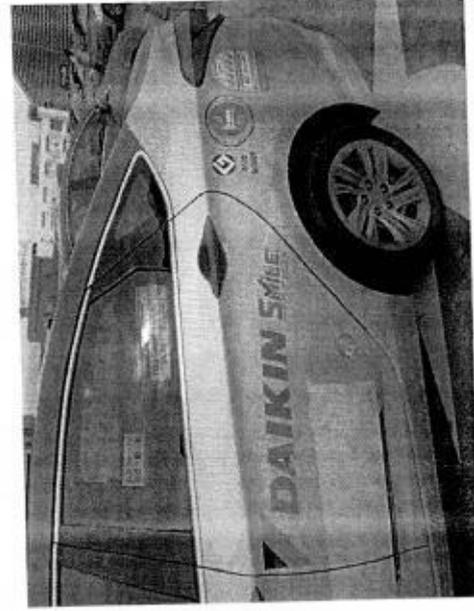
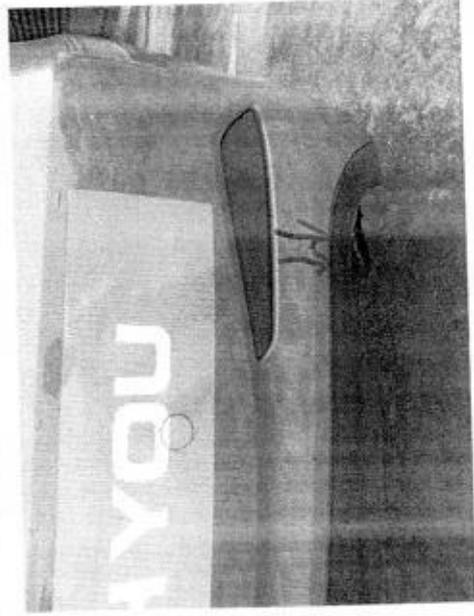
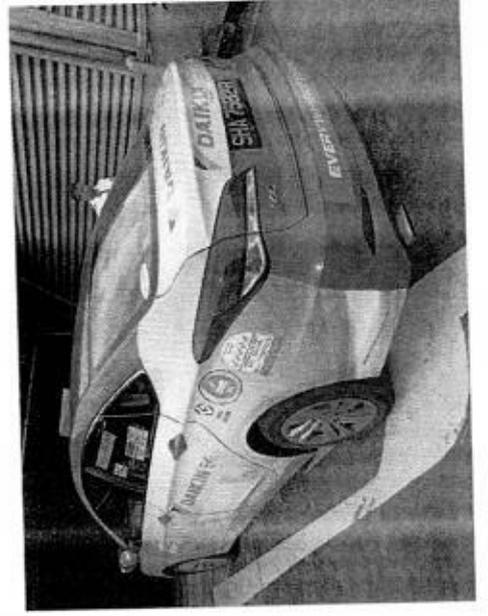
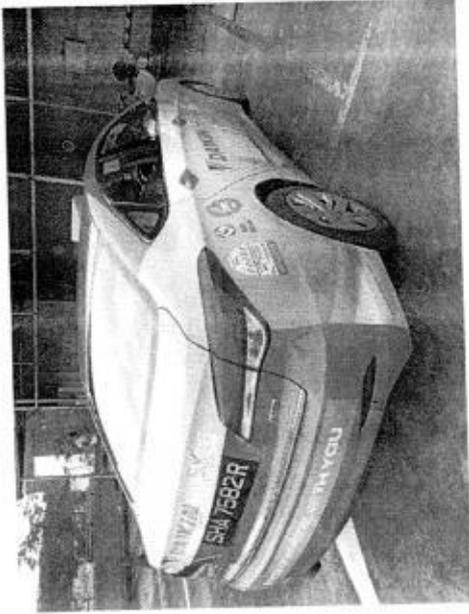
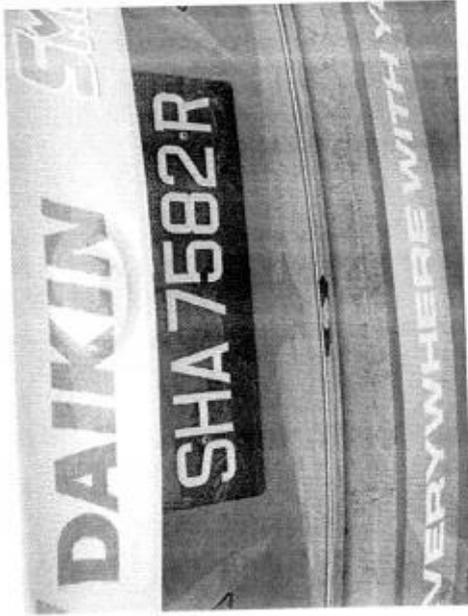
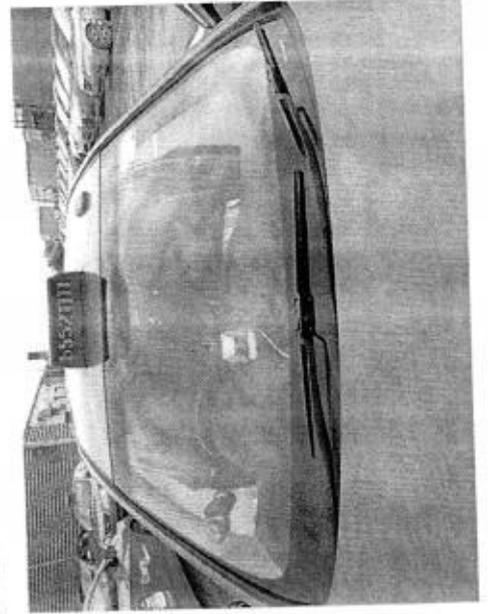
Qty	Description of Parts	Condition	Estimate By Workshop (\$)	Our Adjusted (\$)
REPLACEMENT OF PARTS				
1	REAR BUMPER UNDER COVER	SERVICEABLE	228.00	-
1	EXHAUST PIPE INSULATOR,RH	SERVICEABLE	58.55	-
1	EXHAUST SILENCER,RH	BENT	967.70	967.70
1	EXHAUST PIPE HANGER,RH	TO REPAIR SEE LABOUR	58.55	-
1	EXHAUST PIPE CENTRE	BENT	730.10	730.10
1	REAR BUMPER (NPA)	TO REPAIR SEE LABOUR	-	-
	LESS 20% DISCOUNT		-408.58	-339.56
			1,634.32	1,358.24
SPECIAL NETT ITEMS				
1	REAR BUMPER ADVERTISEMENT LOGO (SN)	NECESSARY	50.00	50.00
2	REAR FENDER ADVERTISEMENT LOGO (LH/RH) @\$100.00 (SN)	NECESSARY	200.00	200.00

250.00	250.00
LABOUR				
	PANEL BEATING.INCLUSIVE OF THE REPAIR OF EXHAUST PIPE HANGER,RH AND REAR BUMPER.		400.00	200.00
	SPRAY PAINTING CHARGE.		300.00	200.00
	WIRING CHARGE.	NOT NECESSARY	30.00	-
	REMOVE/REFIX REVERSE SENSOR.	NOT NECESSARY	80.00	-
	REMOVE/REFIX EXHAUST PIPE.		150.00	50.00

960.00	450.00
GRAND TOTAL			2,844.32	2,058.24
RECOMMENDED COST OF LUMP SUM REPAIRS (TO ITS PRE-ACCIDENT CONDITION) (CONFIRMED)				1,650.00
