From: Motor Claim - III <motorclaim@iii.com.sg>
Sent: Friday, 14 December 2018 9:24 AM
To: Ruby Ong; 'sur@lkkauto.com'; Catherine Chong (LKK Auto)
Cc: Polymath Garage Pte Ltd; Zuhaidah Samsuri
Subject: RE: REQUEST FOR PRE-REPAIR SURVEY PROTOCOL FOR SLL 6553B [OUR REF. TCL.GCN.RO.50511.18.PG]

NOTICE OF ACCIDENT AND PRE-REPAIR SURVEY - ACCIDENT INVOLVING SLL 6553B, SHC 8981E, SLU 3804A & SJR 4321J ALONG CTE TOWARDS BRADDELL EXIT ON 12 DECEMBER 2018 @ 2140HRS

VEHICLE DAMAGE INSPECTION REPORT

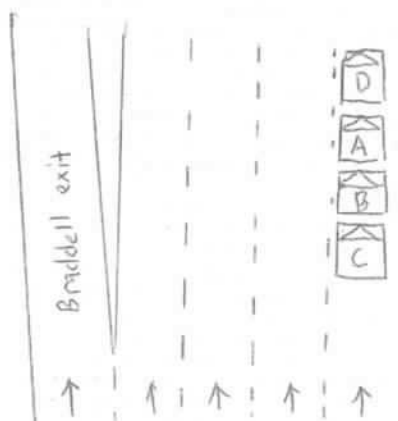
SKETCH PLAN

A = SLL6553B

B = SHC8981E

C = SLV3804A

On the stated date and Time, I vehicle A(SLL6553B) was travelling on the stated venue on lane 1. Suddenly, vehicle D (SJR4321J) slow down and came to a stop and I follow suit and stop in time. Suddenly I felt an impact from the rear and cause my vehicle to propel forward and hit onto Vehicle D. I alighted from my vehicle and realise I'm involve in a chain collision of four vehicle.
