1. Policy Particulars :- THIRD PARTY CLAIM

Insured Veh.	GBE 7717U	Veh. Inspected	SHA 9227D
Policy No.	5088349227-01	Coverage (\$)	0.00
Claim No.	MT/1024171-002	Excess (\$)	0.00
Assign From		Assign Date	17/12/2018

4. Description of Damages

ADJUSTMENT ON REPAIR COST FOR VEHICLE NO. SHA 9227D

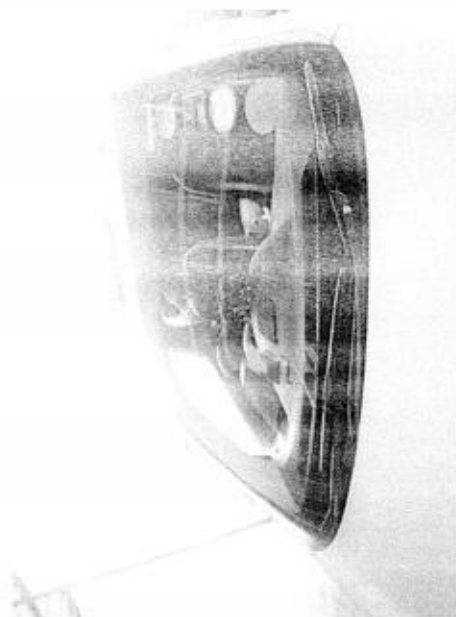
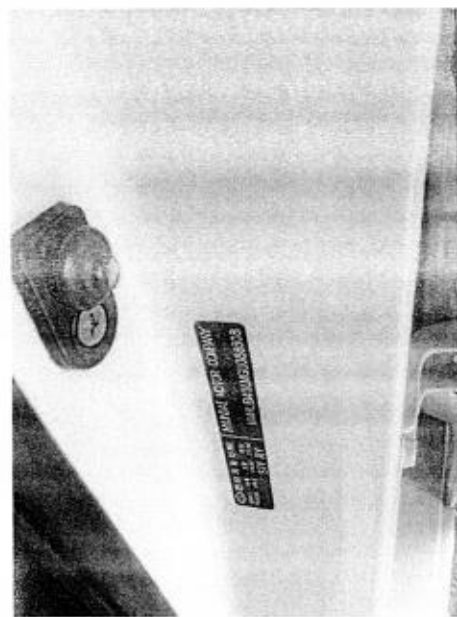
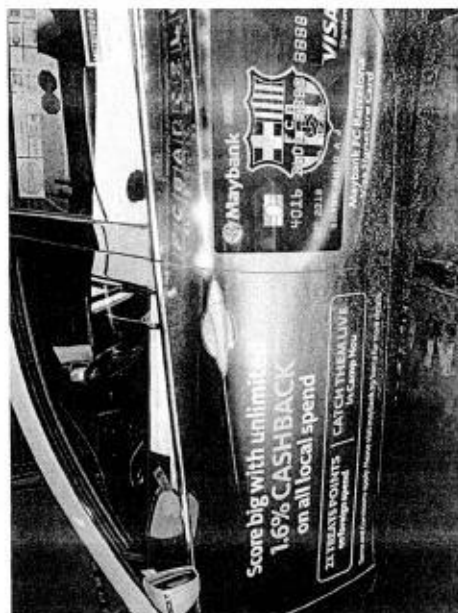
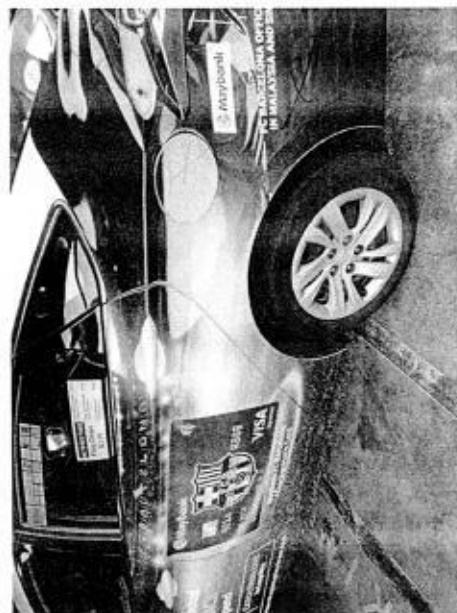
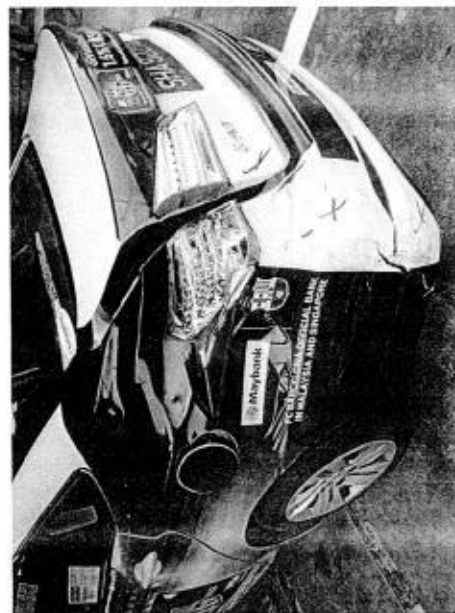
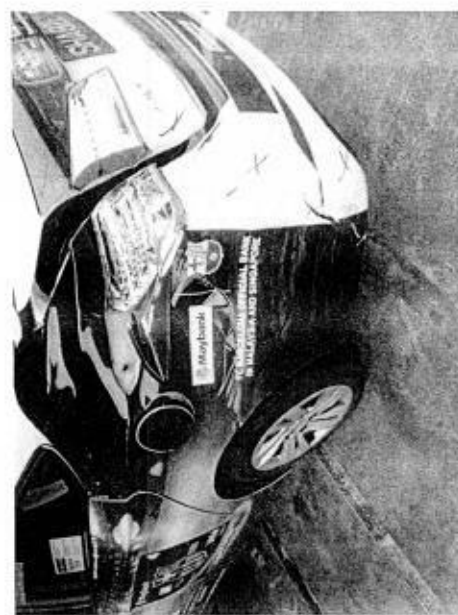
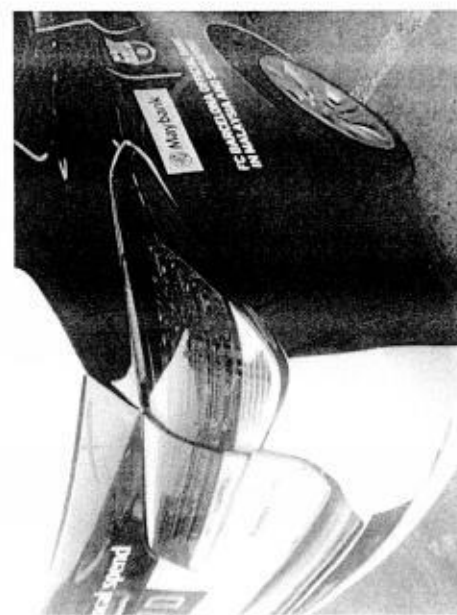
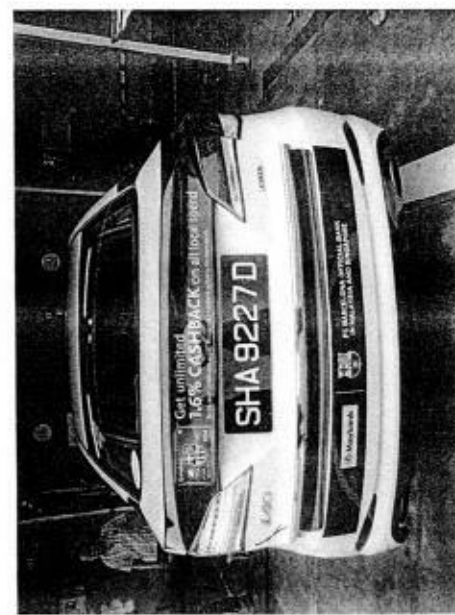
Photos

N/S Rear / Front m/s

The UIC / Chassis frame / Body Structure affected due to collision.

THE VEHICLE SUSTAINED DAMAGES AT THE N/S REAR PORTION AND FRONT N/S PORTION.
DAMAGES SEE DETAILS.

Qty	Description of Parts	Condition	Estimate By Workshop (\$)	Our Adjusted (\$)
	LABOUR			
	PANEL BEATING, INCLUSIVE OF THE REPAIR OF REAR FENDER INNER PANEL (LH), FRONT BUMPER COVER AND REAR FENDER (RH).		1,200.00	800.00
	SPRAY PAINTING CHARGE.		1,200.00	1,000.00
	WIRING CHARGE.		50.00	20.00
	TUFF KOTE.		50.00	20.00
	REMOVE / REFIX CUSHION & UPHOLSTERY REAR.		150.00	50.00
	REMOVE / REFIX REAR WINDSCREEN GLASS.		120.00	100.00
	REMOVE / REFIX REVERSE SENSOR.		80.00	30.00
			2,850.00	2,020.00
	GRAND TOTAL		10,496.56	8,007.04
	RECOMMENDED COST OF LUMP SUM REPAIRS (TO ITS PRE-ACCIDENT CONDITION) (CONFIRMED)			6,400.00
