1.	Policy Particulars	:- THIRD PARTY CLA	IM			
Insured Veh.	YP 8151P	Veh. Inspected	SHA 8047M			
Policy No.	5072463216-02	Coverage (\$)	0.00			
Claim No.	MT/1024163-002	Excess (\$)	0.00			
Assign From		Assign Date	17/12/2018

4.	Descript	tion of Damages				
THE VEHICLE S	USTAINED DAMAGES AT THE RI DETAILS.	EAR N/S PORTION.				
5.		al Information				
Accident Date	15/12/2018	Inspection Date	17/12/2018			
Survey held at	The state of the s					
	59 LOYANG DRIVE SINGAPORE 508969					
5a.		Remarks				
A)THE INSPECT B)IN ACCORDA	TION WAS CONDUCTED ON A"W NCE TO YOUR INSTRUCTIONS,	ITHOUT PREJUDICE" BA WE HAVE NOT AUTHOR	ASIS. ISED REPAIRS.			
5b.		e Days of Repair				
ESTIMATED NO	RMAL PERIOD FOR REPAIR:	3 Working Da	ays

# ADJUSTMENT ON REPAIR COST FOR VEHICLE NO. SHA 8047M

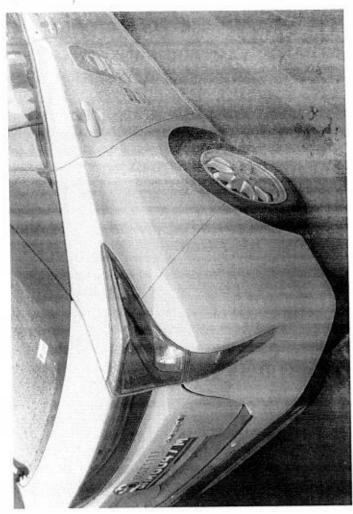
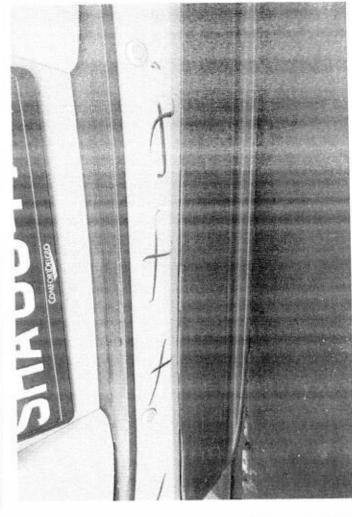
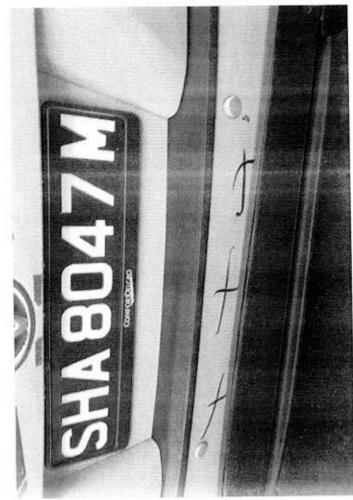
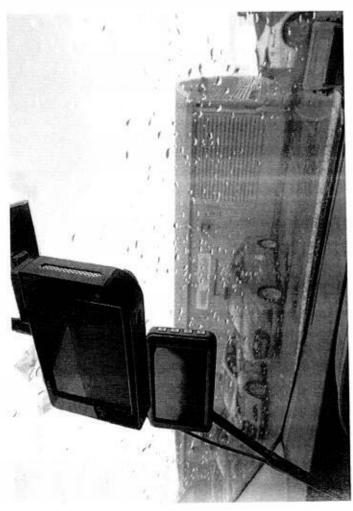
I wanted to avoid collision with the said vehicle and hence applied emergency brake. As a result, there are some scratch marks and rear bumper damaged.

The vehicle behind mine (YP8151P) could not react in time and hit onto the rear portion of my vehicle. The lorry driver did stop but he did not wish to pass me his particulars.

Qty	Description of Parts	Condition	Estimate By Workshop (\$)	Our Adjusted (\$)
	REPLACEMENT OF PARTS			
1	REAR BUMPER	DEFORMED	458.60	458.60
1	REAR BUMPER RE-INFORCEMENT	BENT	318.80	318.80
	REAR BUMPER UNDER COVER	CRACKED	552.60	552.60
1	REAR BUMPER SIDE RETAINER	SERVICEABLE	112.70	
10	REAR BUMPER CLIPS	NECESSARY	22.00	22.00
1	REAR TAILGATE SPOILER (NPA)	TO REPAIR SEE LABOUR	-	-
1	REAR TAILGATE OUTER GARNISH (NPA)	TO REPAIR SEE LABOUR		-
1	REAR BUMPER SIDE LH	CRACKED	148.40	148.40
	LESS 25% DISCOUNT	1 1 1 1 1 1 1 1 1 1 1 1 1 1 1 1 1 1 1	-403.28	-375.10
			1,209.82	1,125.30
	NETT ITEMS			
1	REAR BUMPER REVERSE SENSOR (N)	SHORTED	135.70	
	LESS 10% DISCOUNT			-13.57

135.70	122.13
	SPECIAL NETT ITEMS			
100	REAR BUMPER RUBBER MAT (SN)	NECESSARY	50.00	50.00
	80 90		50.00	50.00
	LABOUR			
	PANEL BEATING.INCLUSIVE OF THE REPAIR OF REAR TAILGATE SPOILER AND REAR TAILGATE OUTER GARNISH.		400.00	90(0.000)
	SPRAY PAINTING CHARGE.		800.00	600.00
	WIRING CHARGE.	NOT NECESSARY	30.00	
F	REMOVE/REFIX REVERSE SENSOR.	NOT NECESSARY	80.08	
			1,310.00	900.00
	GRAND TOTAL		2,705.52	2,197.43
