NS/INC18022656/Klvbnz

1. Policy Particulars :- THIRD PARTY CLAIM

THE VEHICLE SUSTAINED DAMAGES AT THE REAR PORTION. DAMAGES SEE DETAILS.
--

ADJUSTMENT ON REPAIR COST FOR VEHICLE NO. SH 8318P

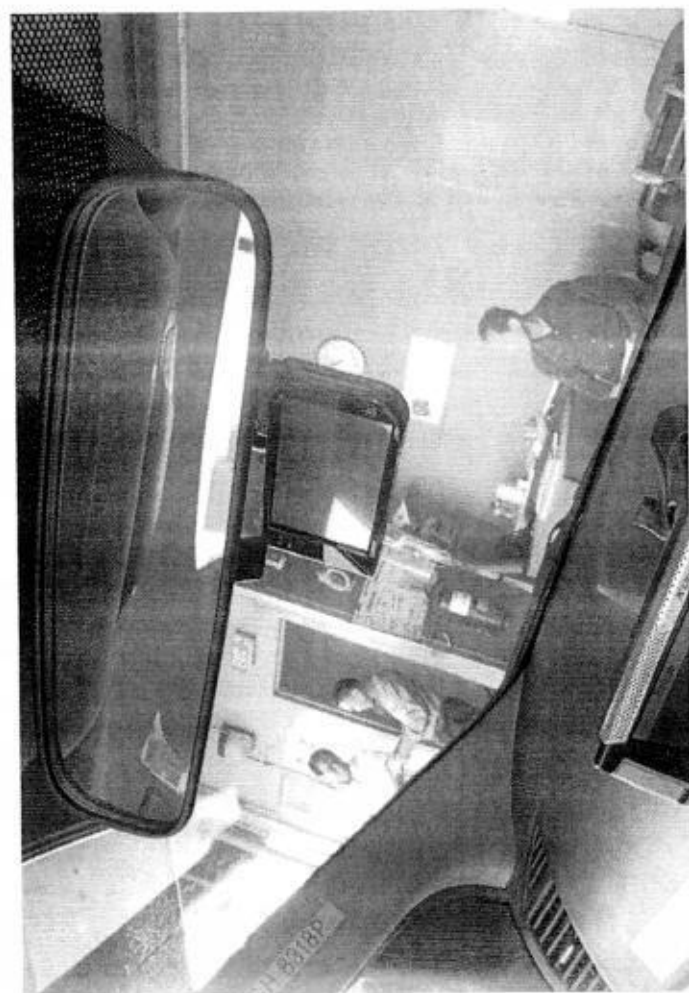
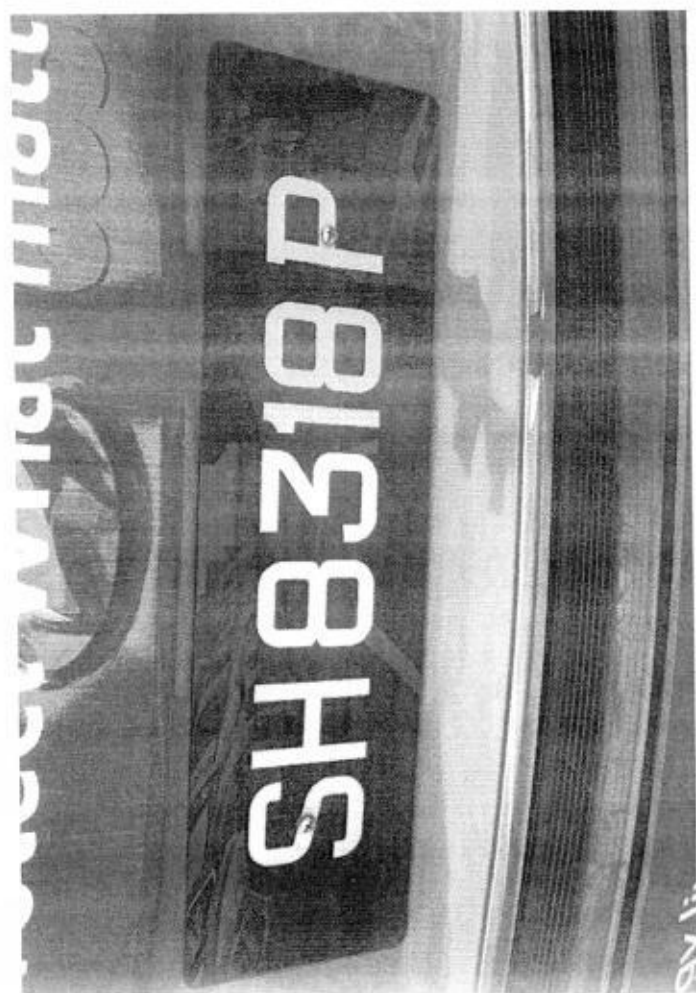
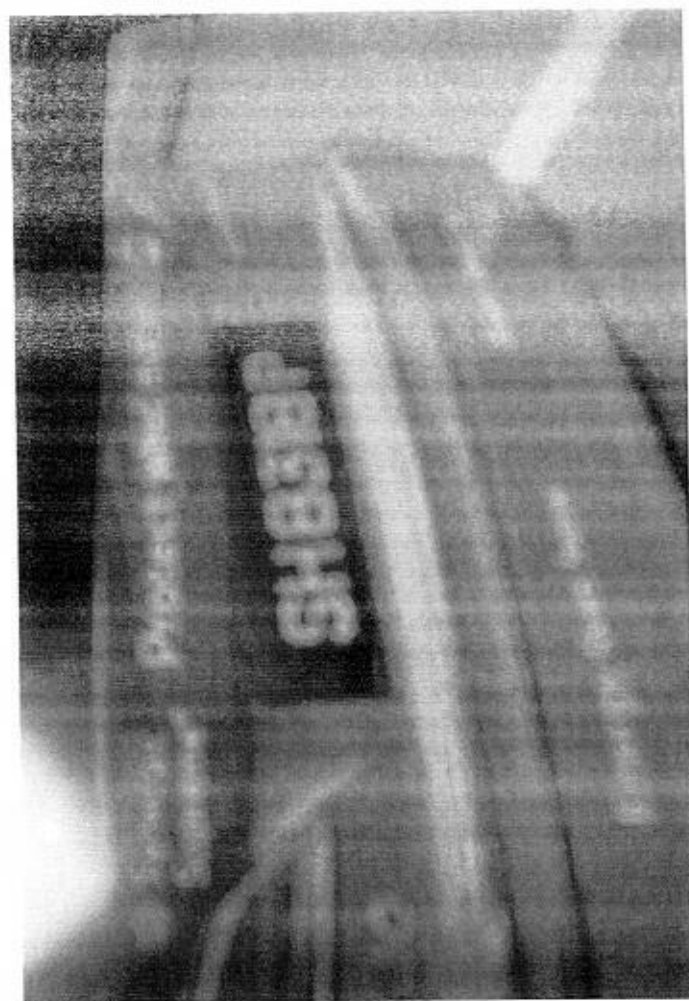
Rear

The UIC / Chassis frame / Body Structure affected due to collision.

Qty	Description of Parts	Condition	Estimate By Workshop (\$)	Our Adjusted (\$)
<u>REPLACEMENT OF PARTS</u>				
1	REAR BUMPER	DEFORMED	553.00	553.00
10	REAR BUMPER CLIP	NECESSARY	22.00	22.00
1	REAR BUMPER UNDER COVER	SERVICEABLE	228.00	-
	LESS 20% DISCOUNT		-160.60	-115.00
			642.40	460.00
<u>SPECIAL NETT ITEMS</u>				
1	REAR BUMPER RUBBER MAT (SN)	NECESSARY	50.00	50.00
1	REAR BUMPER ADVERTISEMENT LOGO (SN)	NECESSARY	50.00	50.00
2	REAR FENDER ADVERTISEMENT LOGO (LH/RH) @\$100.00 (SN)	NECESSARY	200.00	200.00
			300.00	300.00
<u>LABOUR</u>				
	PANEL BEATING.		400.00	200.00
	SPRAY PAINTING CHARGE.		300.00	200.00
	WIRING CHARGE.	NOT NECESSARY	30.00	-
	REMOVE/REFIX REVERSE SENSOR.		80.00	30.00
			810.00	430.00
GRAND TOTAL			1,752.40	1,190.00
RECOMMENDED COST OF LUMP SUM REPAIRS (TO ITS PRE-ACCIDENT CONDITION) (CONFIRMED)				950.00
