Estimated repair cost for vehicle no: SKN5000M HONDA VEZEL 1.5X '16

VEHICLE DAMAGE INSPECTION REPORT

Our File No: CS/SMO18022714/ATBN2

Handling Insurer:	Sompo Insurance Singapore Pte. Ltd.	Policy No:	D18MTPV01015839
Claimant Vehicle No :	SKN5000M	Insured Vehicle No :	SGL8048P
Date of Loss:	15/12/2018	Nature of Claim:	TP
		Claim No:	CMTD1805553

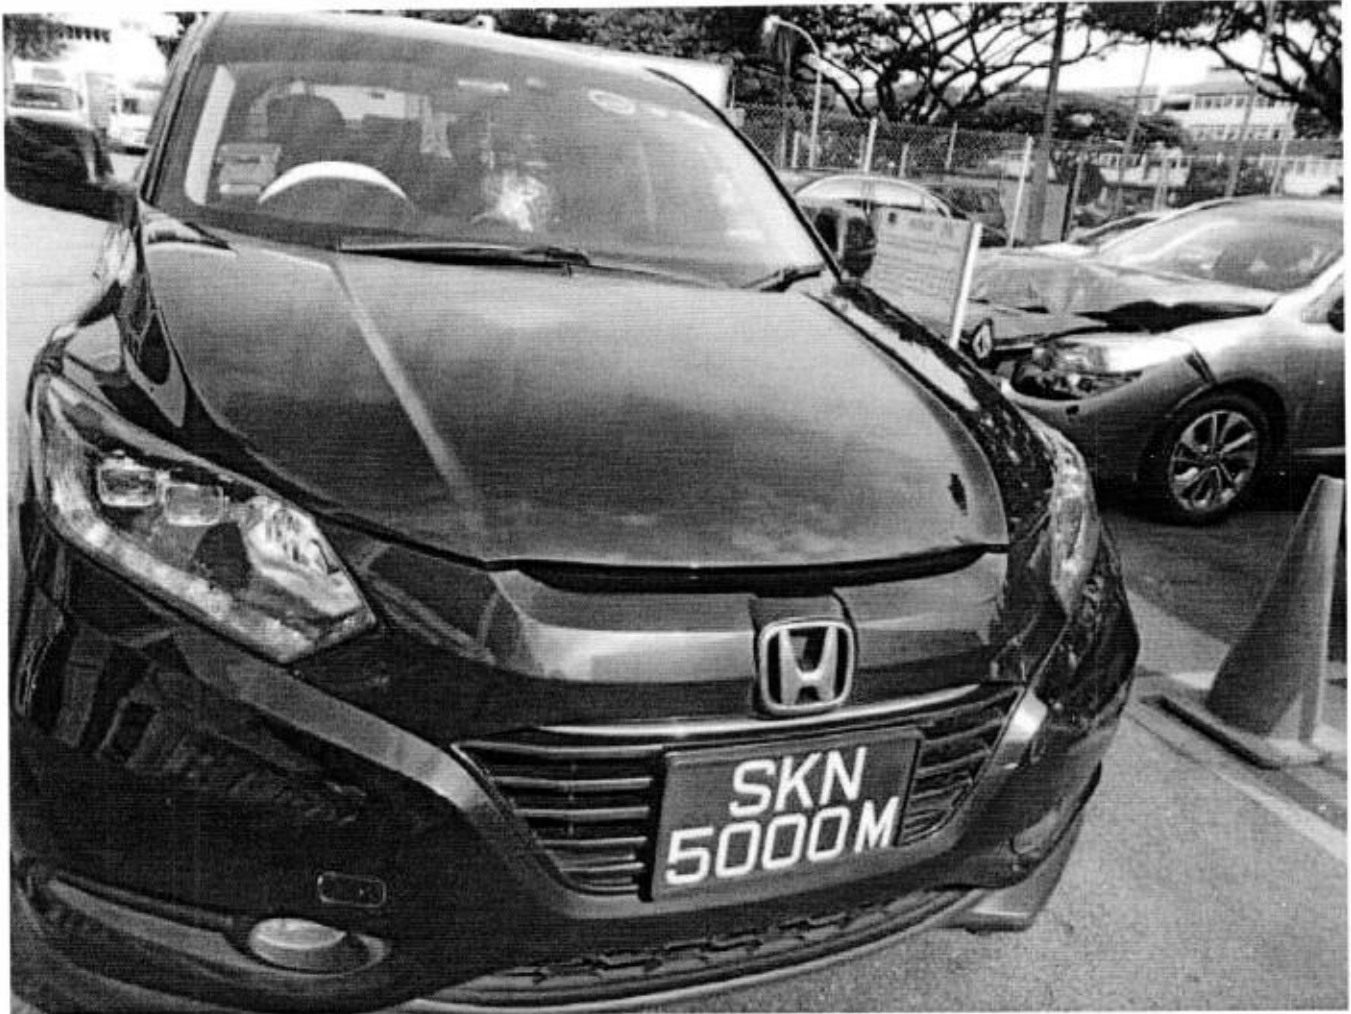
Accident Photo

I then alighted from my vehicle and discovered that there were damages to my vehicle. The damages include damage to the side fender, damage to the rims, the driver side door is unable open properly as well as scratches at the right headlight. My vehicle is also unable to function properly as there will be a noise created whenever I cruise.
