TP Claims against NTUC Income: Follow-Through Survey

NTI	JC INCOME INSU	RANCE CO-OPERATIVE LTD	Ref:	NS/INC1802273	31/K1sbs2	
#05	BRAS BASAH ROA -01 NTUC TRADE 556	AD UNION HOUSESINGAPORE	Date:	02-01-2019 INC4

4. Description of Damag			mages			
	THE VEHICLE SU	STAINED DAMAGES AT THE REA	AR O/S P	ORTION.		
5.		Genera	I Inform	ation		
	Accident Date	17/12/2018	Inspec	tion Date	18/12/2018	
	Survey held at	COMFORTDELGRO ENGINEERING PTE LTD			2000 - 10 CONTROL	
		59 LOYANG DRIVE SINGAPORE 508969				
5a.		R	emarks			
	A)THE INSPECTION B)IN ACCORDANCE	ON WAS CONDUCTED ON A"WIT CE TO YOUR INSTRUCTIONS, W	HOUT PI	REJUDICE" BASIS. NOT AUTHORISED	REPAIRS.	
5b.		Estimate	Days of	Repair		
	ESTIMATED NOR	MAL PERIOD FOR REPAIR:		2 Working Days

ADJUSTMENT ON REPAIR COST FOR VEHICLE NO. SHD 4545C

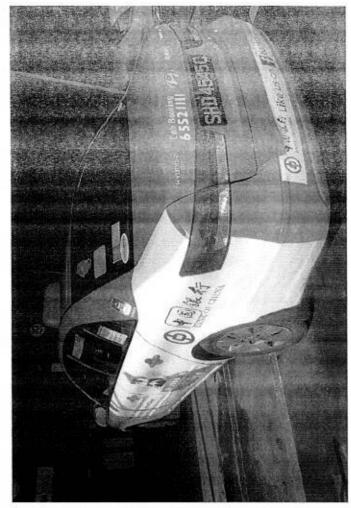
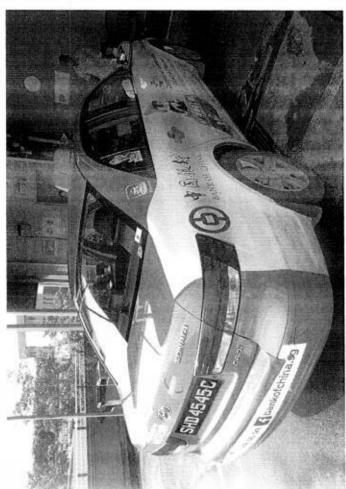
I had went to see a doctor as I felt pain at my back area. I was given with 3 days of medical certificate. My vehicle suffered damages on the rear bumper.

Qty	Description of Parts	Condition	Estimate By Workshop (\$)	Our Adjusted (\$)
	REPLACEMENT OF PARTS			
- 1	REAR BUMPER	TO REPAIR SEE LABOUR	578.40	32
10	REAR BUMPER CLIP	NOT NECESSARY	22.00	
	LESS 20% DISCOUNT		-120.08	8-
			480.32	-
	SPECIAL NETT ITEMS			
1	REAR BUMPER REVERSE SENSOR (SN)	SERVICEABLE	135.70	
1	REAR BUMPER ADVERTISEMENT LOGO (SN)	NECESSARY	50.00	50.00
	REAR FENDER ADVERTISEMENT LOGO (LH/RH) @ \$100.00 (SN)	NECESSARY	200.00	200.00
	904001-400-0-10-0-10-0-10-0-10-0-10-0-10		385.70	250.00
	LABOUR			
	PANEL BEATING. INCLUSIVE OF THE REPAIR OF REAR BUMPER.		350.00	200.00
	SPRAY PAINTING CHARGE.		250.00	200.00
	WIRING CHARGE.	NOT NECESSARY	30.00	794
	REMOVE / REFIX REVERSE SENSOR.	NOT NECESSARY	120.00	95
			750.00	400.00
	GRAND TOTAL		1,616.02	650.00

RECOMMENDED COST OF LUMP SUM REPAIRS	500.00
(TO ITS PRE-ACCIDENT CONDITION)	
(CONFIRMED)
