1. Policy Particulars :- THIRD PARTY CLAIM				
Insured Veh.	SFW 140L	Veh. Inspected	SHC 3051Y	
Policy No.	5106121247	Coverage (\$)	0.00	
Claim No.	MT/1023928-002	Excess (\$)	0.00	
Assign From		Assign Date	18/12/2018

2. Vehicle Particulars & Condition				
Make & Model	MERCEDES BENZ E 220	c.c	2143	
Engine No.	HIDDEN	Year of Reg.	2013	
Chassis No.	WDD2120022A733498	Colour	WHITE	
Odometer	790748	Steering	IN ORDER	
Brakes	IN ORDER	Modification	STANDARD ALLOY RIM	
General	FAIR

4. Description of Damages				
THE VEHICLE SUSTAINED DAMAGES AT THE REAR O/S PORTION. DAMAGES SEE DETAILS.				
5. General Information				
Accident Date	14/12/2018	Inspection Date	18/12/2018	
Survey held at	COMFORTDELGRO ENGINEERING PTE LTD 59 LOYANG DRIVE SINGAPORE 508969			
5a. Remarks				
A)THE INSPECTION WAS CONDUCTED ON A"WITHOUT PREJUDICE" BASIS. B)IN ACCORDANCE TO YOUR INSTRUCTIONS, WE HAVE NOT AUTHORISED REPAIRS.				
5b. Estimate Days of Repair				
ESTIMATED NORMAL PERIOD FOR REPAIR:		2 Working Days

ADJUSTMENT ON REPAIR COST FOR VEHICLE NO. SHC 3051Y

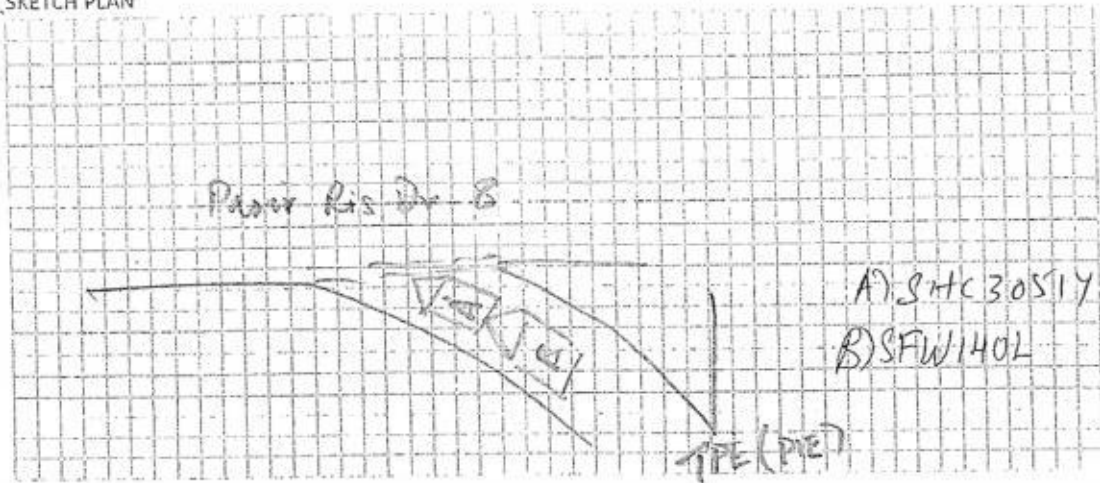
SKETCH PLAN

On 14/12/18 at about 1035hr while I Veh A gradually stopped at the give-way mark along the ship Road from TPE towards Pagar Kis Dr B, Veh B collided on the rear portion of my stationary vehicle.

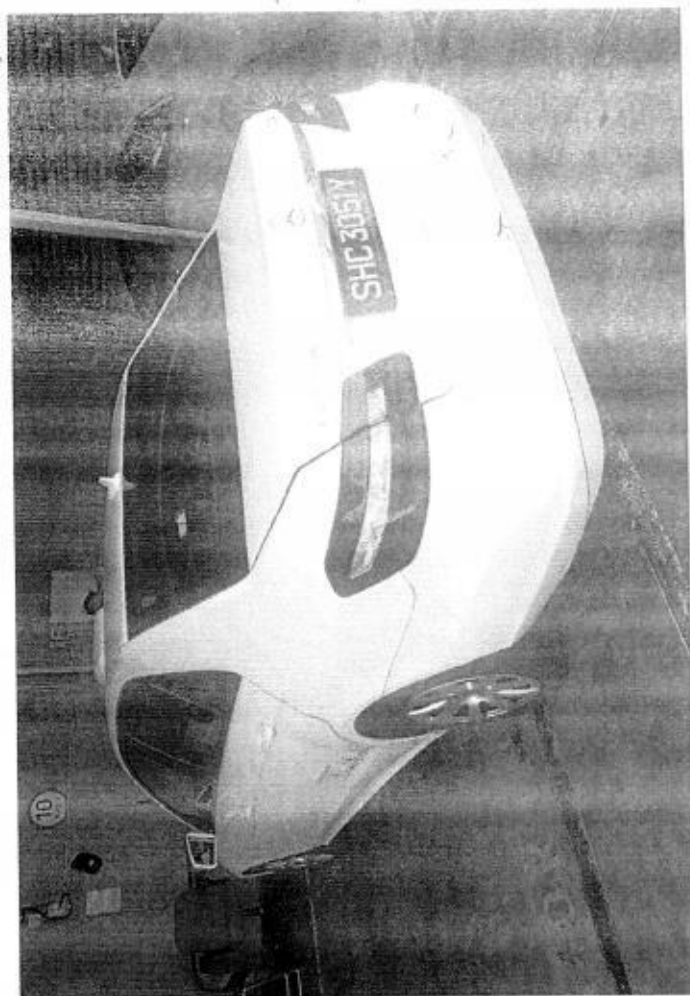
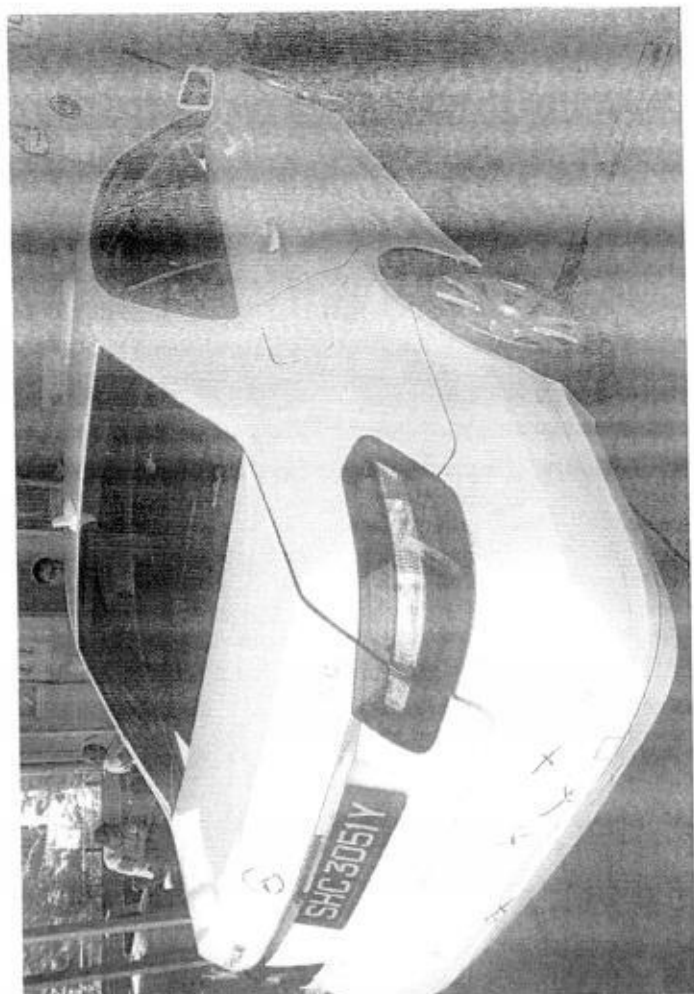
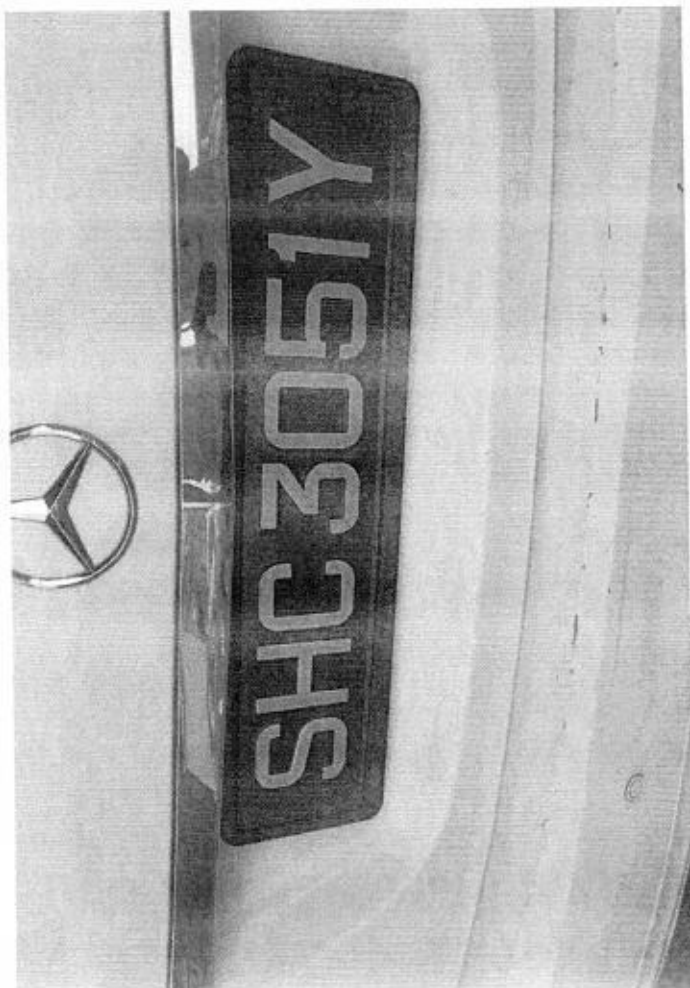
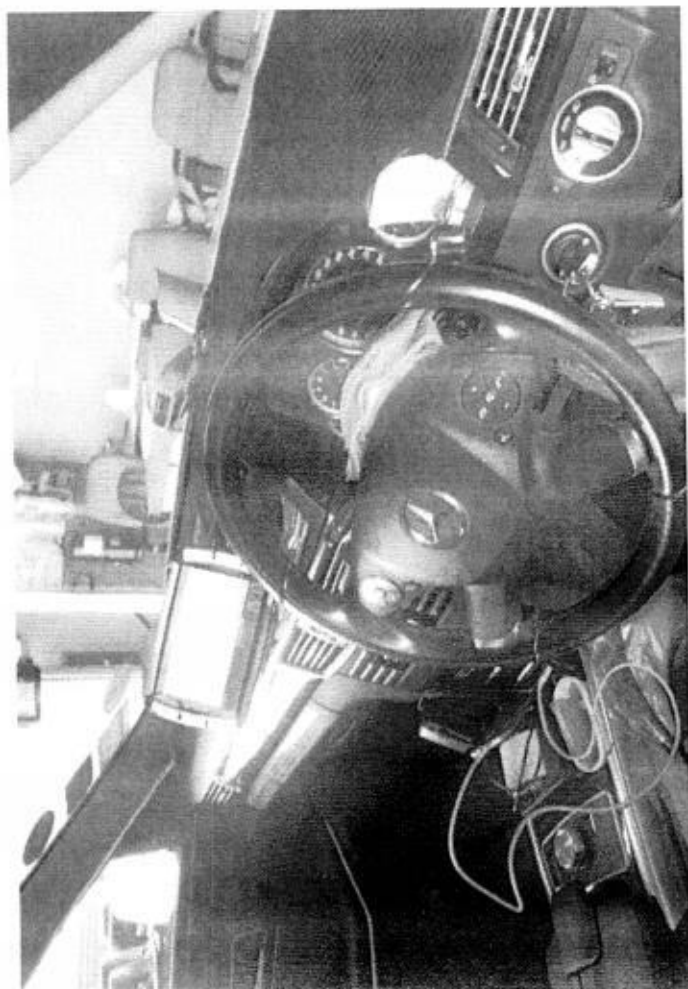
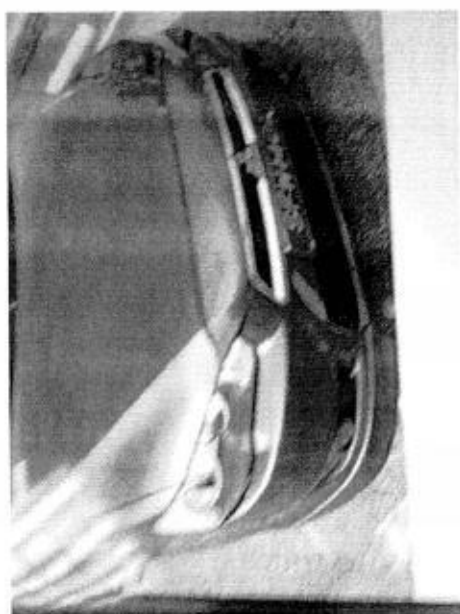
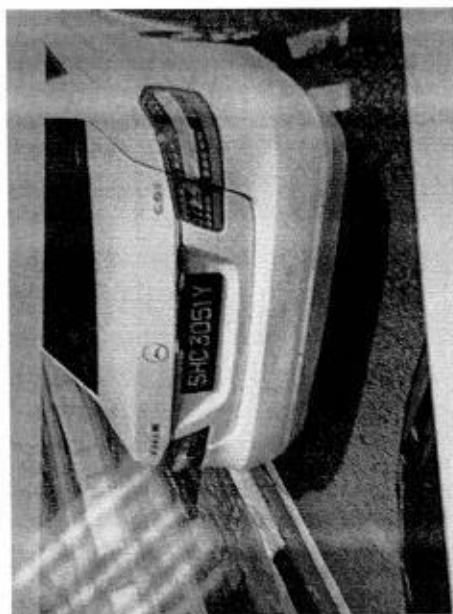
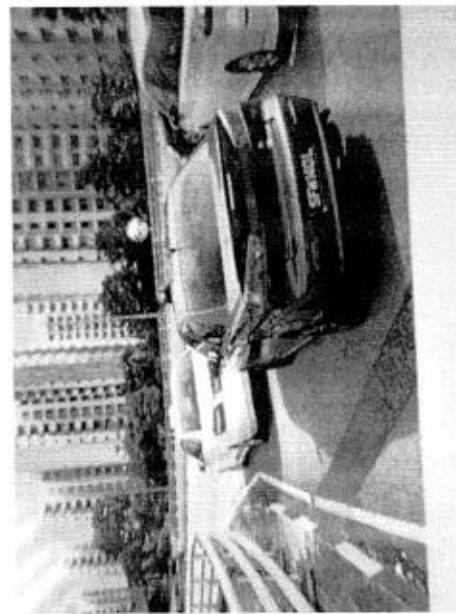
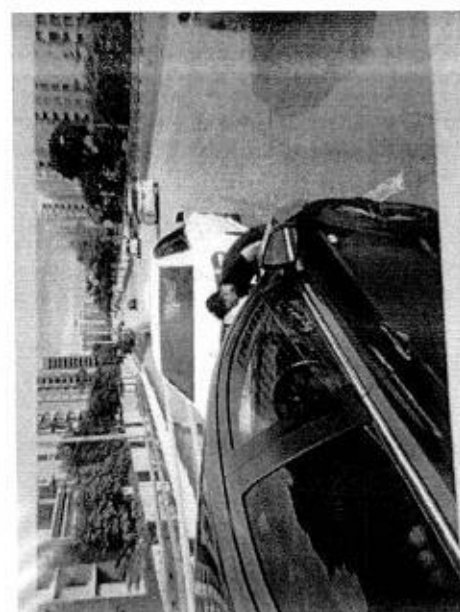
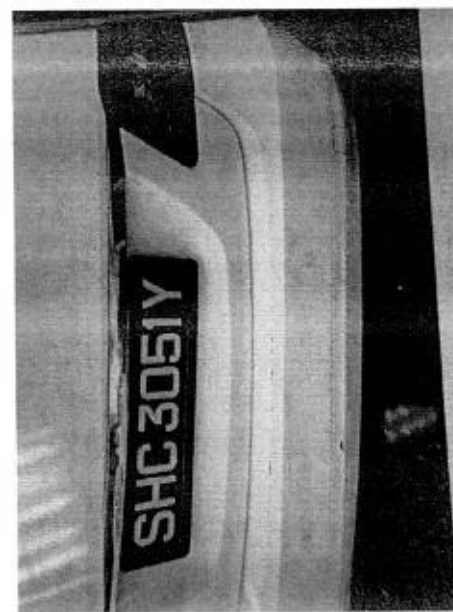
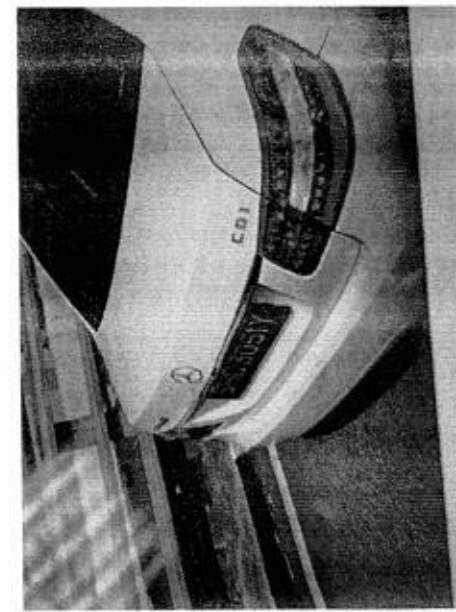
Qty	Description of Parts	Condition	Estimate By Workshop (\$)	Our Adjusted (\$)
	<u>REPLACEMENT OF PARTS</u>			
1	REAR BUMPER	DEFORMED	1,510.00	1,510.00
1	REAR BUMPER REINFORCEMENT	BENT	1,150.00	1,150.00
2	REAR BUMPER BRACKET LOWER (LH/RH) @\$135.00	SERVICEABLE	270.00	-
2	REAR BUMPER BRACKET TOP (LH/RH) @\$125.00	SERVICEABLE	250.00	-
2	REAR BUMPER RETAINER MOUNTING (LH/RH) @\$115.00	SERVICEABLE	230.00	-
	LESS 20% DISCOUNT		-682.00	-532.00
			2,728.00	2,128.00
	<u>SPECIAL NETT ITEMS</u>			
1	REAR BUMPER SENSOR (SN)	SHORTED	388.00	388.00
			388.00	388.00
	<u>LABOUR</u>			
	PANEL BEATING.		400.00	200.00
	SPRAY PAINTING CHARGE.		300.00	200.00
	WIRING CHARGE.	NOT NECESSARY	30.00	-
	REMOVE/REFIX REVERSE SENSOR.		120.00	30.00
			850.00	430.00
	GRAND TOTAL		3,966.00	2,946.00
	RECOMMENDED COST OF LUMP SUM REPAIRS (TO ITS PRE-ACCIDENT CONDITION) (CONFIRMED)			2,300.00
