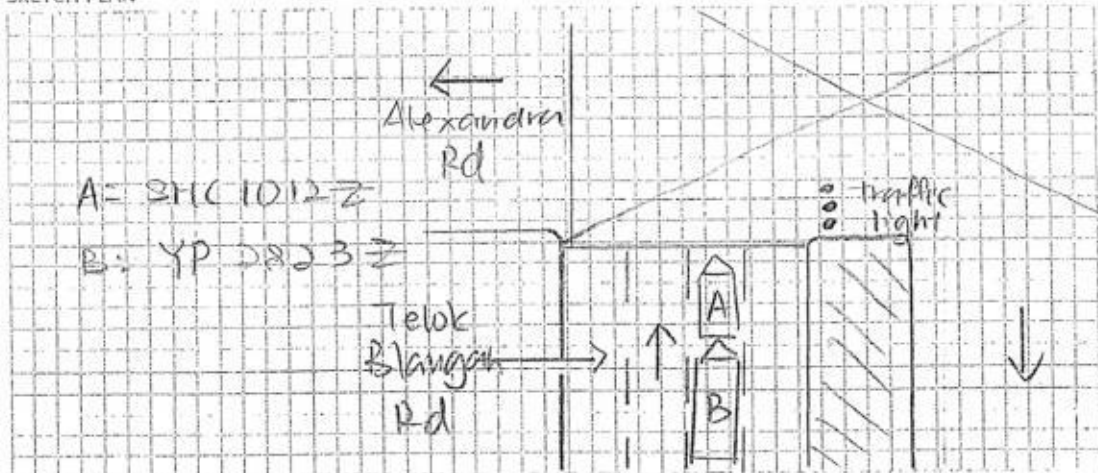
SKETCH PLAN

DESCRIBE CIRCUMSTANCES OF THE ACCIDENT

On 18/12/18 at about 14:45 hrs, my taxi stopped at above said location waiting for traffic light change.

Suddenly Veh B behind of my taxi it front portion hit onto the rear portion of my taxi.
