ASSIGNMENT

Make: HYUNDAI IONIQ c.c. 1,580

4. Description of Damages			
THE VEHICLE SUSTAINED DAMAGES AT THE N/S BODY. DAMAGES SEE DETAILS.			
5. General Information			
Accident Date	20/12/2018	Inspection Date	21/12/2018
Survey held at	COMFORTDELGRO ENGINEERING PTE LTD 59 LOYANG DRIVE SINGAPORE 508969		
5a. Remarks			
A)THE INSPECTION WAS CONDUCTED ON A"WITHOUT PREJUDICE" BASIS. B)IN ACCORDANCE TO YOUR INSTRUCTIONS, WE HAVE NOT AUTHORISED REPAIRS.			
5b. Estimate Days of Repair			
ESTIMATED NORMAL PERIOD FOR REPAIR:		4 Working Days

ADJUSTMENT ON REPAIR COST FOR VEHICLE NO. SHC 7382R

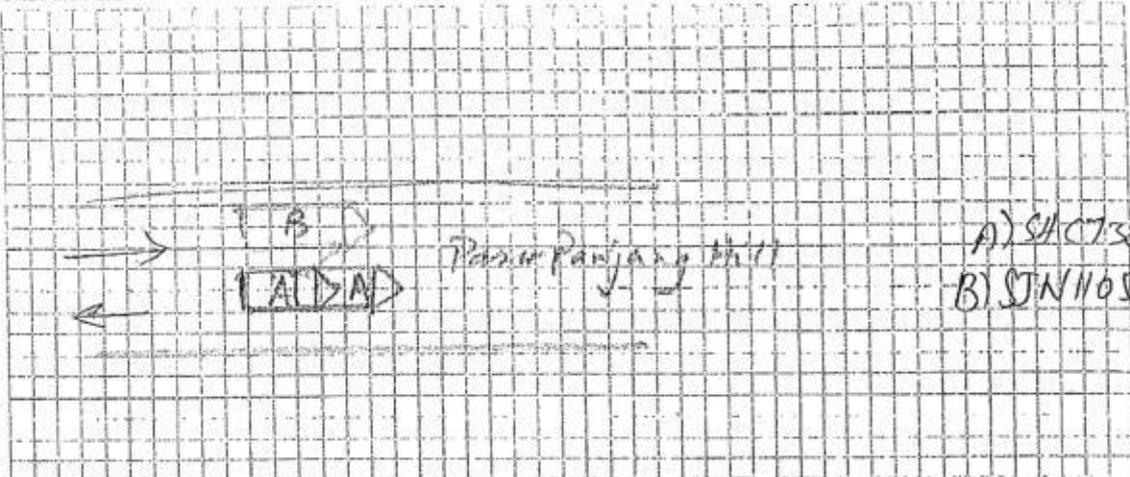
SKETCH PLAN

On 20/12/18 at about 1040hrs while I Veh A was travelling, Veh B opened the right front door which collided onto the left portion of my moving vehicle. My vehicle sustained damages on the whole left portion.

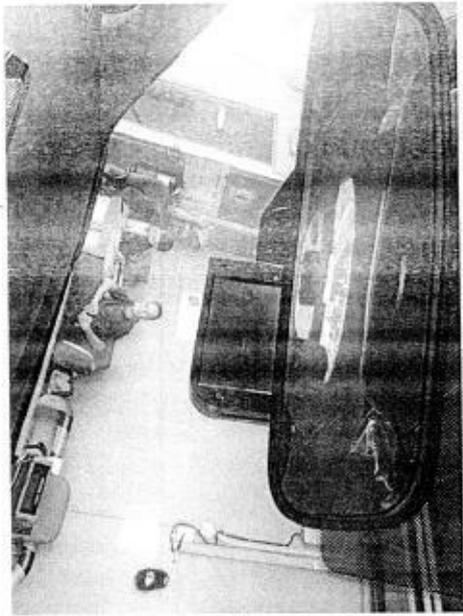
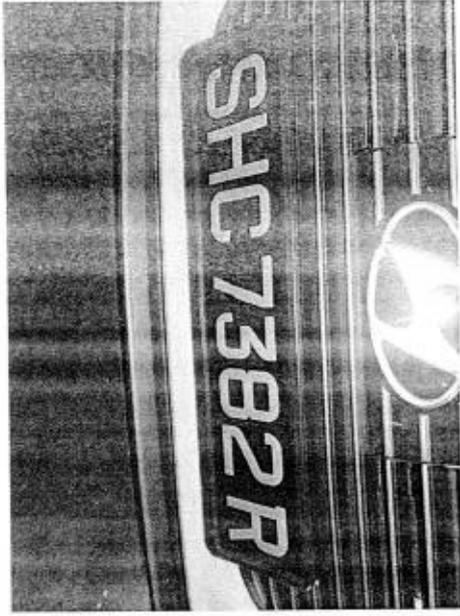
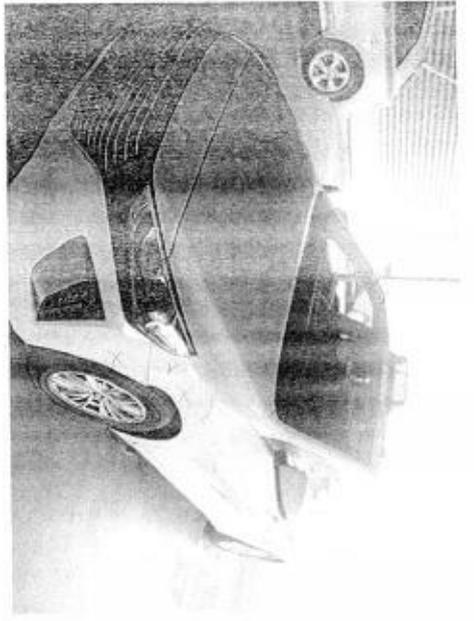
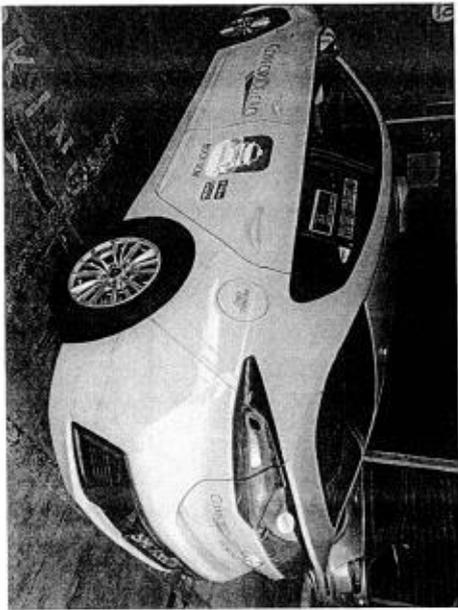
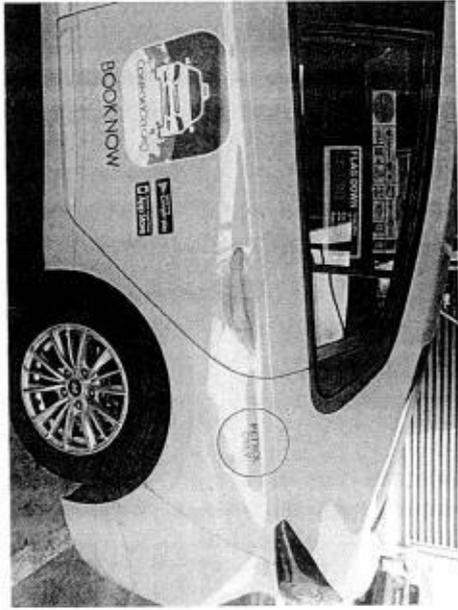
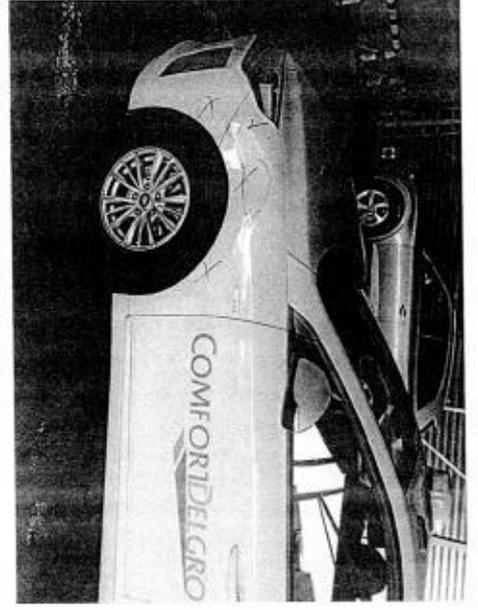
The UIC / Chassis frame / Body Structure affected due to collision

Qty	Description of Parts	Condition	Estimate By Workshop (\$)	Our Adjusted (\$)
REPLACEMENT OF PARTS				
1	FRONT BUMPER COVER	TO REPAIR SEE LABOUR	418.30	-
1	FRONT BUMPER BRACKET (LH)	SERVICEABLE	28.00	-
1	FRONT FENDER (LH)	DEFORMED	490.70	490.70
1	FRONT BUMPER SHIELD (LH)	SERVICEABLE	114.70	-
1	EMBLEM - BLUE DRIVE (LH)	NECESSARY	26.60	26.60
1	FRONT WHEEL RIM (LH)	CUT	1,124.20	1,124.20
1	REAR BUMPER	TO REPAIR SEE LABOUR	459.40	-
10	REAR BUMPER COVER CLIPS LESS 20% DISCOUNT	NOT NECESSARY	22.00 -536.78	- -328.30
			2,147.12	1,313.20
LABOUR				
PANEL BEATING. INCLUSIVE OF THE REPAIR OF FRONT BUMPER COVER AND REAR BUMPER.			900.00	600.00
SPRAY PAINTING CHARGE - REAR FENDER & VIEW MIRROR (LH)			800.00	600.00
WIRING CHARGE.			50.00	30.00
REMOVE / REFIX REVERSE SENSOR.			120.00	20.00
REAR WHEEL ALIGNMENT.			120.00	-
			1,990.00	1,250.00
GRAND TOTAL			4,137.12	2,563.20
RECOMMENDED COST OF REPAIRS (CONFIRMED)				2,563.20

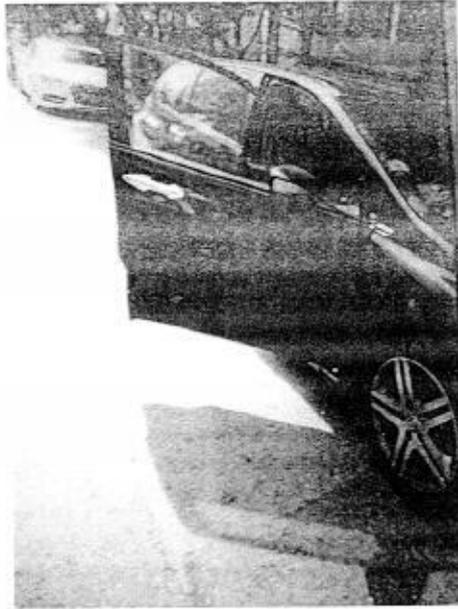
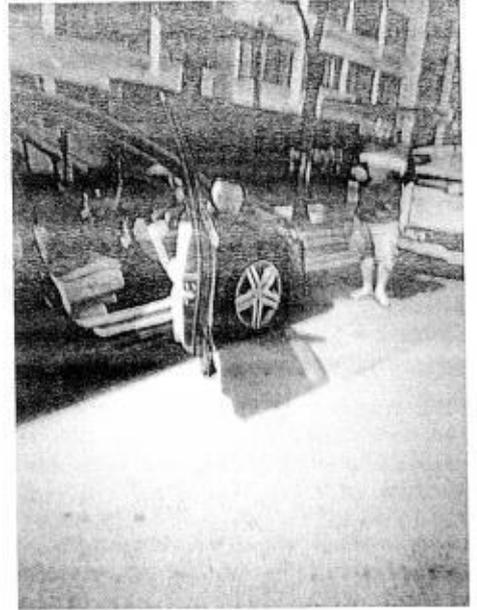
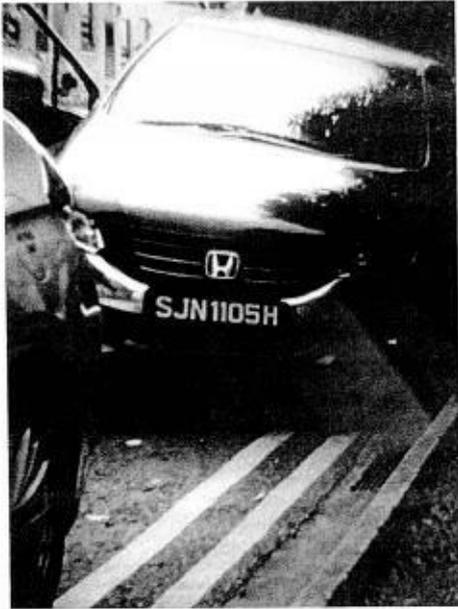
Remark: The veh had commenced its repair at the time of inspection.

(a) Spare Parts after List discount	<u>\$1,313.20</u>
(b) Labour Charges	<u>\$1,250.00</u>
Total for Part-By-Part Repair Cost	<u>\$2,563.20</u>
(c.) Lumpsum Repair (if applicable)	
Total for Lumpsum repair cost after Less: <u>20%</u>	<u> </u>
Final Lumpsum Repair cost	<u> </u>

3. Estimated normal period for repairs: 4 working days.
