NS/INC18023011/Klsbn2

NTUC INCOME INSURANCE CO-OPERATIVE LTD Ref: NS/INC18023011/K1sbn2

1. Policy Particulars :- THIRD PARTY CLAIM

ADJUSTMENT ON REPAIR COST FOR VEHICLE NO. SHD 4885X

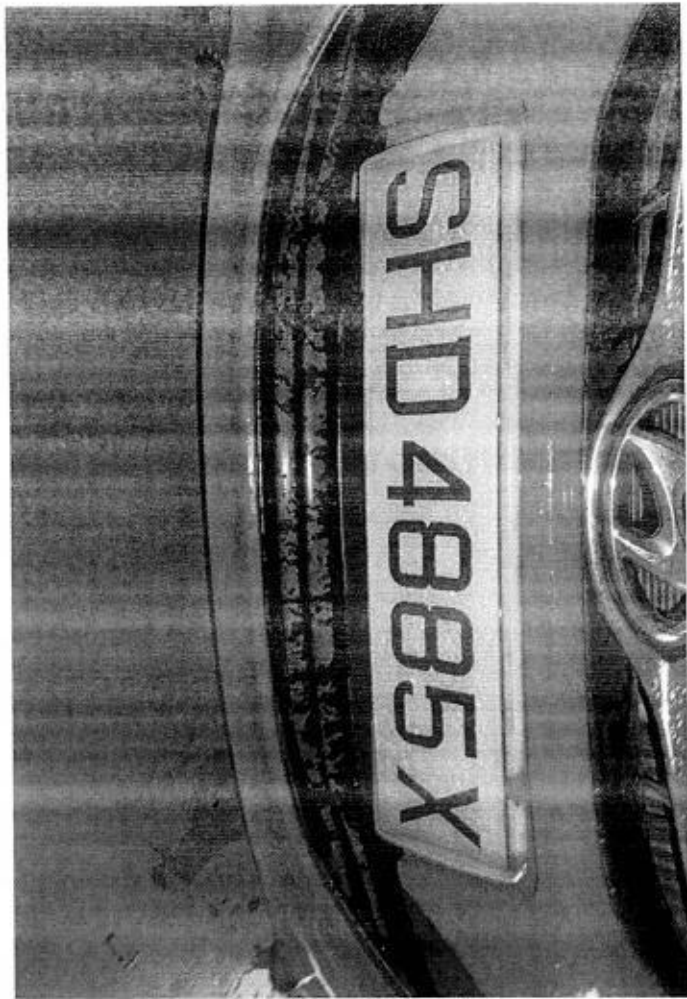
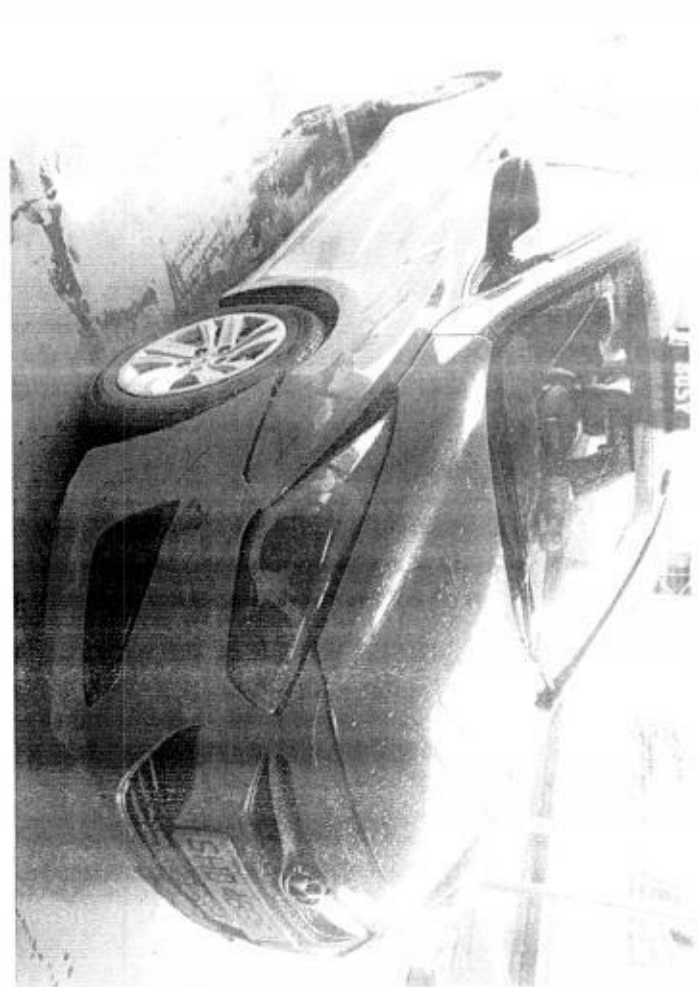
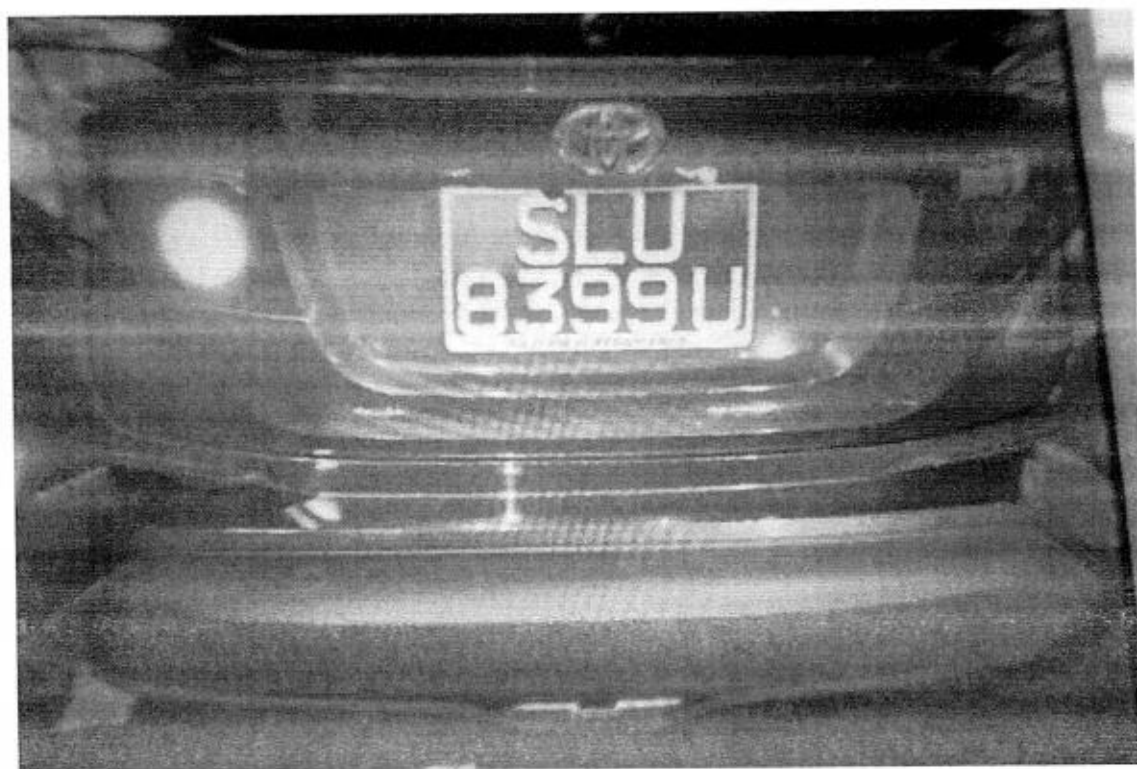
The UIC / Chassis frame / Body Structure affected due to collision.

THE VEHICLE SUSTAINED DAMAGES AT THE O/S FRONT PORTION. DAMAGES SEE DETAILS.

Qty	Description of Parts	Condition	Estimate By Workshop (\$)	Our Adjusted (\$)
REPLACEMENT OF PARTS				
1	FRONT BUMPER COVER	DEFORMED	544.50	544.50
1	FRONT BUMPER GRILLE (RH)	CUT	41.60	41.60
1	FRONT BUMPER BRACKET TOP (RH)	SERVICEABLE	22.40	-
1	FRONT BUMPER BRACKET (RH)	CRACKED	24.60	24.60
1	HEADLAMP (RH)	GRAZED	1,388.00	1,388.00
1	FRONT FENDER (RH)	DENTED	566.30	566.30
1	FRONT FENDER RETAINER	SERVICEABLE	24.60	-
	LESS 20% DISCOUNT		-522.40	-513.00
			2,089.60	2,052.00
LABOUR				
	PANEL BEATING.		400.00	300.00
	SPRAY PAINTING CHARGE.		600.00	400.00
	WIRING.		30.00	30.00
	TUFF KOTE.		50.00	30.00
			1,080.00	760.00
GRAND TOTAL			3,169.60	2,812.00
RECOMMENDED COST OF LUMP SUM REPAIRS (TO ITS PRE-ACCIDENT CONDITION) (CONFIRMED)				2,250.00
