NTUC INCOME INSURANCE CO-OPERATIVE LTD		Ref: NS/INC18023015/K1vbn2	
73 BRAS BASAH ROAD #05-01 NTUC TRADE UNION HOUSESINGAPORE 189556		Date: 31-12-2018

1. Policy Particulars :- THIRD PARTY CLAIM			
Insured Veh.	SHD 2443B	Veh. Inspected	SHD 7187H
Policy No.	5068045737-04	Coverage (\$)	0.00
Claim No.	MT/1024913-002	Excess (\$)	0.00
Assign From		Assign Date	24/12/2018

4. Description of Damages			
THE VEHICLE SUSTAINED DAMAGES AT THE REAR PORTION. DAMAGES SEE DETAILS.			
5. General Information			
Accident Date	21/12/2018	Inspection Date	24/12/2018
Survey held at	COMFORTDELGRO ENGINEERING PTE LTD 59 LOYANG DRIVE SINGAPORE 508969		
5a. Remarks			
A)THE INSPECTION WAS CONDUCTED ON A"WITHOUT PREJUDICE" BASIS. B)IN ACCORDANCE TO YOUR INSTRUCTIONS, WE HAVE NOT AUTHORISED REPAIRS.			
5b. Estimate Days of Repair			
ESTIMATED NORMAL PERIOD FOR REPAIR:		2 Working Days

ADJUSTMENT ON REPAIR COST FOR VEHICLE NO. SHD 7187H

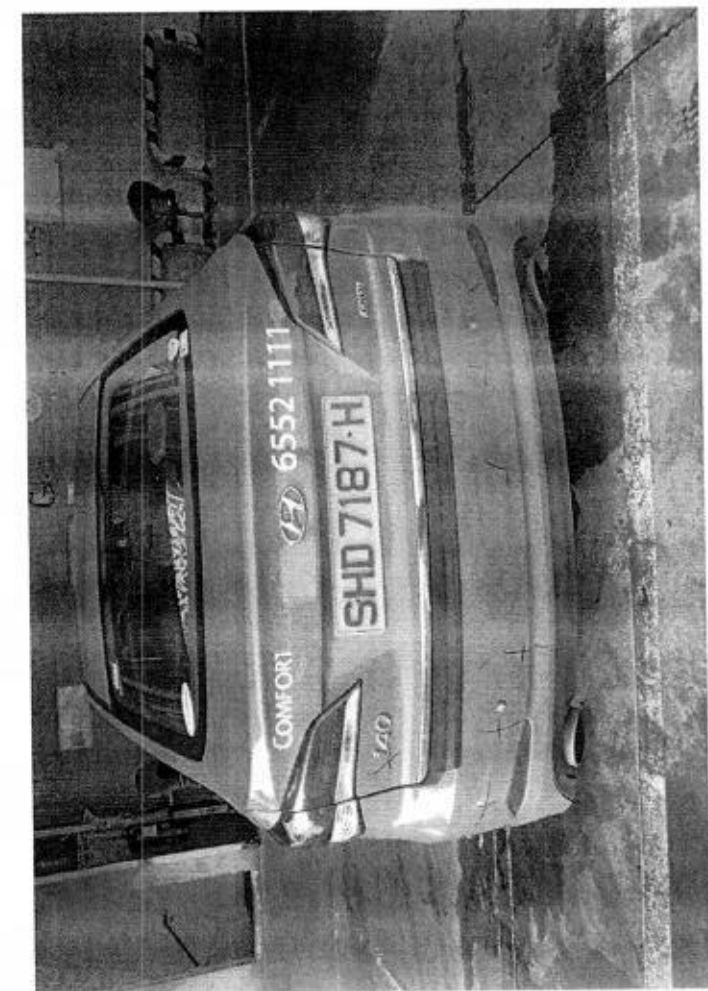
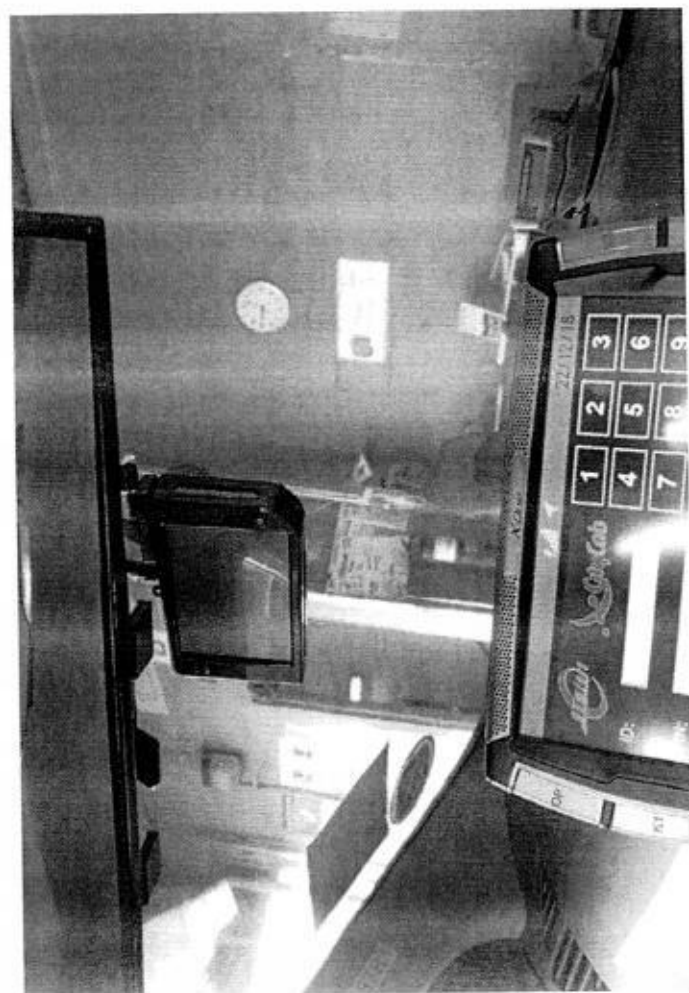
The U/C / Chassis frame / Body Structure affected due to collision.

Qty	Description of Parts	Condition	Estimate By Workshop (\$)	Our Adjusted (\$)
REPLACEMENT OF PARTS				
1	REAR BUMPER	DEFORMED	553.00	553.00
10	REAR BUMPER CLIP	NECESSARY	22.00	22.00
1	REAR BUMPER UNDER COVER	CUT	228.00	228.00
	LESS 20% DISCOUNT		-160.60	-160.60
			642.40	642.40
SPECIAL NETT ITEMS				
1	REAR BUMPER RUBBER MAT (SN)	NECESSARY	50.00	50.00
			50.00	50.00
LABOUR				
	PANEL BEATING.		400.00	200.00
	SPRAY PAINTING CHARGE.		300.00	200.00
	WIRING CHARGE.	NOT NECESSARY	30.00	-
	REMOVE/REFIX REVERSE SENSOR.		80.00	30.00
			810.00	430.00
GRAND TOTAL			1,502.40	1,122.40
RECOMMENDED COST OF LUMP SUM REPAIRS (TO ITS PRE-ACCIDENT CONDITION) (CONFIRMED)				900.00
