REF: NS/INC18023128 / K11612

1. Policy Particulars :- THIRD PARTY CLAIM

4. Description of Damages

ADJUSTMENT ON REPAIR COST FOR VEHICLE NO. SH 8071A

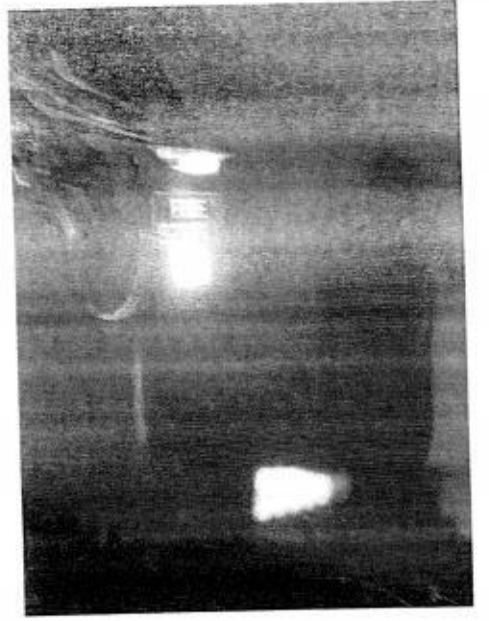
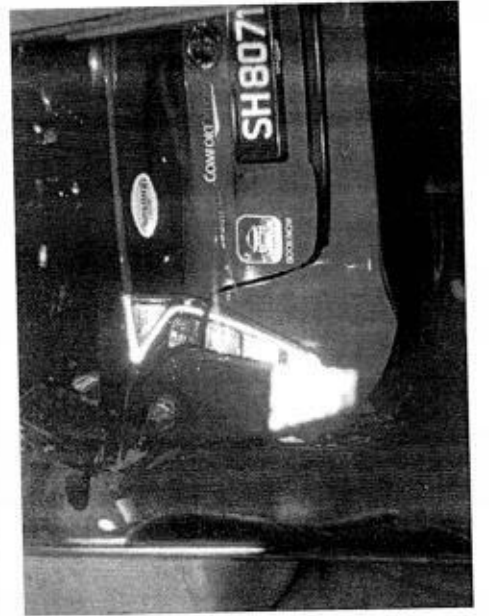
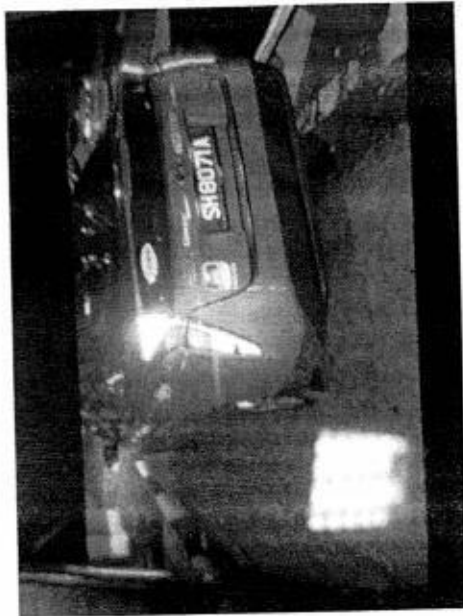
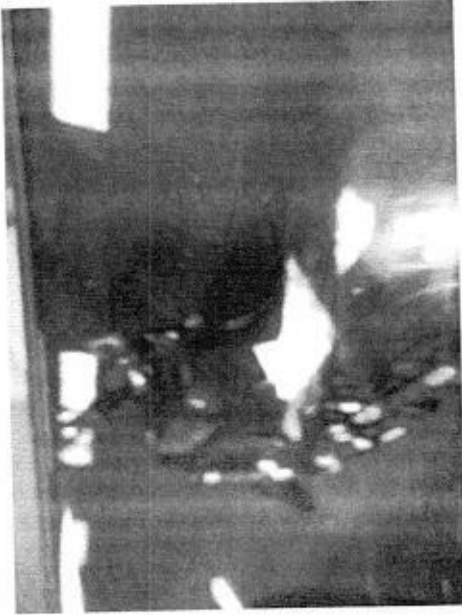
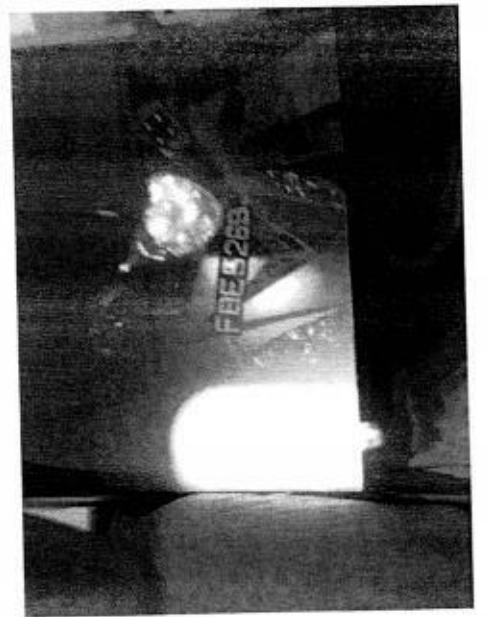
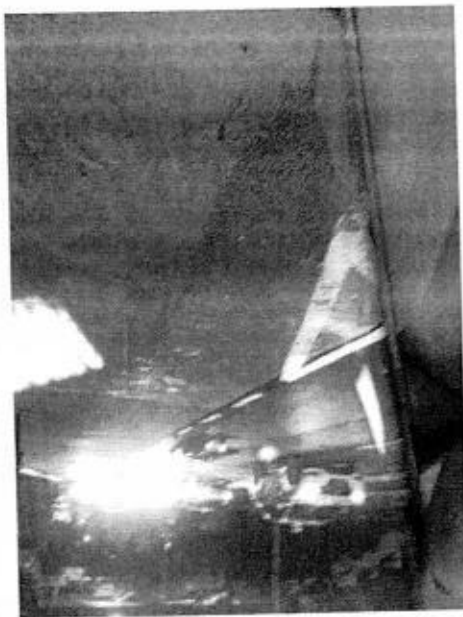
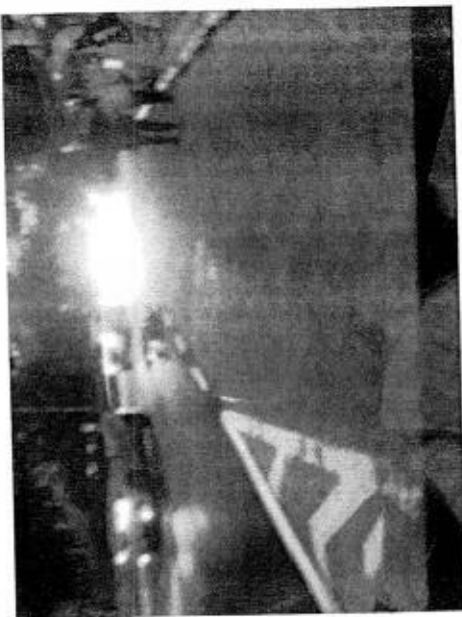
BS / DUN / EXNOVA / GY / FS / LIZA / MIC / OH / SU / PIR / SUMI /
 TOYO / YOKO or Waller
 Front Rear
 R/Bal. 7 mm R/Bal. 7 mm
 L/Bal. 7 mm L/Bal. 7 mm
 D.O.A. 21/12/18 D.O.I. 26/12/18
 Survey held at C D G E (Loyang)
 Des. of Damages: Frt / Rear / O/S / N/S / UIC / Rooftop or
Rear N/S.
 The UIC / Chassis frame / Body Structure affected due to collision.

THE VEHICLE SUSTAINED DAMAGES AT THE REAR N/S PORTION.
DAMAGES SEE DETAILS.

Qty	Description of Parts	Condition	Estimate By Workshop (\$)	Our Adjusted (\$)
REPLACEMENT OF PARTS				
1	REAR BUMPER	TO REPAIR SEE LABOUR	458.60	-
1	REAR BUMPER UNDER COVER	CUT	552.60	552.60
10	REAR BUMPER CLIPS	NECESSARY	22.00	22.00
1	SEAL, REAR BUMPER SIDE, LH	MISSING	148.40	148.40
	LESS 25% DISCOUNT		-295.40	-180.75
			886.20	542.25
SPECIAL NETT ITEMS				
1	REAR BUMPER REVERSE SENSOR (SN)	SERVICEABLE	135.70	-
			135.70	-
LABOUR				
	PANEL BEATING. INCLUSIVE OF THE REPAIR OF REAR BUMPER.		350.00	200.00
	SPRAY PAINTING CHARGE.		250.00	200.00
	WIRING CHARGE.	NOT NECESSARY	30.00	-
	REMOVE/REFIX REVERSE SENSOR.	NOT NECESSARY	80.00	-
			710.00	400.00
GRAND TOTAL			1,731.90	942.25
RECOMMENDED COST OF LUMP SUM REPAIRS (TO ITS PRE-ACCIDENT CONDITION) (CONFIRMED)				750.00
