### 1. Policy Particulars :- THIRD PARTY CLAIM

Insured Veh.	SLV 4930G	Veh. Inspected	SHB 3100U
Policy No.	5098060055	Coverage (\$)	0.00
Claim No.	MT/1024648-002	Excess (\$)	0.00
Assign From		Assign Date	27/12/2018

### 4. Description of Damages

**ADJUSTMENT ON REPAIR COST FOR VEHICLE NO. SHB 3100U**

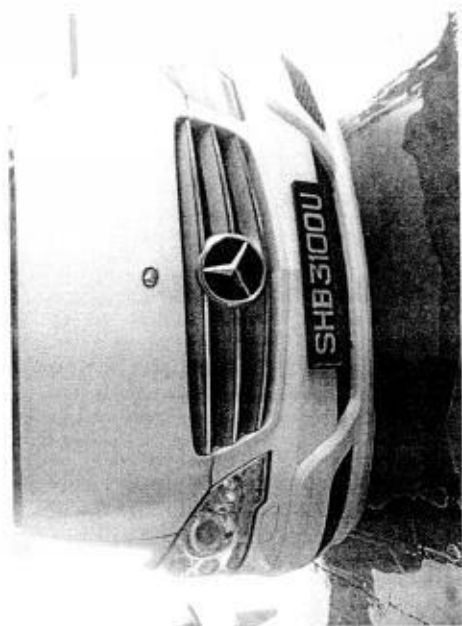
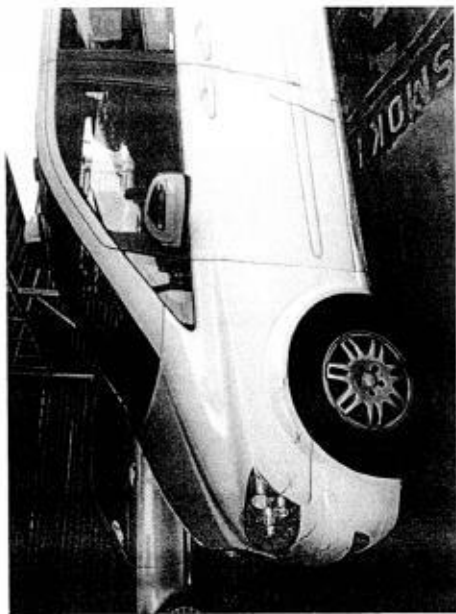
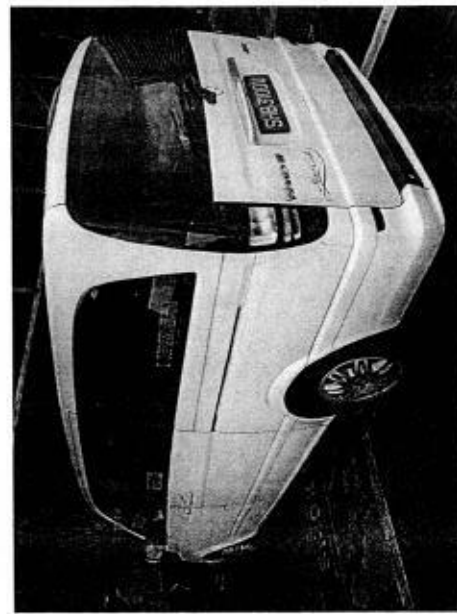
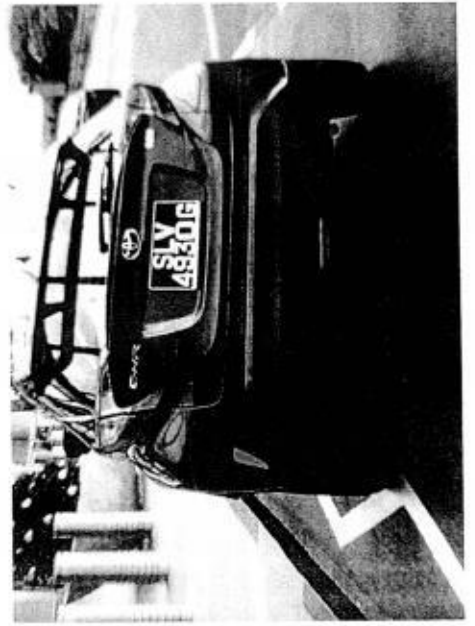
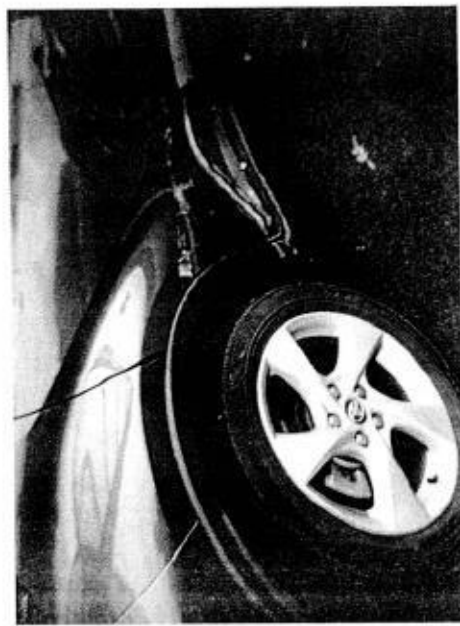
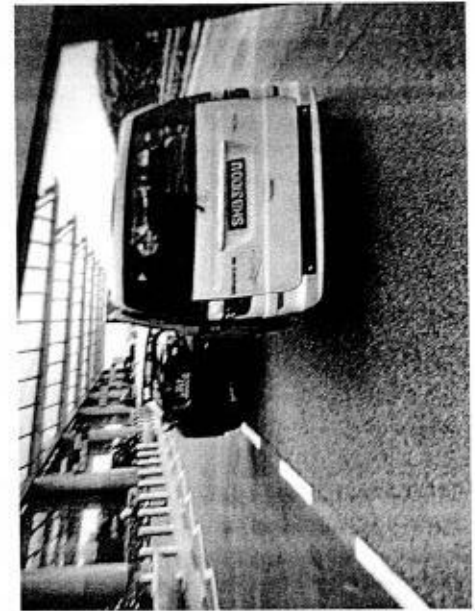
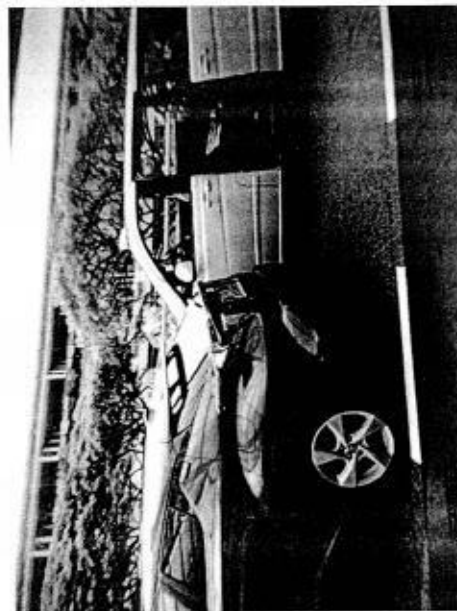
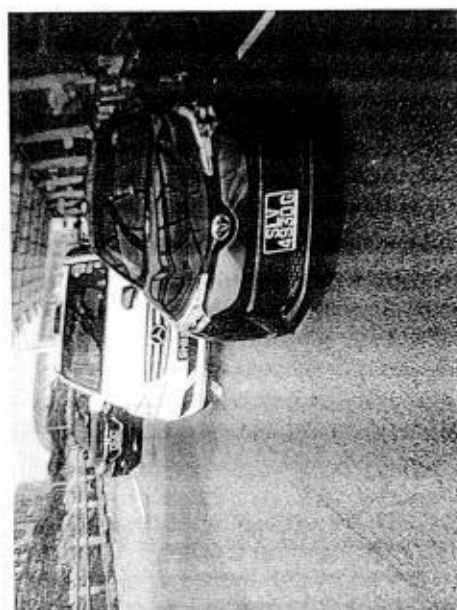
THE VEHICLE SUSTAINED DAMAGES AT THE N/S FRONT PORTION. DAMAGES SEE DETAILS.
---

Qty	Description of Parts	Condition	Estimate By Workshop (\$)	Our Adjusted (\$)
	<b><u>REPLACEMENT OF PARTS</u></b>			
1	BUMPER, FRT	DEFORMED	1,920.00	1,920.00
1	BUMPER REINFORCEMENT, FRT	SERVICEABLE	1,480.00	-
1	BUMPER BRACKET, FRT/LH	SERVICEABLE	66.00	-
1	HEAD LAMP ASSY, LH	CRACKED	3,620.00	3,620.00
1	FENDER, FRT/LH	DENTED	1,320.00	1,320.00
	LESS 20% DISCOUNT		-1,681.20	-1,372.00
			6,724.80	5,488.00
	<b><u>LABOUR</u></b>			
	PANEL BEATING.		500.00	300.00
	SPRAY PAINTING CHARGE.		600.00	400.00
	WIRING CHARGE.		50.00	20.00
	TUFF KOTE.		50.00	20.00
			1,200.00	740.00
	<b>GRAND TOTAL</b>		<b>7,924.80</b>	<b>6,228.00</b>
	<b>RECOMMENDED COST OF LUMP SUM REPAIRS (TO ITS PRE-ACCIDENT CONDITION) (CONFIRMED)</b>			<b>5,000.00</b>

ESTIMATED NORMAL PERIOD FOR REPAIR:	2 Working Days
-------------------------------------	----------------
