TP Claims against NTUC Income: Follow-Through Survey

VEHICLE NO: SHA 4979A :

4.	Descript	ion of D	amages			
THE VEHICLE SU	STAINED DAMAGES AT THE RE	EAR N/S	PORTION.			
5.		al Inforr	nation			
Accident Date	26/12/2018	ACCURE BUILDING	ection Date	27/12/2018		
Survey held at	COMFORTDELGRO ENGINEE	RING P	TE LTD			
	59 LOYANG DRIVE SINGAPORE 508969					
5a.		Remarks				
A)THE INSPECTI B)IN ACCORDAN	ON WAS CONDUCTED ON A"W CE TO YOUR INSTRUCTIONS, \	ITHOUT WE HAVI	PREJUDICE" BASI: E NOT AUTHORISE	S. ED REPAIRS.		
5b.	Estimate	Days o	of Repair			
ESTIMATED NOF	RMAL PERIOD FOR REPAIR:		2 Working Days

ADJUSTMENT ON REPAIR COST FOR VEHICLE NO. SHA 4979A

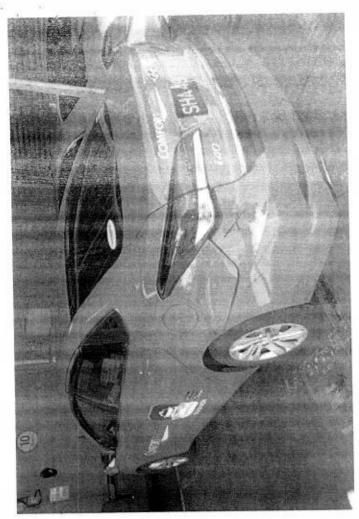
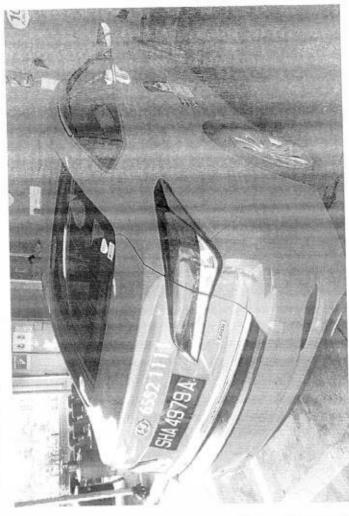
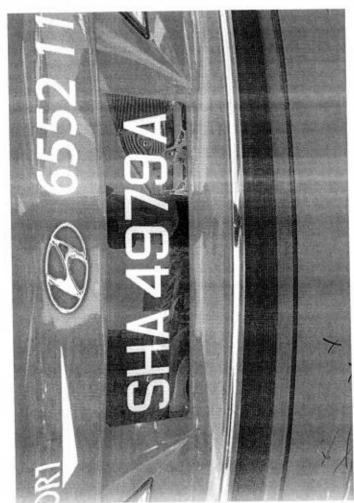
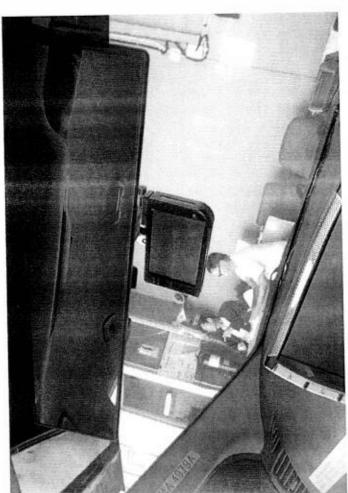
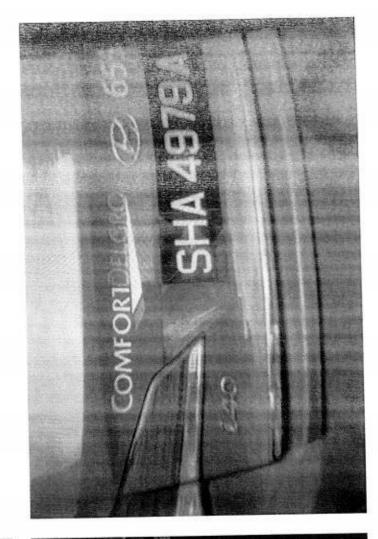
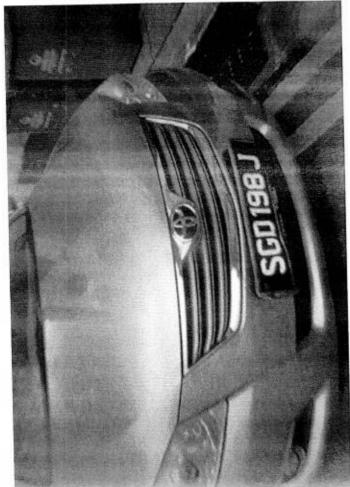
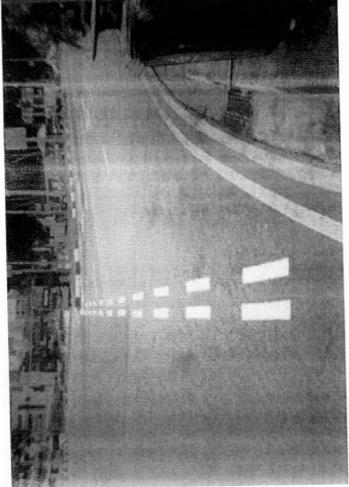
Qty	Description of Parts	Condition	Estimate By Workshop (\$)	Our Adjusted (\$)
	REPLACEMENT OF PARTS			
1	REAR BUMPER	DEFORMED	553.00	553.00
1	REAR BUMPER REINFORCEMENT	SERVICEABLE	428.40	
2	REAR BUMPER REINFORCEMENT BRACKET (LH/RH) @\$80.30	SERVICEABLE	160.60	-
10	REAR BUMPER CLIP	NECESSARY	22.00	22.00
1	REAR BUMPER SPONGE	SERVICEABLE	103.50	1

- 1	REAR BUMPER UNDER COVER	CUT	228.00	228.00
	LESS 20% DISCOUNT		-299.10	-160.60
	Commission of the Commission of the Commission of Commissi		1,196.40	642.40
	SPECIAL NETT ITEMS			
1	REAR BUMPER REVERSE SENSOR (SN)	SERVICEABLE	135.70	
1	REAR BUMPER RUBBER MAT (SN)	NECESSARY	50.00	50.00
		A(185.70	50.00
	LABOUR		9207.00090000	INVO SAND
	PANEL BEATING.		350.00	
	SPRAY PAINTING CHARGE.		250.00	200.00
	WIRING CHARGE.	NOT NECESSARY	30.00	
	REMOVE/REFIX REVERSE SENSOR.		80.00	30.00

710.00	430.00
	GRAND TOTAL		2,092.10	1,122.40
	RECOMMENDED COST OF LUMP SUM REPAIRS (TO ITS PRE-ACCIDENT CONDITION)			900.00
