NTUC INCOME INSURANCE CO-OPERATIVE LTD Ref: NS/INC18023295/K1qd3e2			
73 BRAS BASAH ROAD #05-01 NTUC TRADE UNION HOUSESINGAPORE 189556		Date: 10-01-2019	 
Code: INC4

1. Policy Particulars :- THIRD PARTY CLAIM			
Insured Veh.	SMC 3831D	Veh. Inspected	SH 8356D
Policy No.	5101737138	Coverage (\$)	0.00
Claim No.	MT/1025318-002	Excess (\$)	0.00
Assign From		Assign Date	28/12/2018

4. Description of Damages			
THE VEHICLE SUSTAINED DAMAGES AT THE O/S BODY. DAMAGES SEE DETAILS.			
5. General Information			
Accident Date	26/12/2018	Inspection Date	28/12/2018
Survey held at	COMFORTDELGRO ENGINEERING PTE LTD 59 LOYANG DRIVE SINGAPORE 508969		
5a. Remarks			
A)THE INSPECTION WAS CONDUCTED ON A"WITHOUT PREJUDICE" BASIS. B)IN ACCORDANCE TO YOUR INSTRUCTIONS, WE HAVE NOT AUTHORISED REPAIRS.			
5b. Estimate Days of Repair			
ESTIMATED NORMAL PERIOD FOR REPAIR:		2 Working Days

ADJUSTMENT ON REPAIR COST FOR VEHICLE NO. SH 8356D

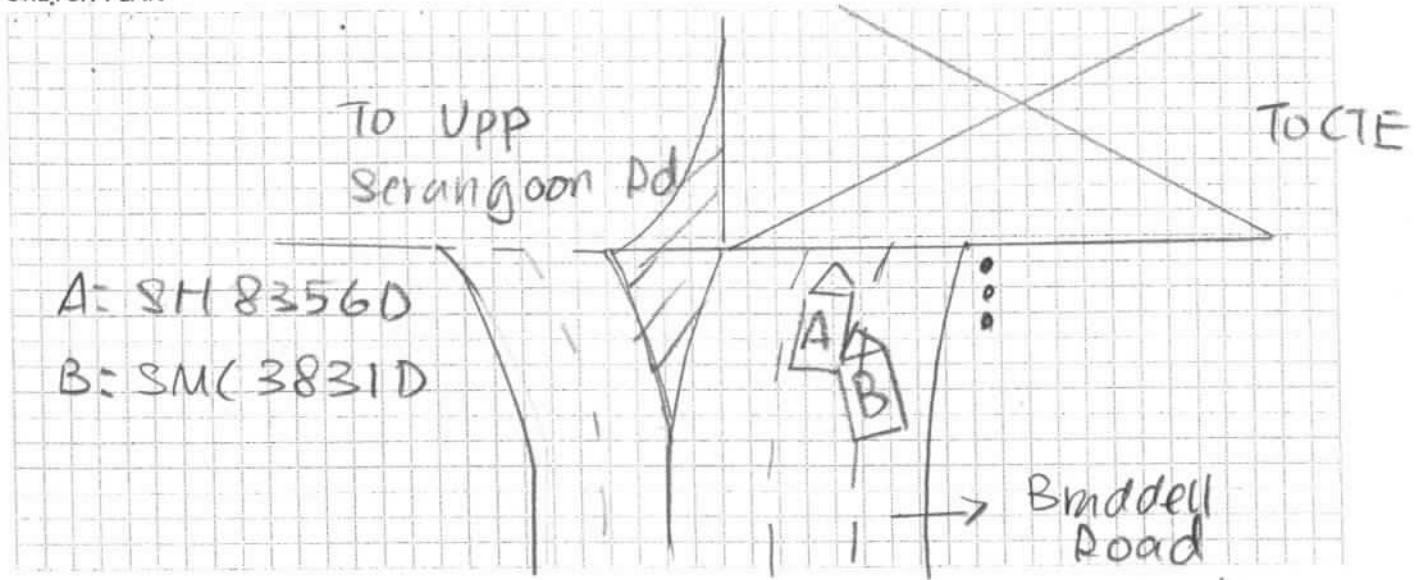
SKETCH PLAN

On 26/12/18 at about 20:00 hrs, I was driving at above said location.

When I was about to stopped at the junction, veh B dashed out from right it front left portion collided onto the right rear portion of my taxi.

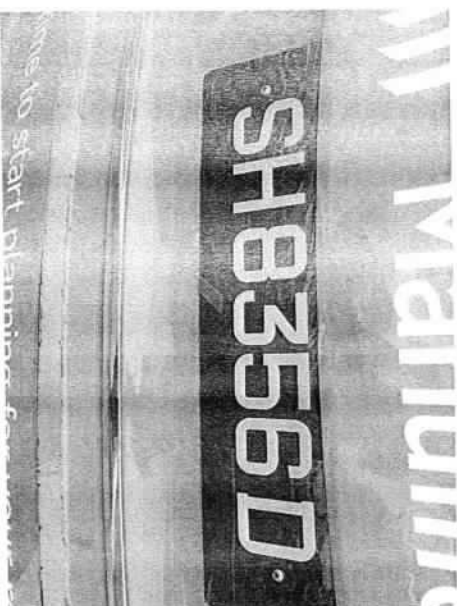
Photos

The U/C / Chassis frame / Body Structure affected due to collision.

Qty	Description of Parts	Condition	Estimate By Workshop (\$)	Our Adjusted (\$)
	<u>REPLACEMENT OF PARTS</u>			
1	ROCKER PANEL OUTER GARNISH (RH)	TO REPAIR SEE LABOUR	341.40	-
1	REAR WHEEL HUP-CAP (RH)	GRAZED	107.10	107.10
1	REAR FENDER (RH)(NPA)	TO REPAIR SEE LABOUR	-	-
1	REAR DOOR (RH)(NPA)	TO REPAIR SEE LABOUR	-	-
	LESS 20% DISCOUNT		-89.70	-21.42

358.80	85.68
	<u>SPECIAL NETT ITEMS</u>			
1	REAR FENDER ADVERTISEMENT LOGO (RH)(SN)	NECESSARY	100.00	100.00
1	REAR DOOR ADVERTISEMENT LOGO (RH)(SN)	NECESSARY	100.00	100.00
1	REAR DOOR COMFORTDELGRO & APPS STICKER (RH) (SN)	NECESSARY	80.00	80.00

280.00	280.00
	<u>LABOUR</u>			
	PANEL BEATING.INCLUSIVE OF THE REPAIR OF ROCKER PANEL OUTER GARNISH (RH),REAR FENDER (RH) AND REAR DOOR (RH).		400.00	200.00
	SPRAY PAINTING CHARGE.		750.00	600.00
	REAR WHEEL ALIGNMENT.	NOT NECESSARY	80.00	-
			1,230.00	800.00
	GRAND TOTAL		1,868.80	1,165.68
	RECOMMENDED COST OF LUMP SUM REPAIRS (TO ITS PRE-ACCIDENT CONDITION) (CONFIRMED)			900.00
