NTUC INCOME INSURANCE CO-OPERATIVE LTD Ref: NS/INC18023296/K1qd3n2

1. Policy Particulars :- THIRD PARTY CLAIM

Insured Veh.	SGU 5180L	Veh. Inspected	SHA 3267C
Policy No.	5073296371-03	Coverage (\$)	0.00
Claim No.	MT/1025432-002	Excess (\$)	0.00
Assign From		Assign Date	28/12/2018

ADJUSTMENT ON REPAIR COST FOR VEHICLE NO. SHA 3267C

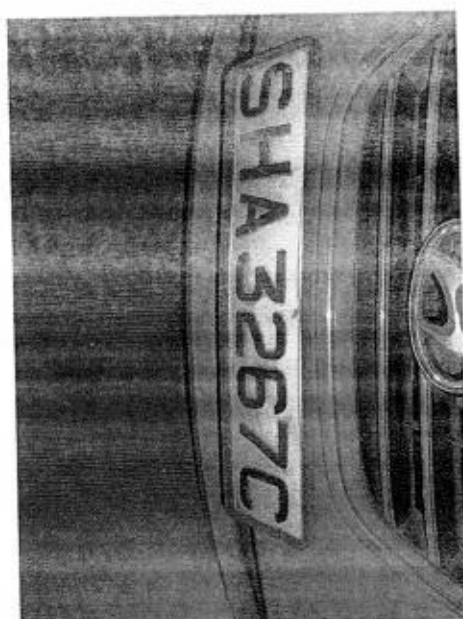
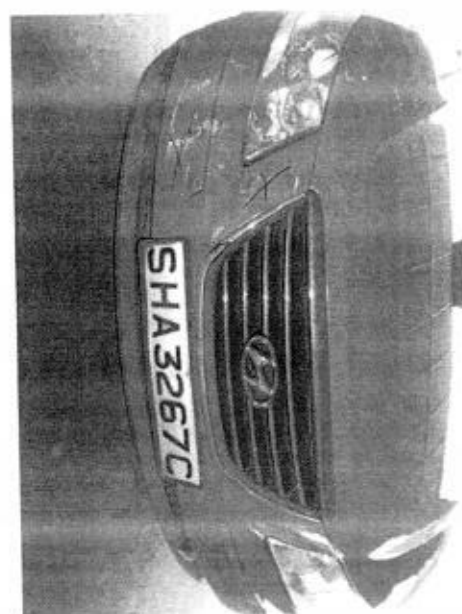
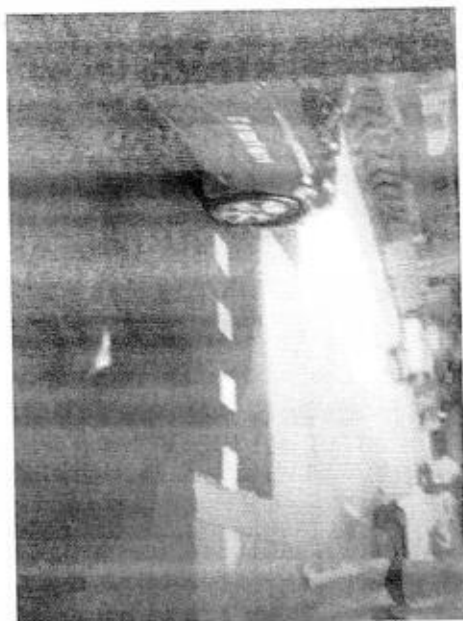
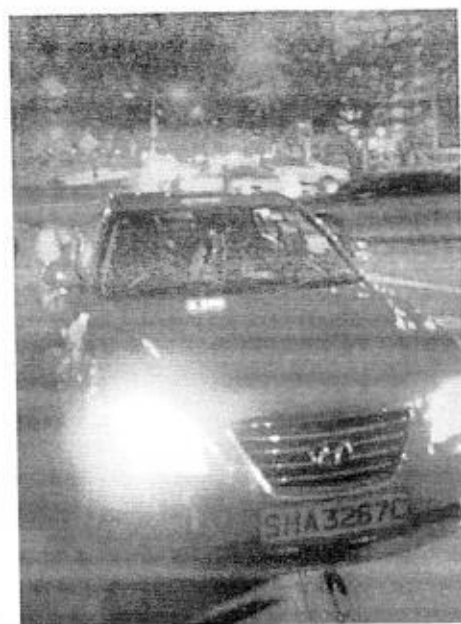
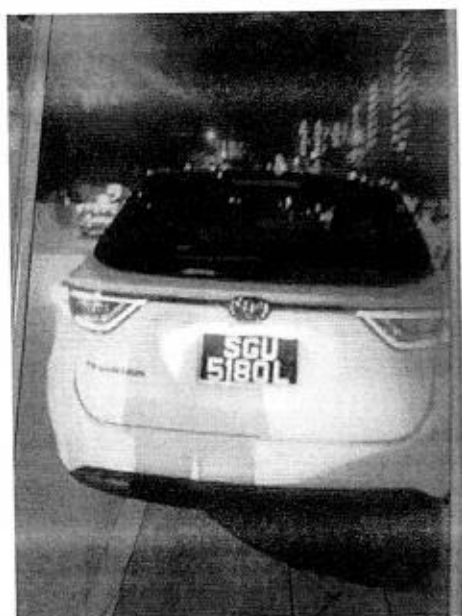
THE VEHICLE SUSTAINED DAMAGES AT THE FRONT O/S PORTION. DAMAGES SEE DETAILS.

Qty	Description of Parts	Condition	Estimate By Workshop (\$)	Our Adjusted (\$)
<u>REPLACEMENT OF PARTS</u>				
1	BONNET	DENTED	1,151.80	1,151.80
1	BONNET INSULATOR	SERVICEABLE	232.80	-
1	BONNET INSULATOR CLIPS	NOT NECESSARY	10.00	-
1	RADIATOR GRILLE U MOULDING	CUT	108.90	108.90
1	FRONT BUMPER COVER	CRACKED	538.80	538.80
1	FRONT BUMPER SPONGE	SERVICEABLE	136.30	-
1	FRONT BUMPER REINFORCEMENT	SERVICEABLE	504.10	-
1	FRONT BUMPER GRILLE (RH)	SERVICEABLE	17.60	-
1	FRONT BUMPER BRACKET TOP (RH)	SERVICEABLE	22.40	-
1	FRONT BUMPER PROTECTOR (RH)	CRACKED	29.20	29.20
1	FRONT BUMPER BRACKET (RH)	SERVICEABLE	20.10	-
1	HEADLAMP SUPPORT PANEL ASSY	SERVICEABLE	1,023.00	-
1	HEADLAMP (RH)	GRAZED	797.90	797.90
1	FRONT FENDER (RH)	DENTED	593.00	593.00
1	FRONT FENDER SHIELD (RH)	SERVICEABLE	86.00	-
1	WIPER CONTAINER	SERVICEABLE	59.00	-
1	WIPER CONTAINER MOTOR	SERVICEABLE	63.00	-
	LESS 20% DISCOUNT		-1,078.78	-643.92
			4,315.12	2,575.68

<u>SPECIAL NETT ITEMS</u>				
1	FRONT NUMBER PLATE (SN)	DENTED	25.00	25.00
1	FRONT NO PLATE TRIM COVER (SN)	CUT	30.00	30.00
			55.00	55.00
<u>LABOUR</u>				
	PANEL BEATING.		1,000.00	600.00
	SPRAY PAINTING CHARGE.		750.00	600.00
	WIRING CHARGE.		50.00	20.00
	TUFF KOTE.		50.00	20.00
	TOWING CHARGE.		60.00	-

Qty	Description of Parts	Condition	Estimate By Workshop (\$)	Our Adjusted (\$)
	REMOVE/REFIX AIRCON & REFILL GAS.	NOT NECESSARY	150.00	-
			2,060.00	1,240.00
GRAND TOTAL			6,430.12	3,870.68
RECOMMENDED COST OF LUMP SUM REPAIRS (TO ITS PRE-ACCIDENT CONDITION) (CONFIRMED)				3,100.00
