1. Policy Particulars :- THIRD PARTY CLAIM

Insured Veh.	SJM 2931M	Veh. Inspected	SHC 3035U
Policy No.	5105716215	Coverage (\$)	0.00
Claim No.	MT/1025801-002	Excess (\$)	0.00
Assign From		Assign Date	31/12/2018

4. Description of Damages

ADJUSTMENT ON REPAIR COST FOR VEHICLE NO. SHC 3035U

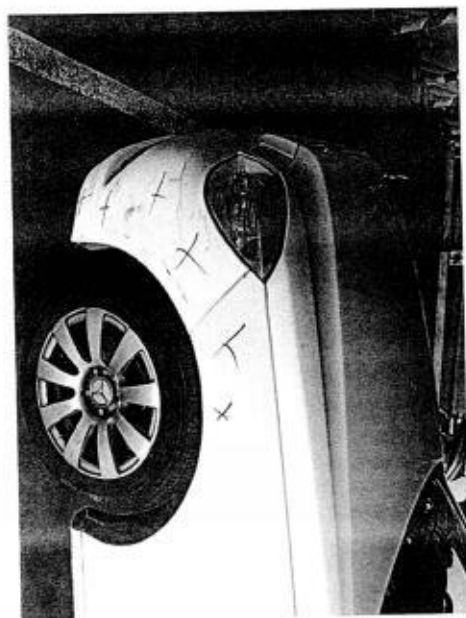
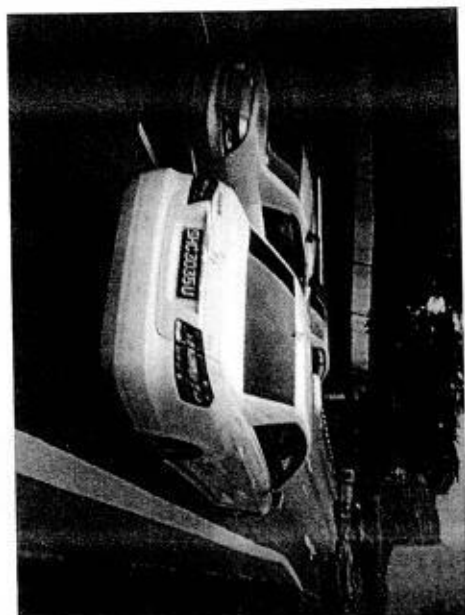
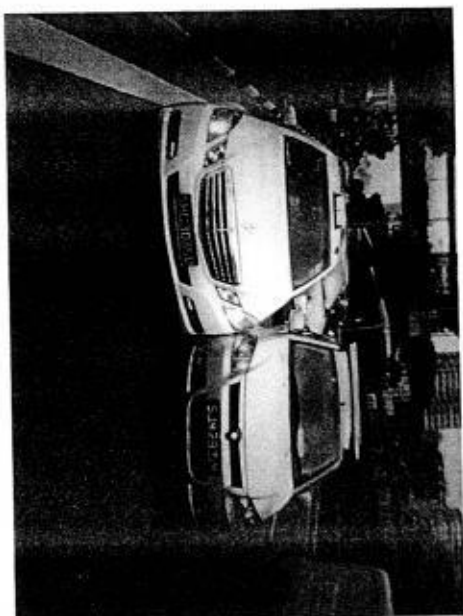
THE VEHICLE SUSTAINED DAMAGES AT THE N/S FRONT PORTION. DAMAGES SEE DETAILS.

Qty	Description of Parts	Condition	Estimate By Workshop (\$)	Our Adjusted (\$)
	<u>REPLACEMENT OF PARTS</u>			
1	BUMPER ASSY,FRT	DEFORMED	1,890.50	1,890.50
1	BUMPER BRACKET,FRT/LH	SERVICEABLE	95.00	-
1	HEAD LAMP ASSY (LH)	GRAZED	2,380.00	2,380.00
1	HEAD LAMP BRACKET (LH)	SERVICEABLE	300.00	-
1	FENDER (LH)(NPA)	TO REPAIR SEE LABOUR	-	-
	LESS 20% DISCOUNT		-933.10	-854.10
			3,732.40	3,416.40
	<u>LABOUR</u>			
	PANEL BEATING.INCLUSIVE OF THE REPAIR OF FENDER (LH).		400.00	200.00
	SPRAY PAINTING CHARGE.		600.00	400.00
	WIRING CHARGE.		30.00	20.00
	TUFF KOTE.	NOT NECESSARY	50.00	-
			1,080.00	620.00
	GRAND TOTAL		4,812.40	4,036.40
RECOMMENDED COST OF LUMP SUM REPAIRS (TO ITS PRE-ACCIDENT CONDITION) (CONFIRMED)				3,200.00
