- Pre repair inspection request - SLD7171E VS SKX6026E (OI) DOA 16/12/2018

**YOUR INSURED VEHICLE REGISTRATION NO. SKX 6026E  
ACCIDENT ON 16<sup>th</sup> DECEMBER 2018 INVOLVING SLD 7171E AND SKX 6026E AT 1840  
HOURS ALONG JUNCTION OF QUEENS ROAD AND PRINCE ROAD**

## VEHICLE DAMAGE INSPECTION REPORT

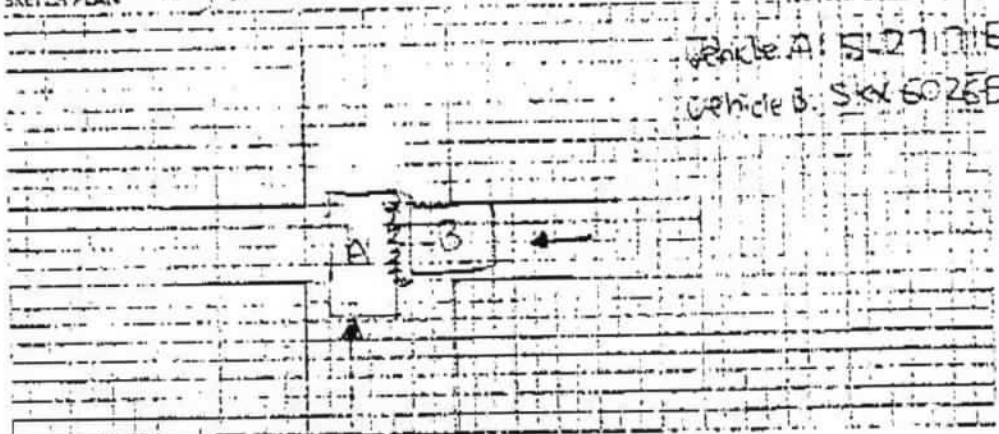
# Accident Sketch Plan

SKETCH PLAN Along Junction of Road 1 and Road 2, Queen's Road, Prince Road

On 16/12/2018 at about 1840hrs, I was driving along Queen's Rd towards Empress Rd. As I was driving past the junction of Queen's Rd and Prince Rd when suddenly a black Mazda (SKX6026E) had collided onto the driver side of my vehicle. I made a check on my 4 passengers before exiting the vehicle. The driver and I exchanged particulars and agreed to settle with our insurance. No one was injured. The driver side of my vehicle (SCD7171E) sustained dents and scratches from the impact. The other vehicle sustained damages on the front bumper.
