CS/MSG19000313/Usd3 9

SLZ 9034P

Vehicle Model: ELANTRA AD 1.6 GLS AT (AMS)

VEHICLE DAMAGE INSPECTION REPORT

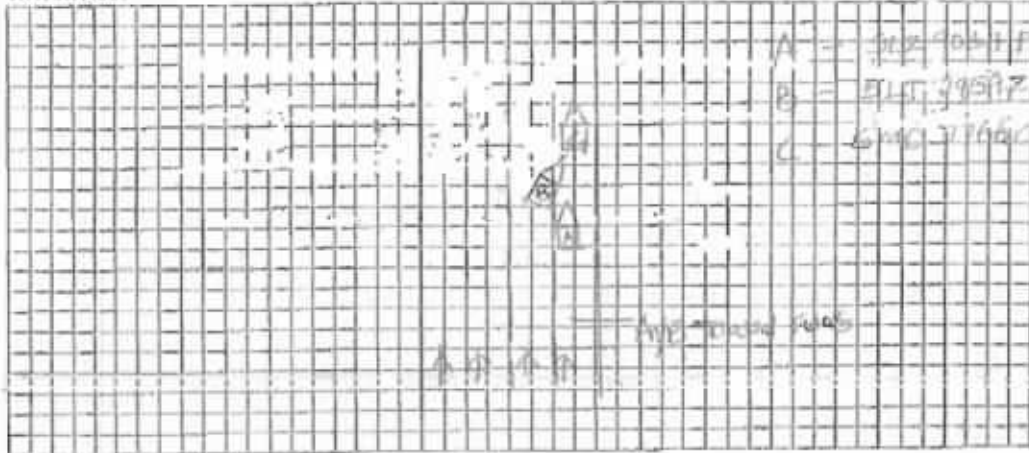
SKETCH PLAN

DESCRIBE CIRCUMSTANCES OF THE ACCIDENT

As I travelling on the extreme right lane, the front car bearing (SLT 7766C) slowing down, I follow suit as I was 30 car length of the front car suddenly, a car bearing SLT 295172 which was from my left swerved to my lane, and hit onto the front portion of my vehicle.
