To Inspect Vehicle No. **SLT 5436X** Insured **FBM1380D**

From: Jowyn Tay <jowyn_tay@sg.msig-asia.com>
Sent: Monday, 7 January, 2019 3:23 PM
To: SUR; Admin-D (LKKAuto)
Subject: ASSIST TO DO PAPER RE-SURVEY OF SLT5436X (OUR REF: MSC/V/18-001195)

TRAFFIC ACCIDENT INVOLVING SLT5436X AND FBM1380D AT BLK 496 OF JURONG WEST STREET 41 OSCP ON 22nd MAY 2018 AT ABOUT 1255HRS

VEHICLE DAMAGE INSPECTION REPORT

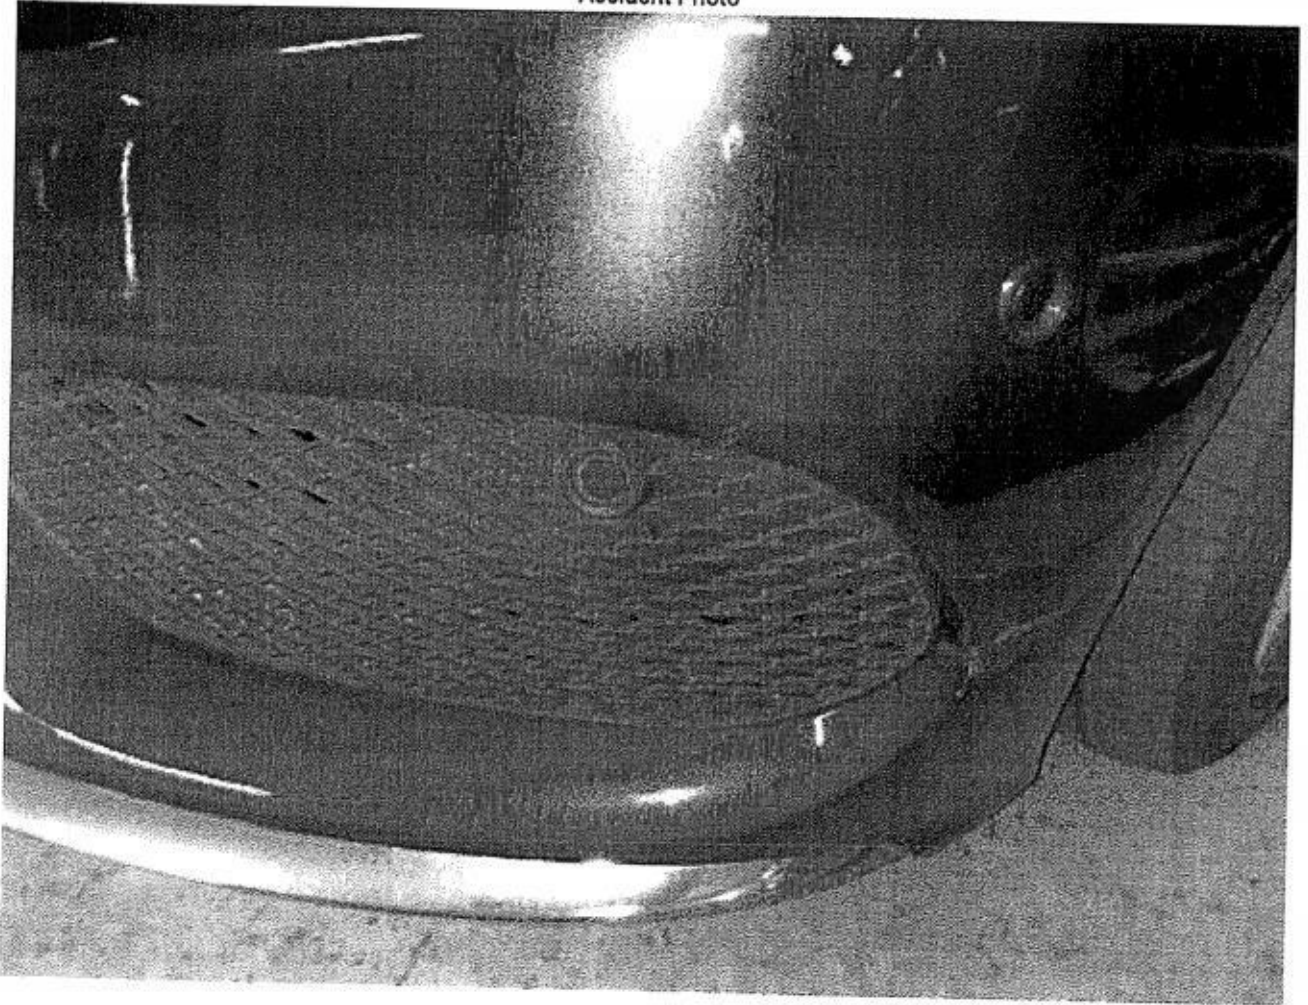
Accident Photo

Details of Vehicle Involved						
Vehicle No.	Type	Make	Model	Colour	Condition	No. of Passenger
FBM1380D	Motorcycle				No Damage	0
SLT5436X	Car	MERCEDES BENZ	C180 COUPE AMG LINE (R18 LED)	Blue	Slightly Damaged	1
