Veh No: SJB 6393Y Yr Regn: 4 06

Toyota wish

NOTICE OF ACCIDENT & PRE-REPAIR SURVEY - ACCIDENT INVOLVING SJB 6393Y, SHD 3182Y, SHB 4967D & SHB 5248P AT JUNCTION OF SENGKANG WEST AVENUE & FERNVALE ROAD ON 11 JANUARY 2019 @ 2000HRS

VEHICLE DAMAGE INSPECTION REPORT

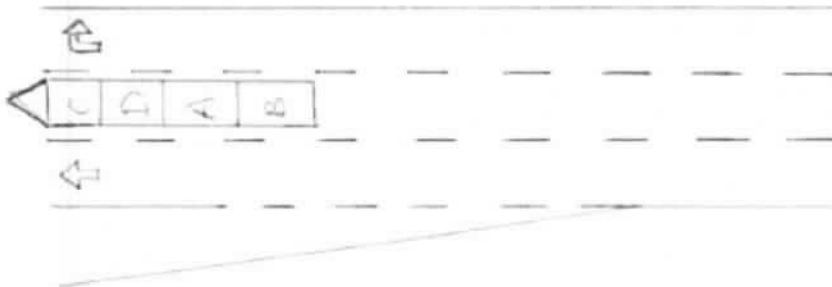
Sketch Plan #2

A: 57B6593Y
B: 57D3182Y
C: 5HB4967D
D: 5HD5248P

3000000 WEST AVE X FERNVALE RD

ON THE STATED DATE / TIME AND LOCATION, I WAS
TRAVELING ON SAUGKANG WEST AVE ON MY WAY HOME
I STOPPED BEHIND A VEHICLE DUE TO RED LIGHT
ALL OF A SUDDEN VEHICLE "B" COLLIDED ONTO MY REAR
AND MY VEHICLE MOVE FORWARD AND HITS ONTO MY
FRONT VEHICLE. AFTER THAT I REALISE I WAS INVOLVE
IN A 4 CARS ACCIDENT WE PROCEED TO INSURANCES
