SH 9999S

Make: TOYOTA PRIUS A/C: Insur. d / Std / NI / NA

The U/C / Chassis frame / Body Structure affected due to collision

VEHICLE DAMAGE INSPECTION REPORT

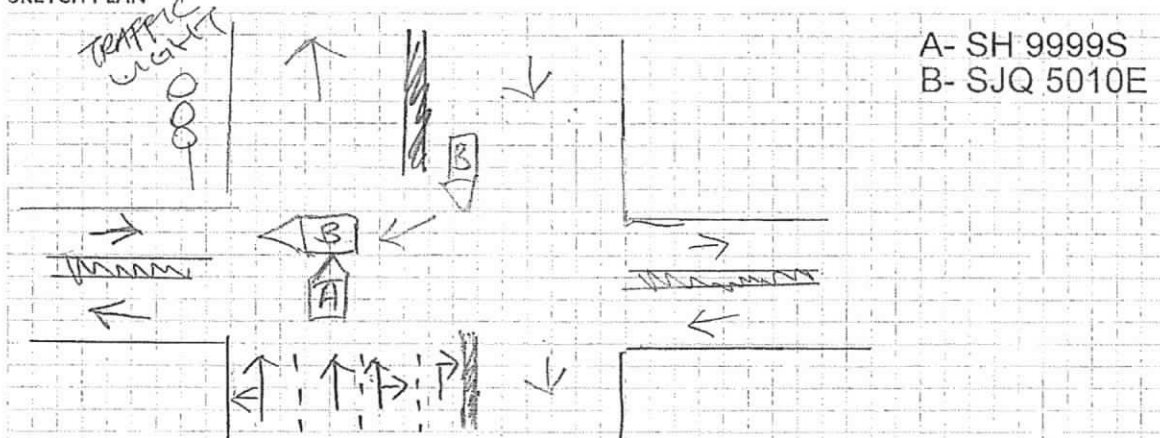
SKETCH PLAN

Along Yishun Ave 7 x Junction Yishun Industrial Park A

On 14.01.2019@0725HRS I was travelling along Yishun AVE 7 X Junction Yishun Industrial Park A with one male passenger onboard.

On the traffic junction I was travelling straight and the traffic light was green. I proceeded straight, upon crossing the Junction traffic light turns amber and I could not stop in time. Veh (B) SJQ 5010E did not gave way to my taxi(A) and collided onto my taxi entire front portion.
--
