**Preliminary Advice**

Insured Vehicle No	: GBD439Z		
TP Vehicle No	: SKZ1740Z	Accident Date	: 15/01/2019
Make	: VOLKSWAGEN GOLF	Assignment Date	: 16/01/2019
Date of Inspection	: 18/01/2019	Est. Duration of Repair	: 6.00
Inspection At	: VOLKSWAGEN GROUP SINGAPORE PTE LTD (-) 247 ALEXANDRA ROAD SINGAPORE 159934

## VEHICLE DAMAGE INSPECTION REPORT

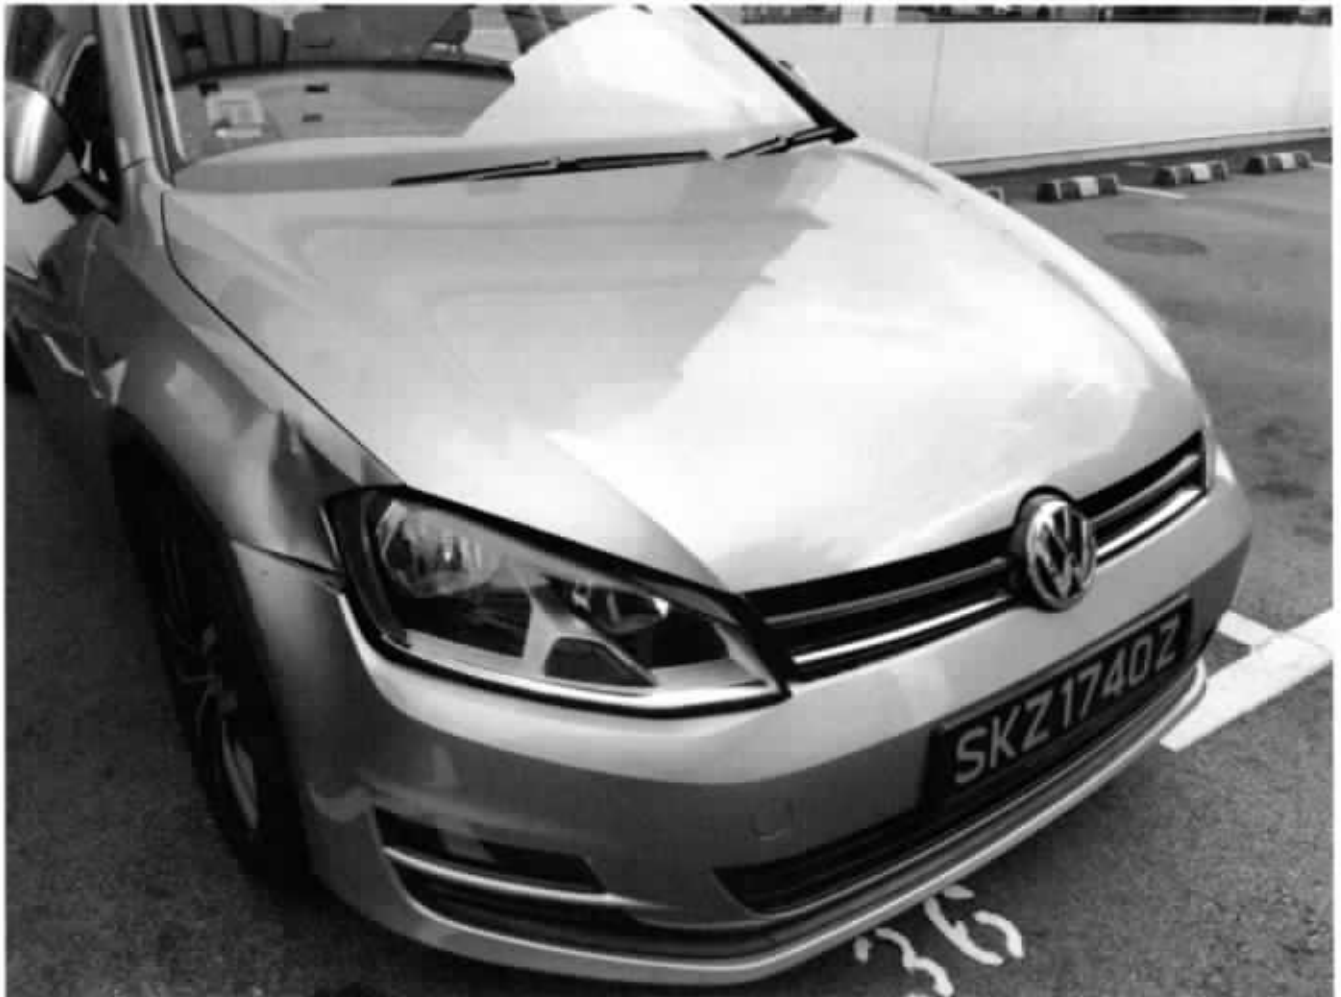
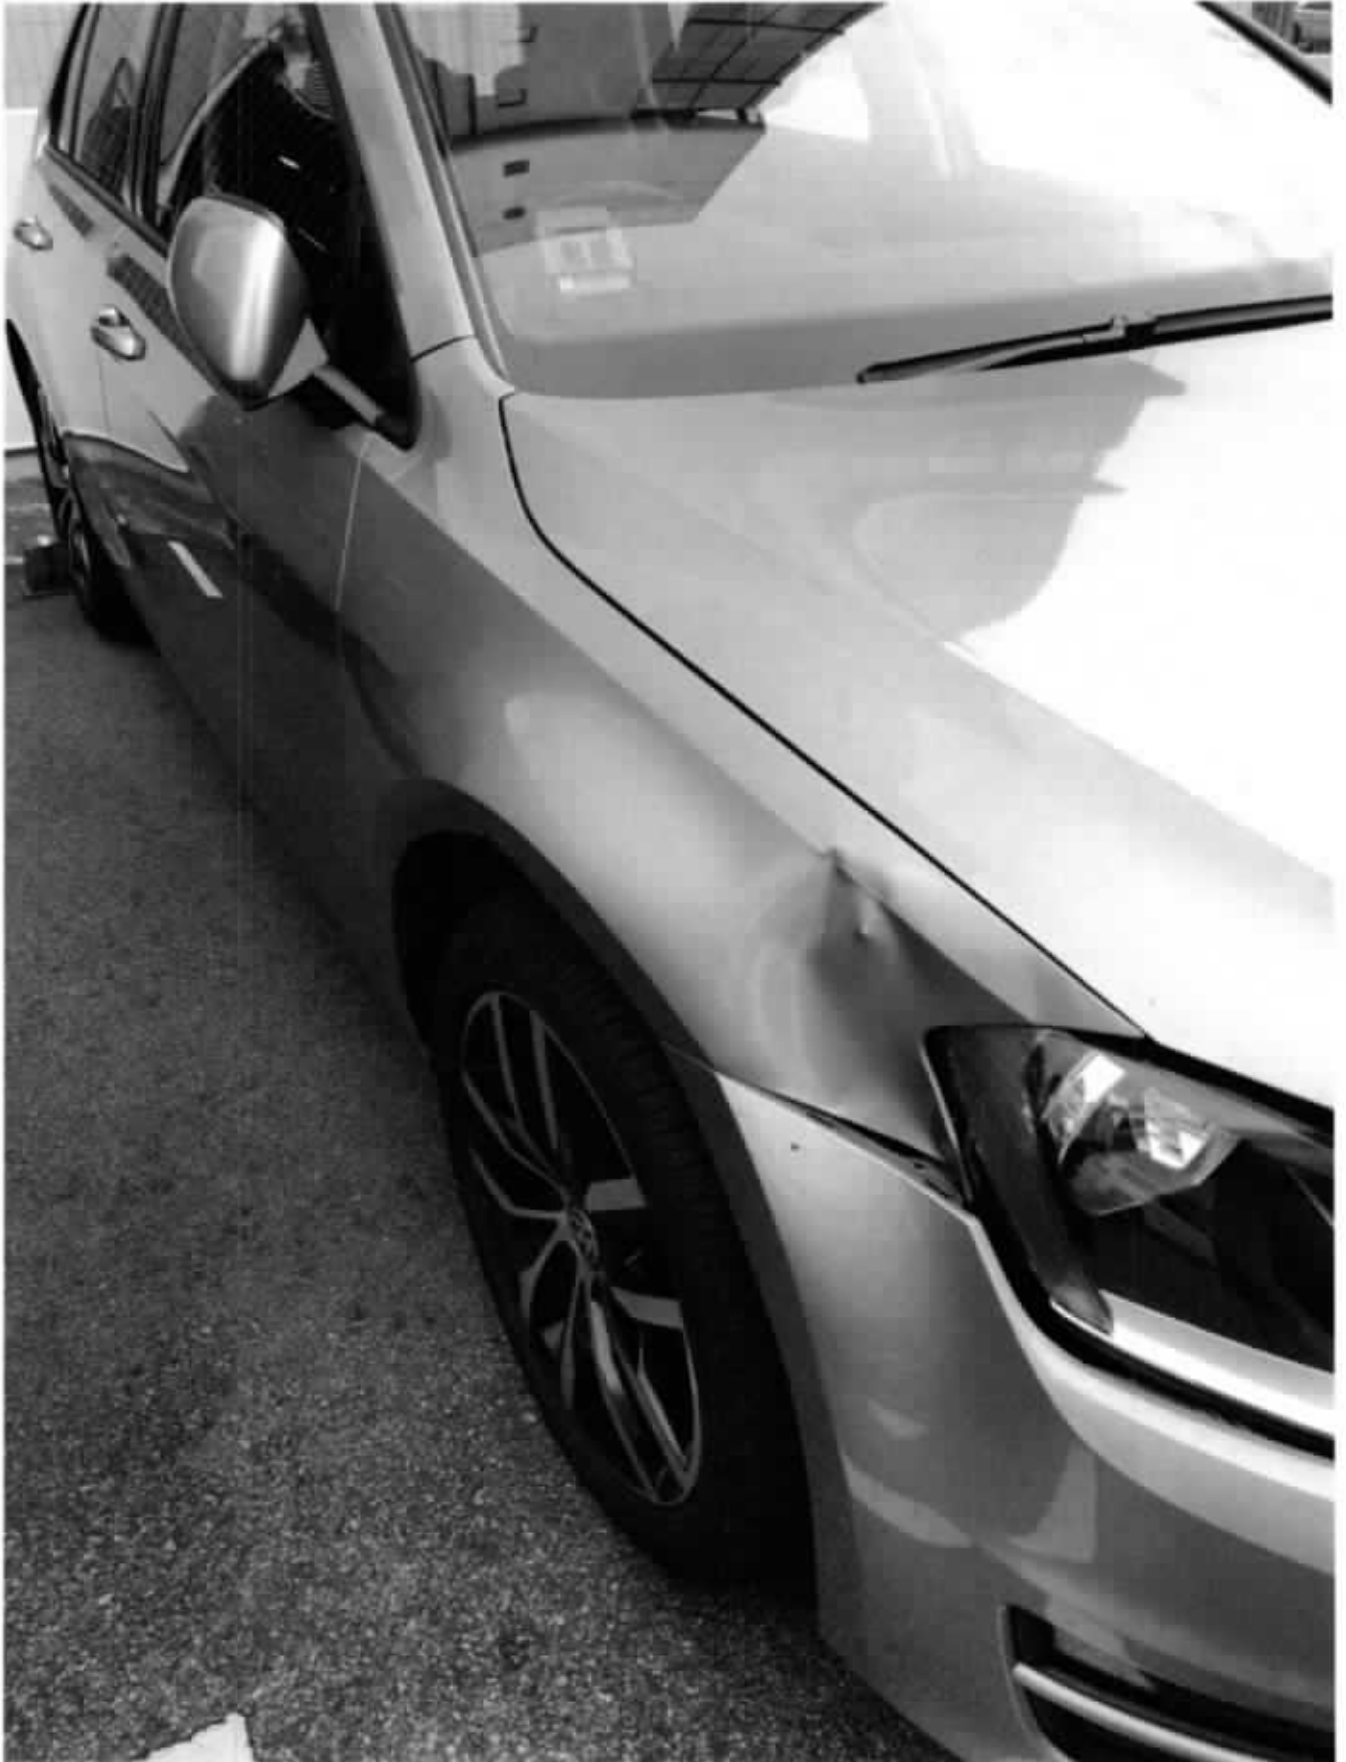
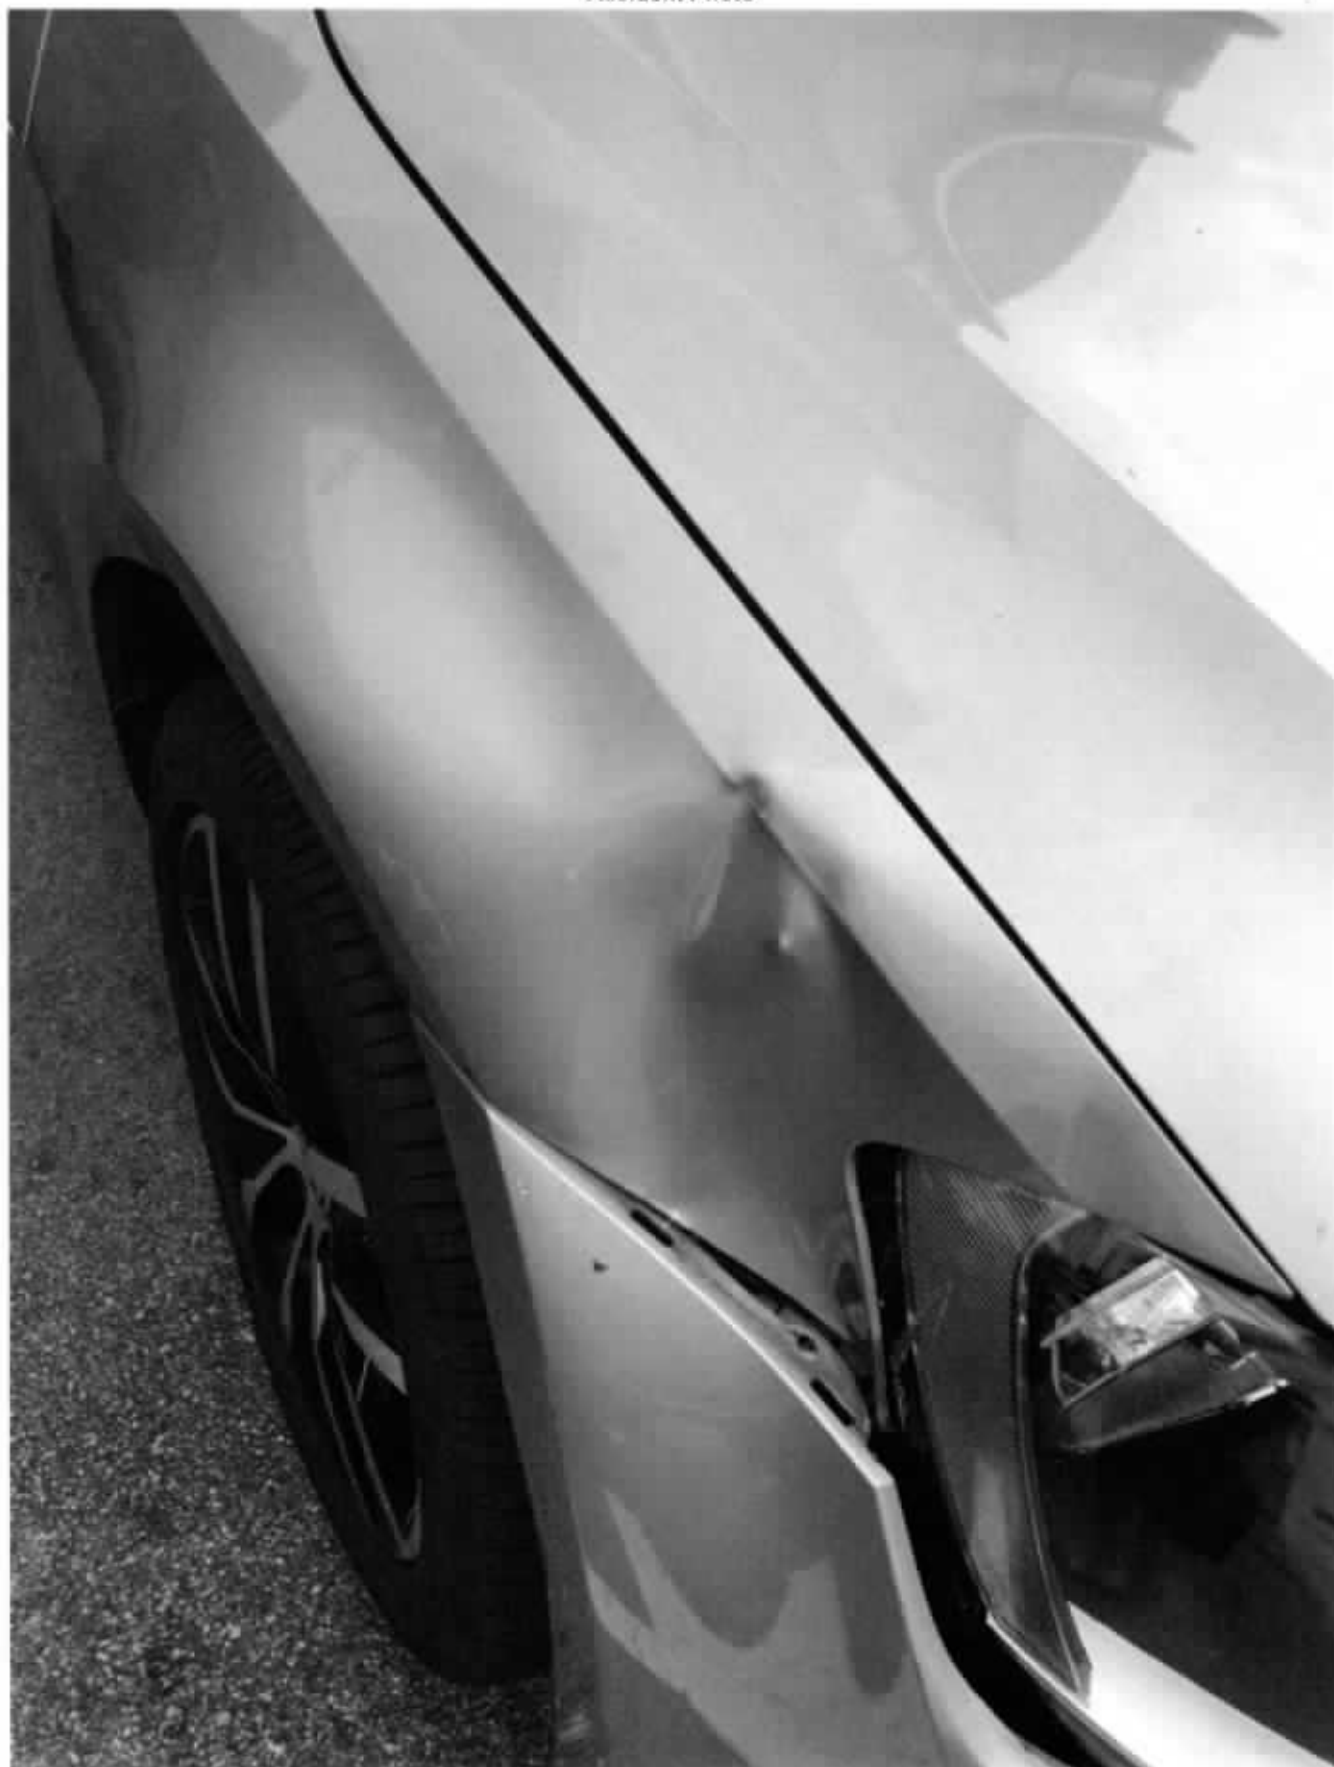
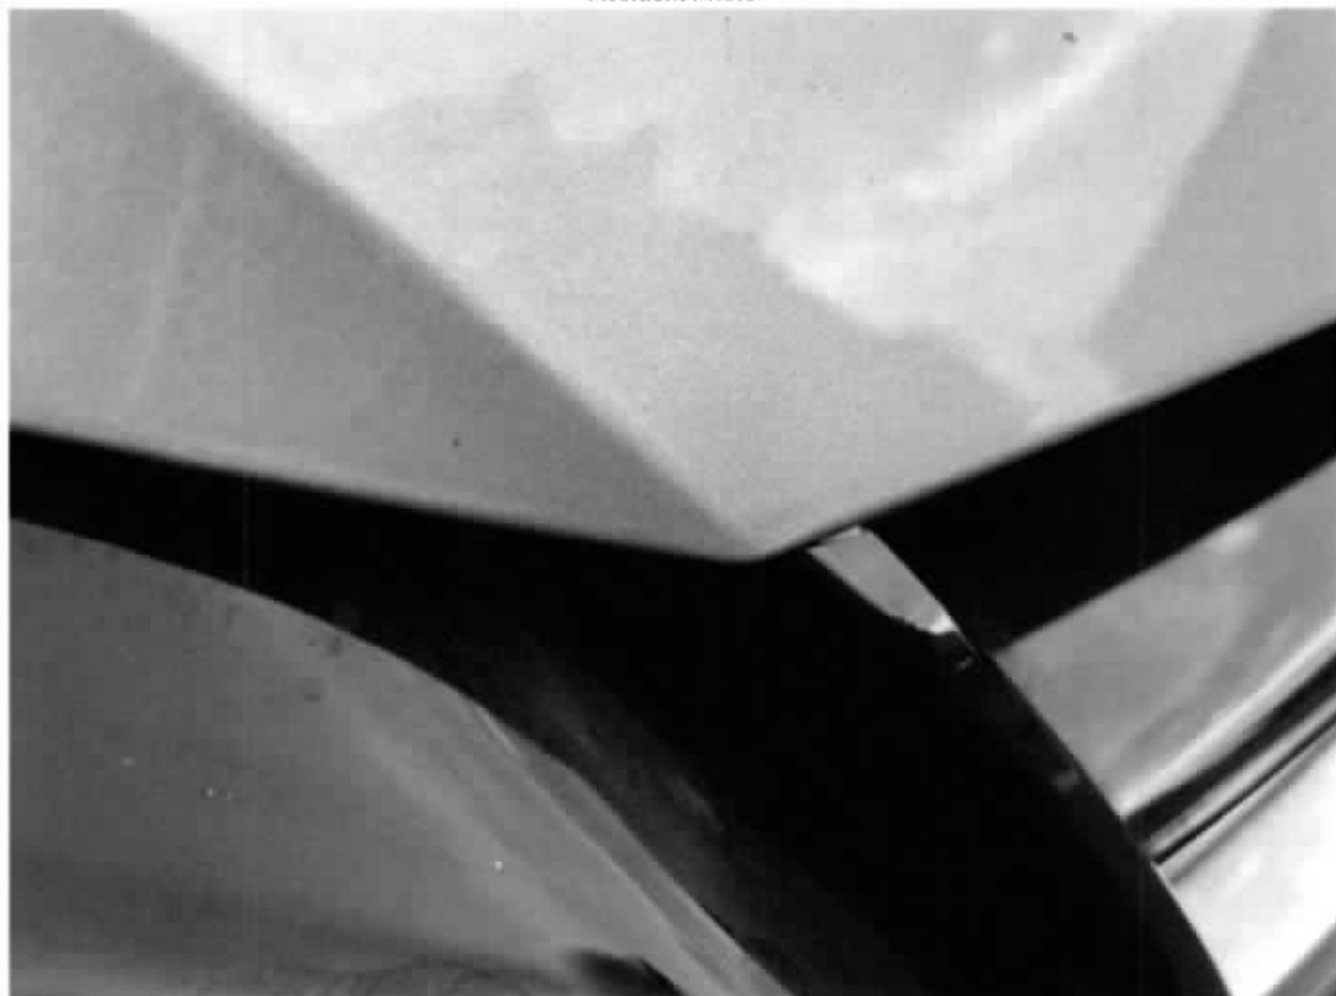
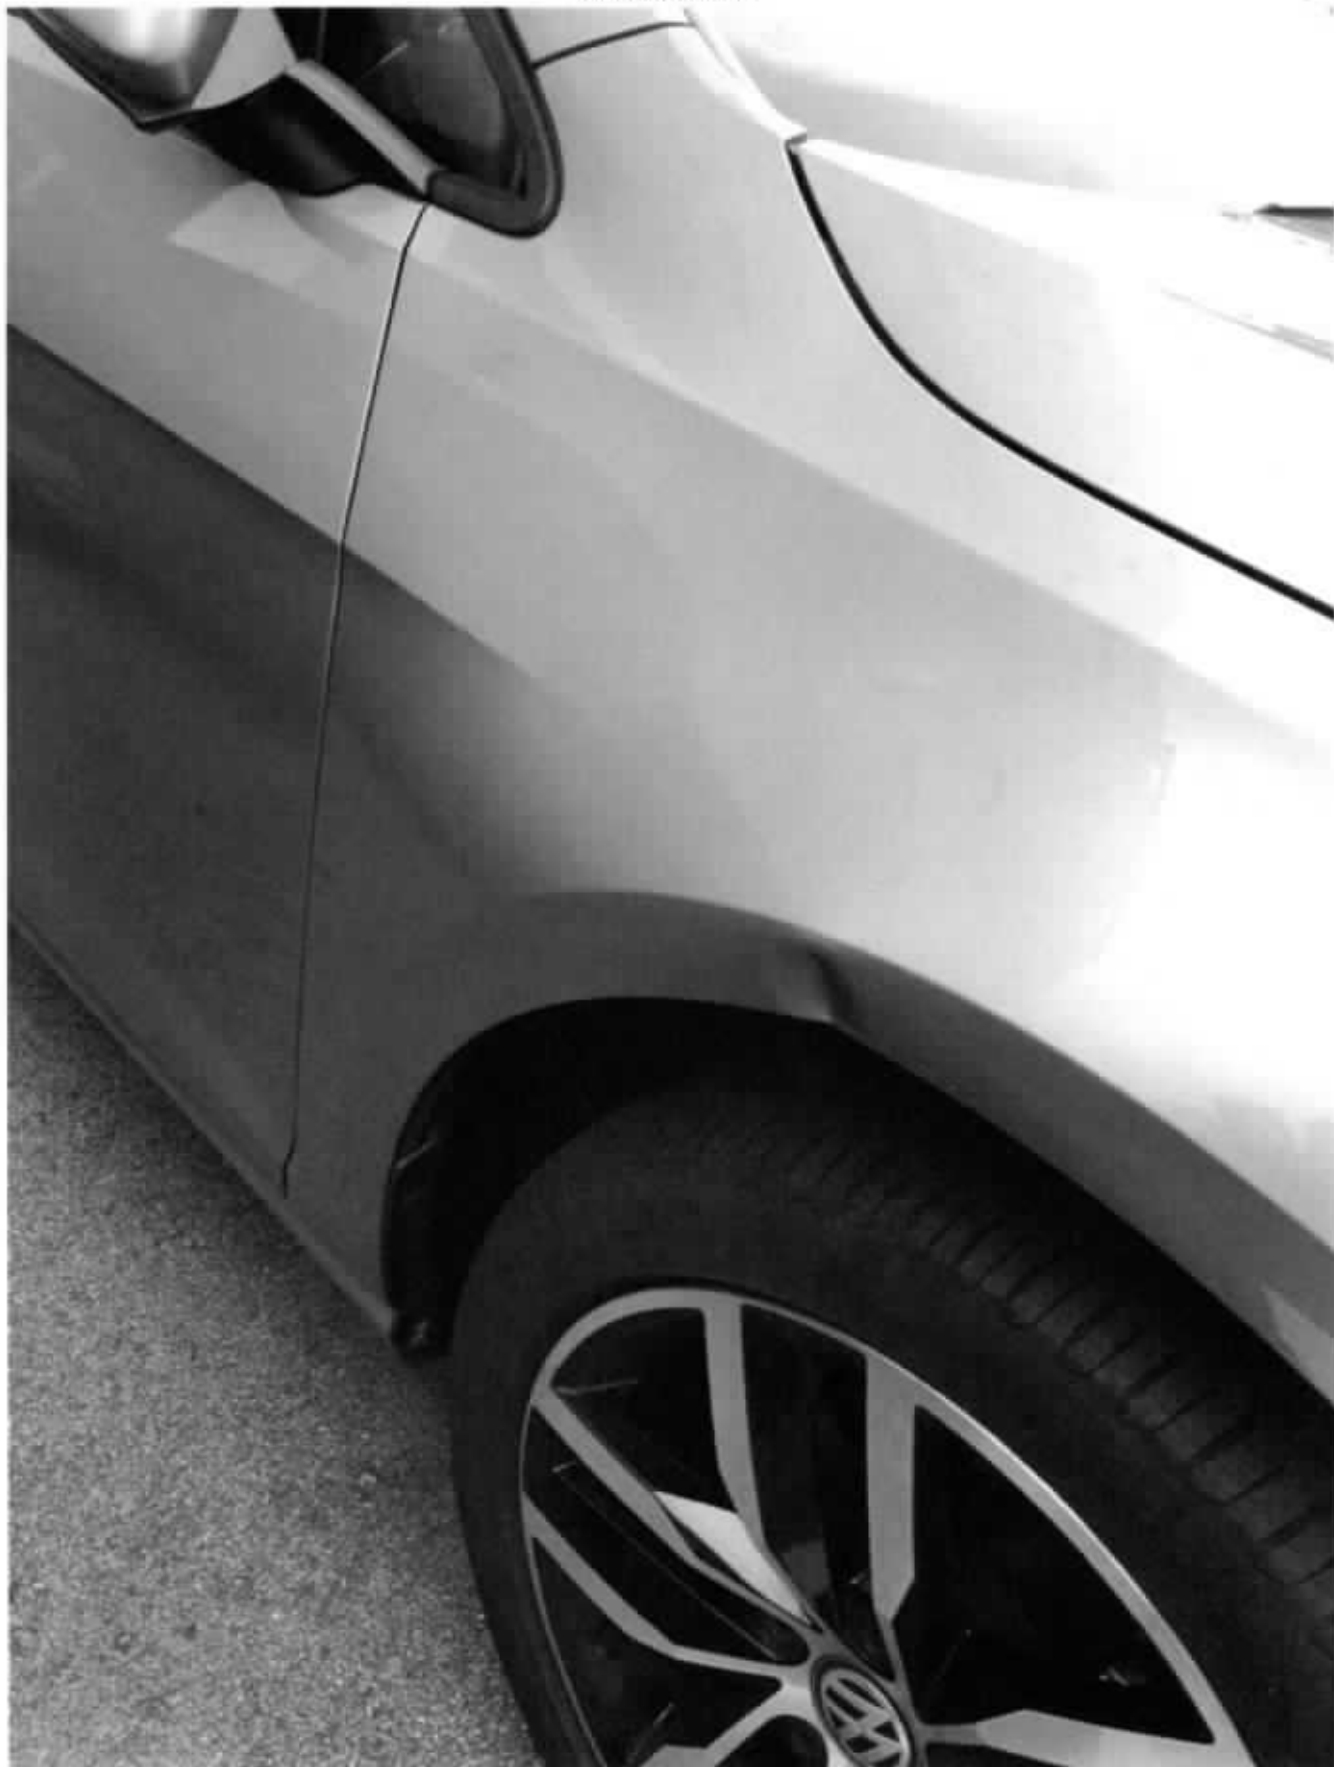
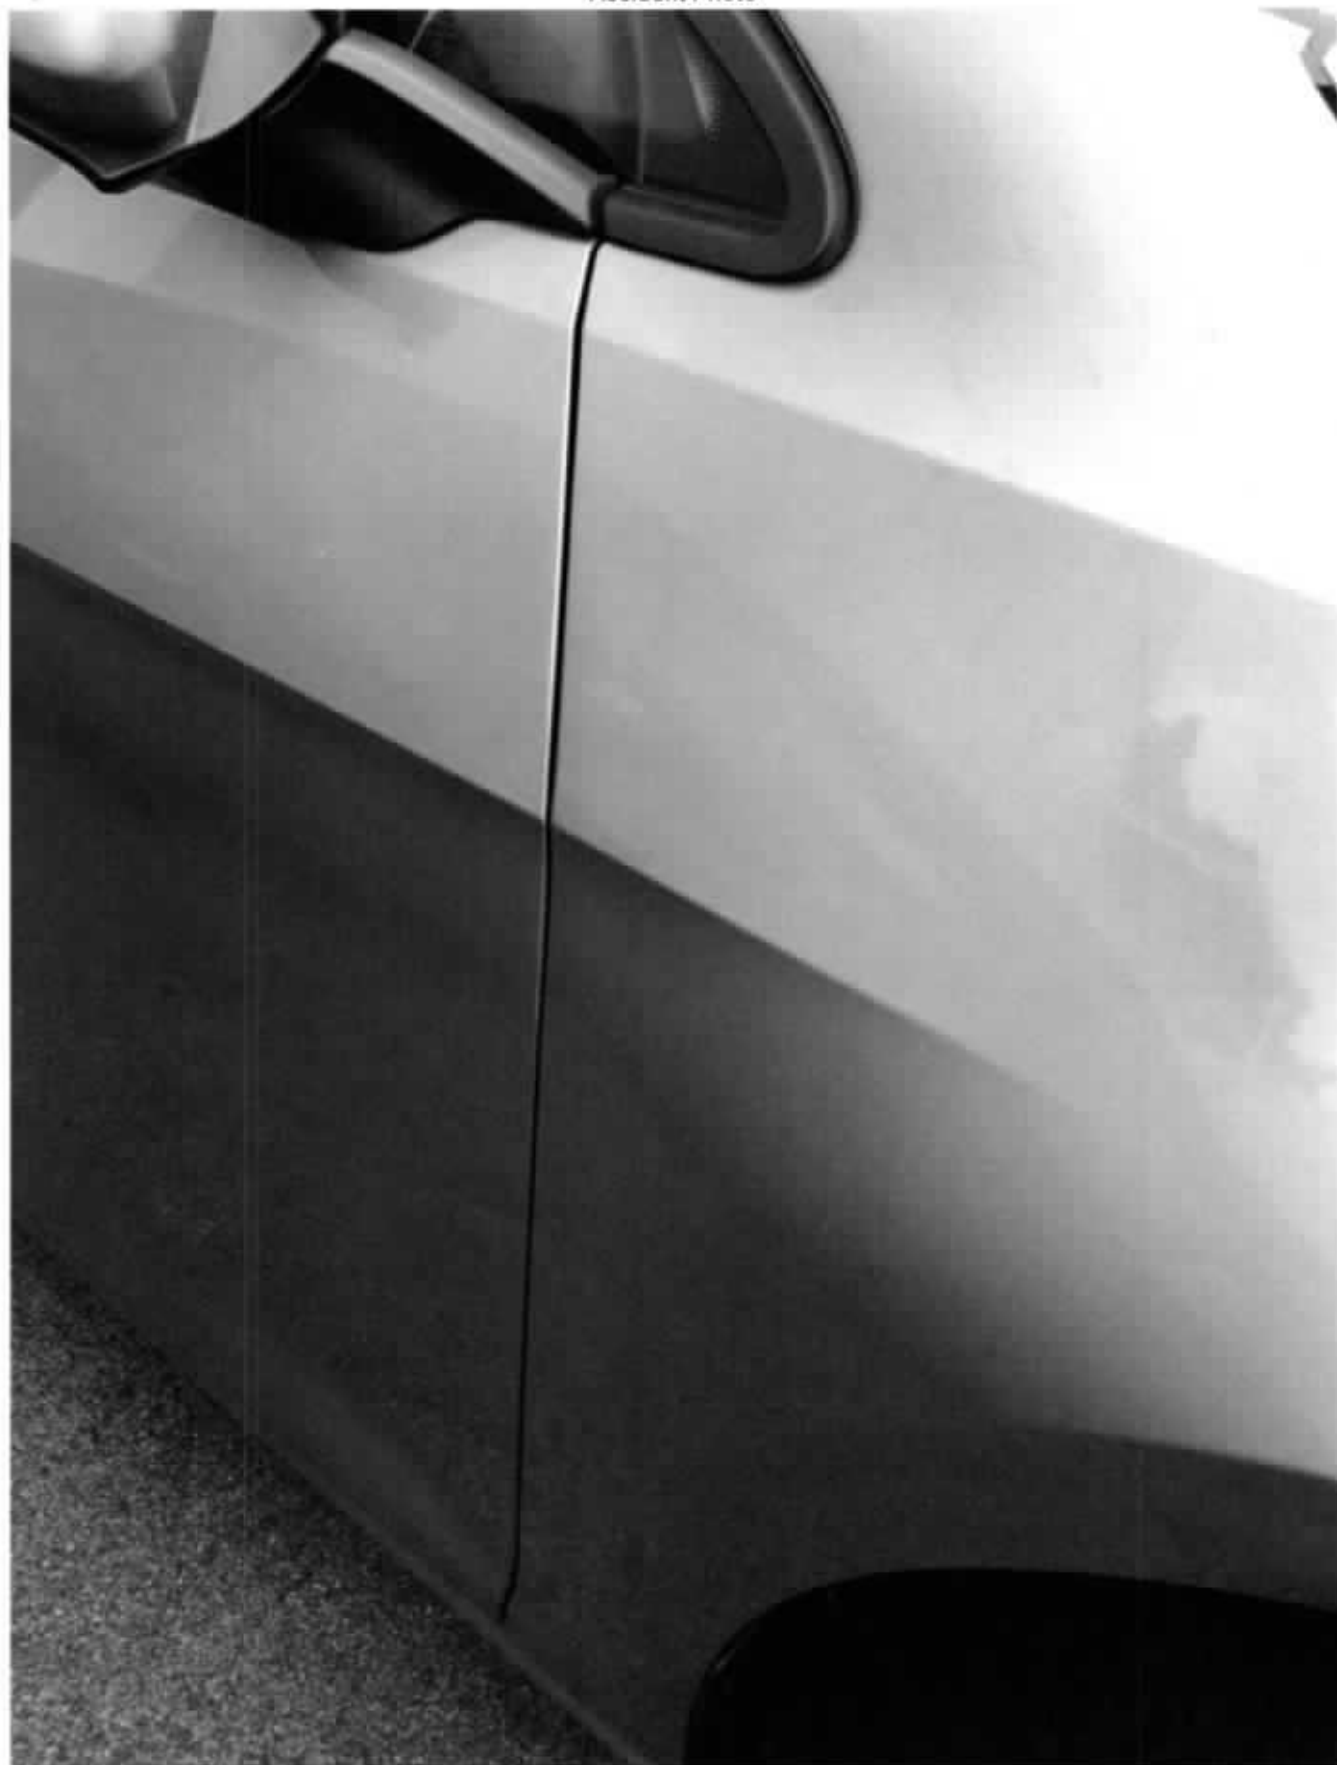
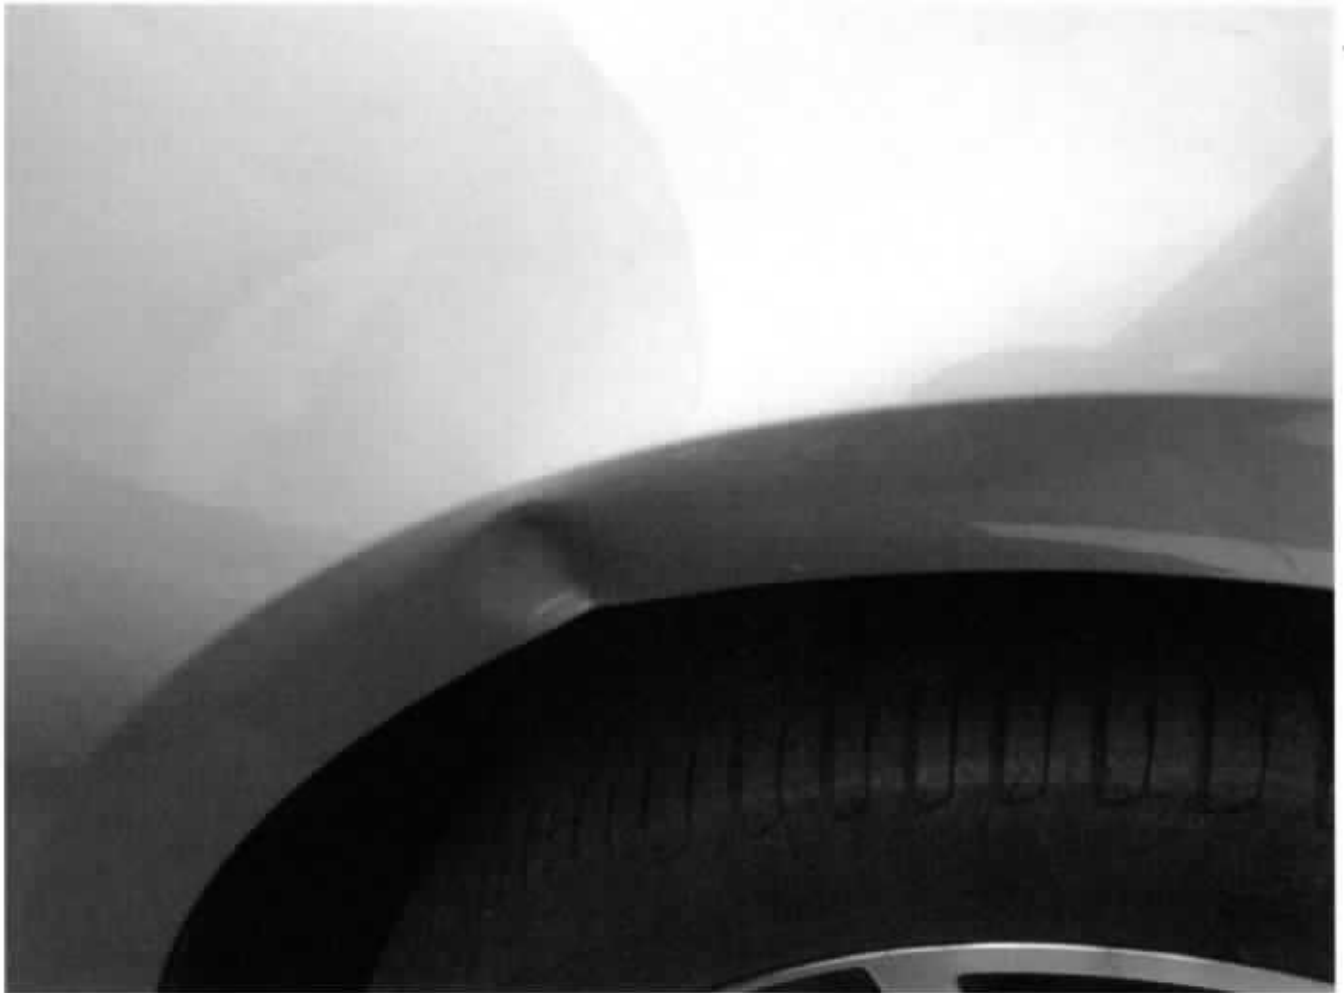
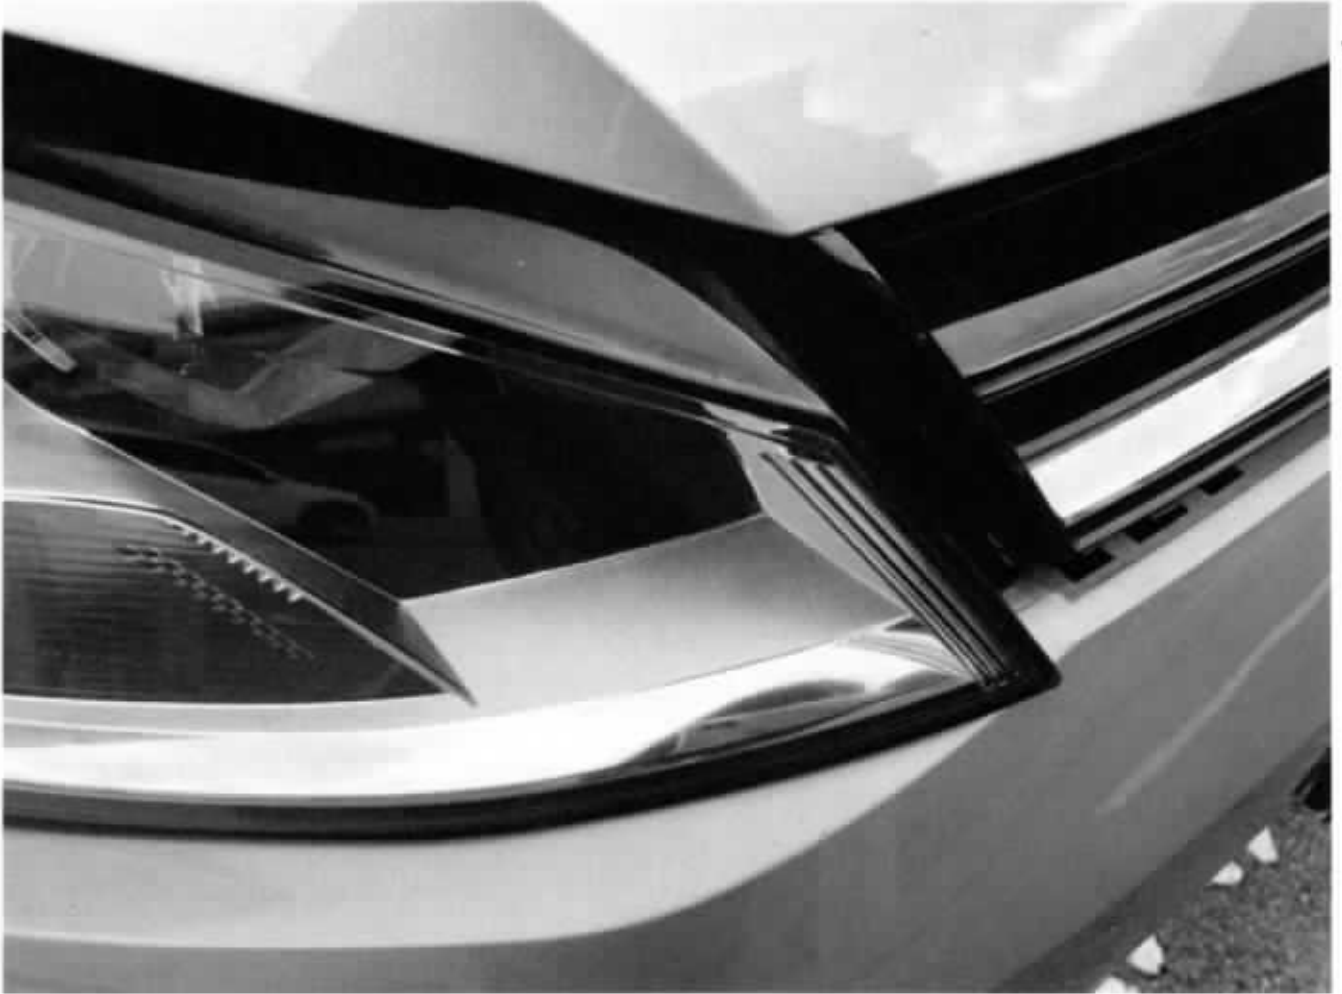
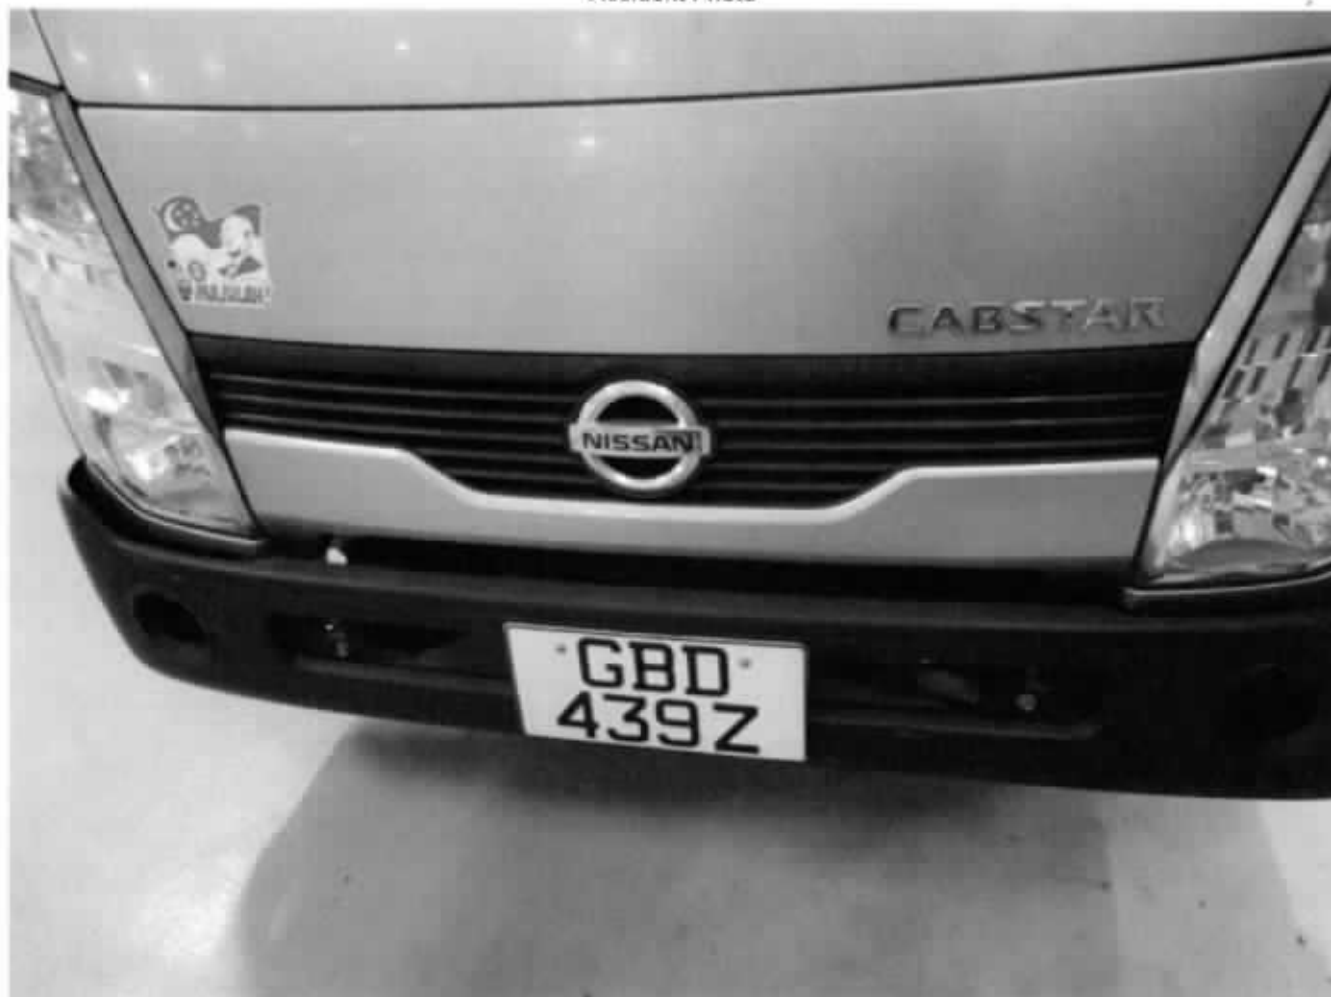
Accident Photo

The vehicle sustained impact / damages front o/s portion and parts claimed are consistent to the accident.
