- PRE-REPAIR INSPECTION - ACCIDENT INVOLVING OUR INSURE...

PROPERTY DAMAGE CLAIM ARISING FROM A ROAD TRAFFIC ACCIDENT ON 14 JANUARY 2019 AT ABOUT 09:40HRS INVOLVING MOTOR VEHICLES NO(S). SKU4845L & SGT775J ALONG BKE/PIE BEFORE DAIRY FARM

VEHICLE DAMAGE INSPECTION REPORT

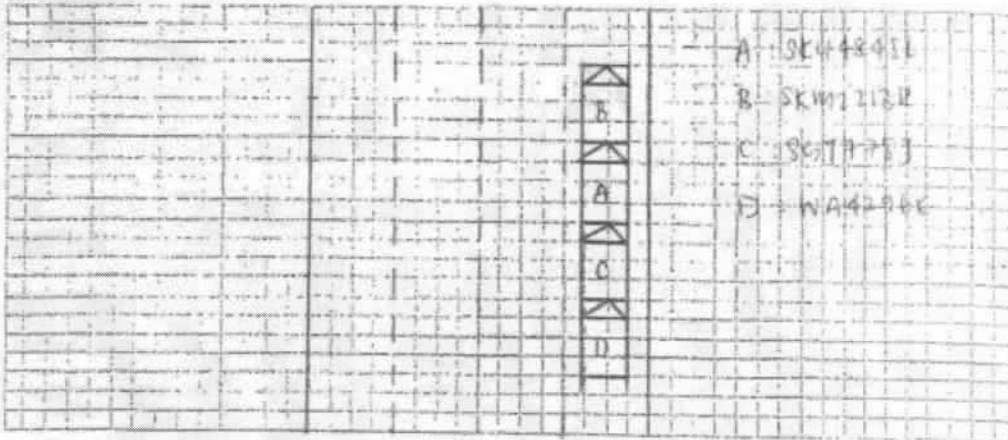
Sketch Plan #2

DESCRIBE CIRCUMSTANCES OF THE ACCIDENT

On the stated time and date, I was travelling on vehicle A bearing carplate number SKU484SL on BRE PIE towards Dairy Farm, vehicle B (SKM2213R) who was in front of me stopped suddenly and I managed to brake on time, however shortly after I felt an impact from the rear. I alighted from my vehicle and realise that vehicle C (SBT775J) had collided head to rear of my vehicle that caused me to hit vehicle A. I wish to state that it is a 4 car chain collision where it also involves vehicle D (WA4296K).
